Priority Restoration Sites Upper Gunnison Basin

Gunnison Climate Working Group

Wolf Creek Ranch (Private) - East Fork and Middle Fork Upper Gunnison Basin Restoration Structures and Monitoring

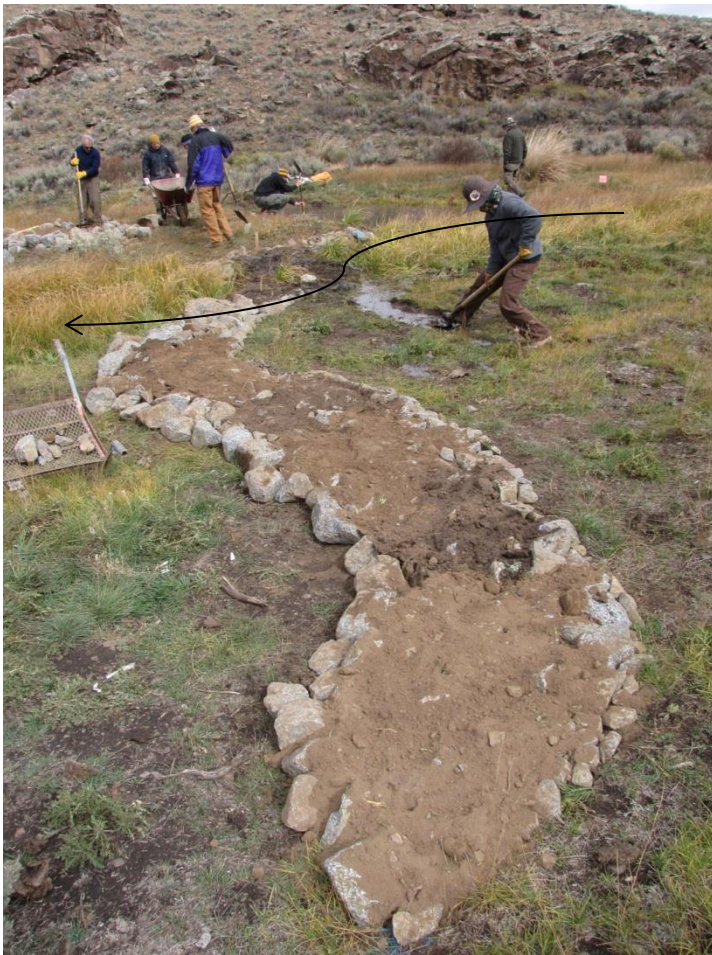
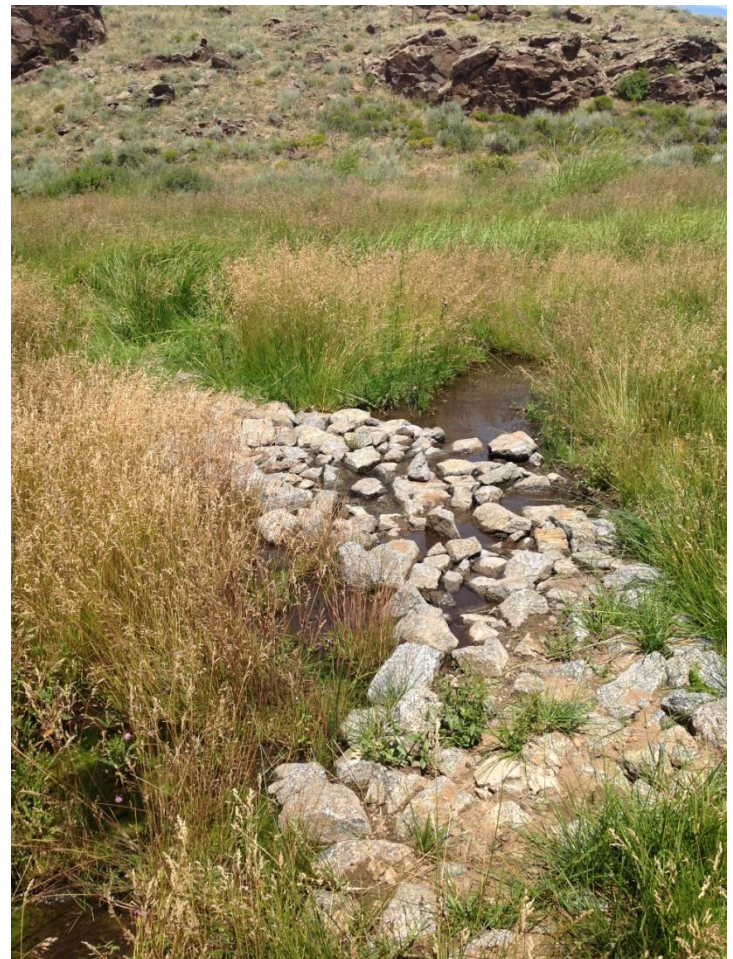
Media Luna, 43

This media luna spread the water across the meadow within one year of its placement. Species composition will probably change within a year or two.

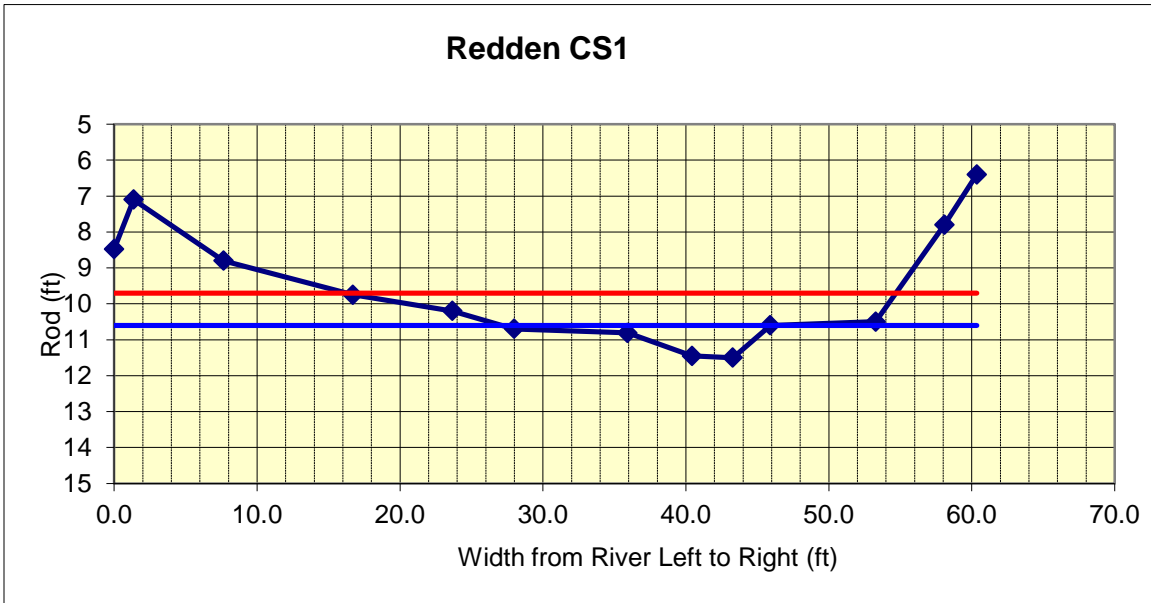
This site has filled in with sediment, and has a healthy channel shape with a floodplain.

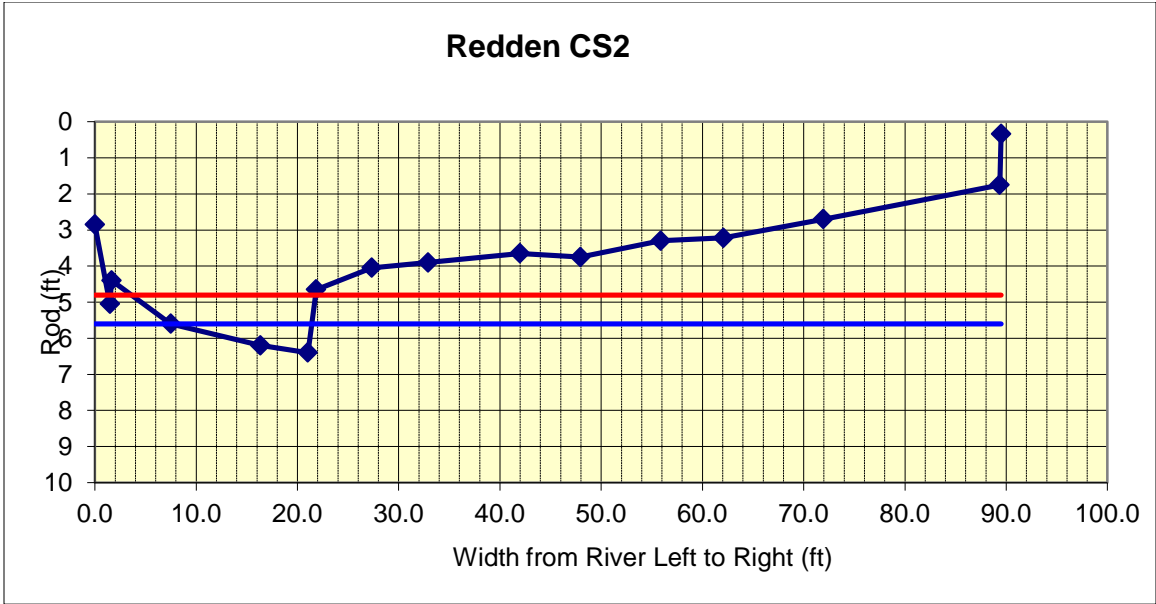
This site is still gullied, blue line is bankfull, red line “flood-prone width”, an estimated 20 year storm, which could not overflow the banks of the gully at present.

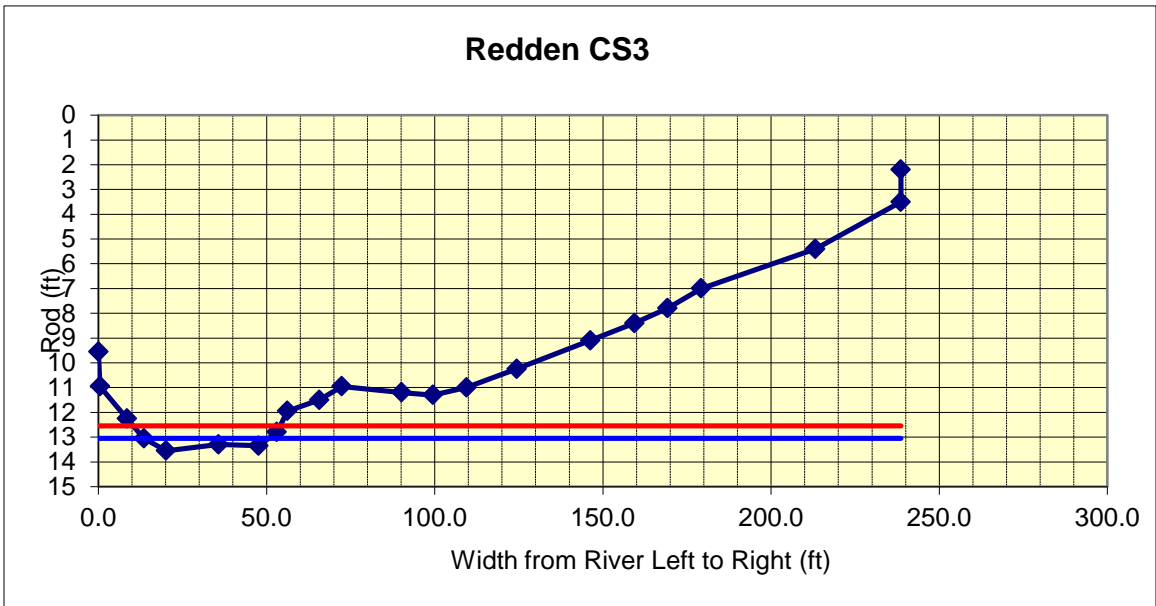
Notice a swale at station 100 that was a former channel before the gully, when the site was a wet meadow.

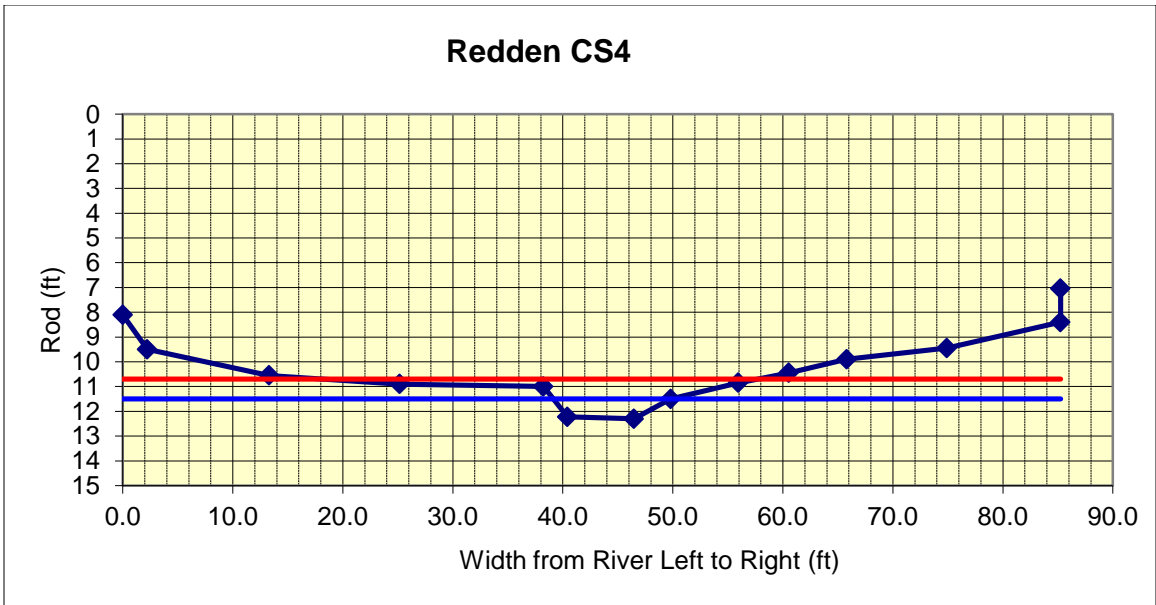
This cross section was taken low in the watershed at a point where the channel begins to braid around some willows. Raising the grade at this point could irrigate much of the former wet meadow between stations 10 and 40 on the cross section.

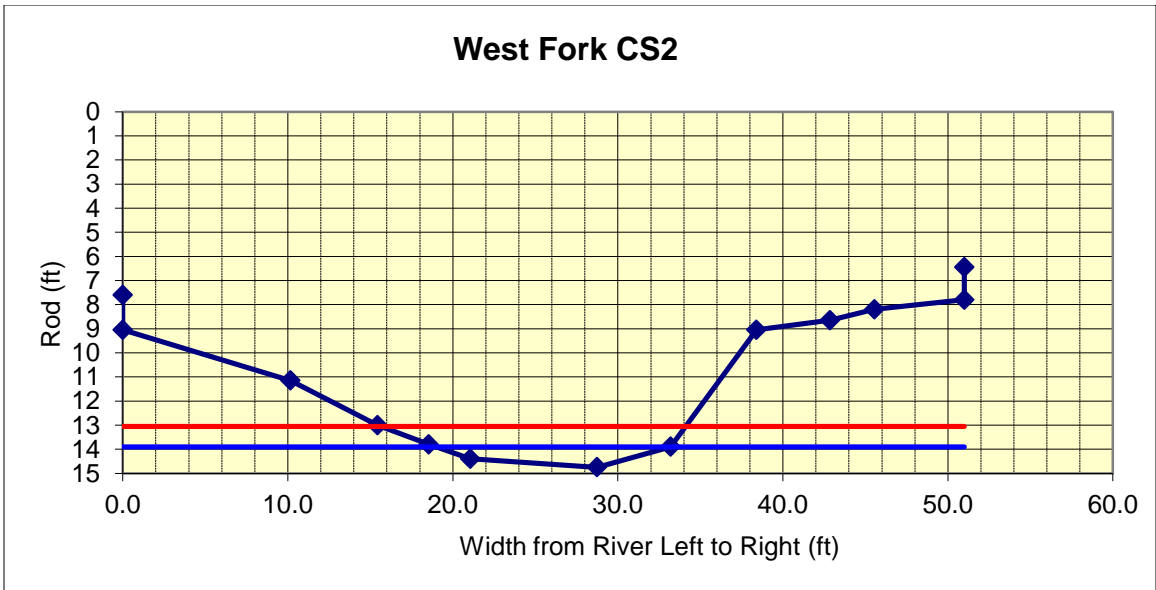
This cross section was in the lower, gullied portion of the site between steep hills on either side. This channel will fill in with sediment captured behind the one rock dam structures. This wet sediment will grow in with wetland vegetation and the defined channel will disappear (the area under the blue bankfull line should be filled in).

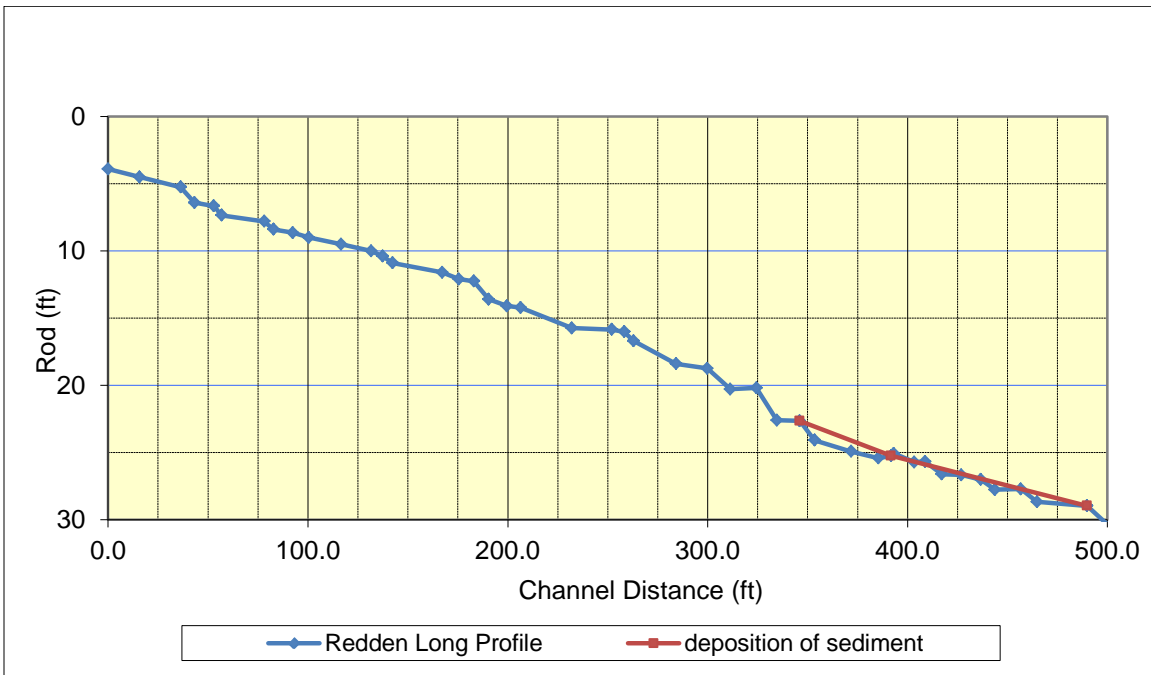
The upper portion of this profile has filled in and “smoothed”, as this sediment works downstream, it will fill in the area under the “deposition of sediment” line.

The two graphs shown above for the Redden Ranch show the effects of the restoration structures after one year of channel flooding and deposition. The cross section shows a channel that is un-gullied and has an active floodplain. The longitudinal profile shown has filled in with sediment and the structures are actually obscured under fresh sand and silt. This deposition will proceed from upstream (the sediment source) downstream through the longitudinal profile (the sediment sink).
