Monitoring Result and Project Update

Large Wood Habitat Enhancement and
Stream Bank Stabilization Sites
Soquel Demonstration State Forest

Cheryl Hayhurst, P.G.
California Geological Survey

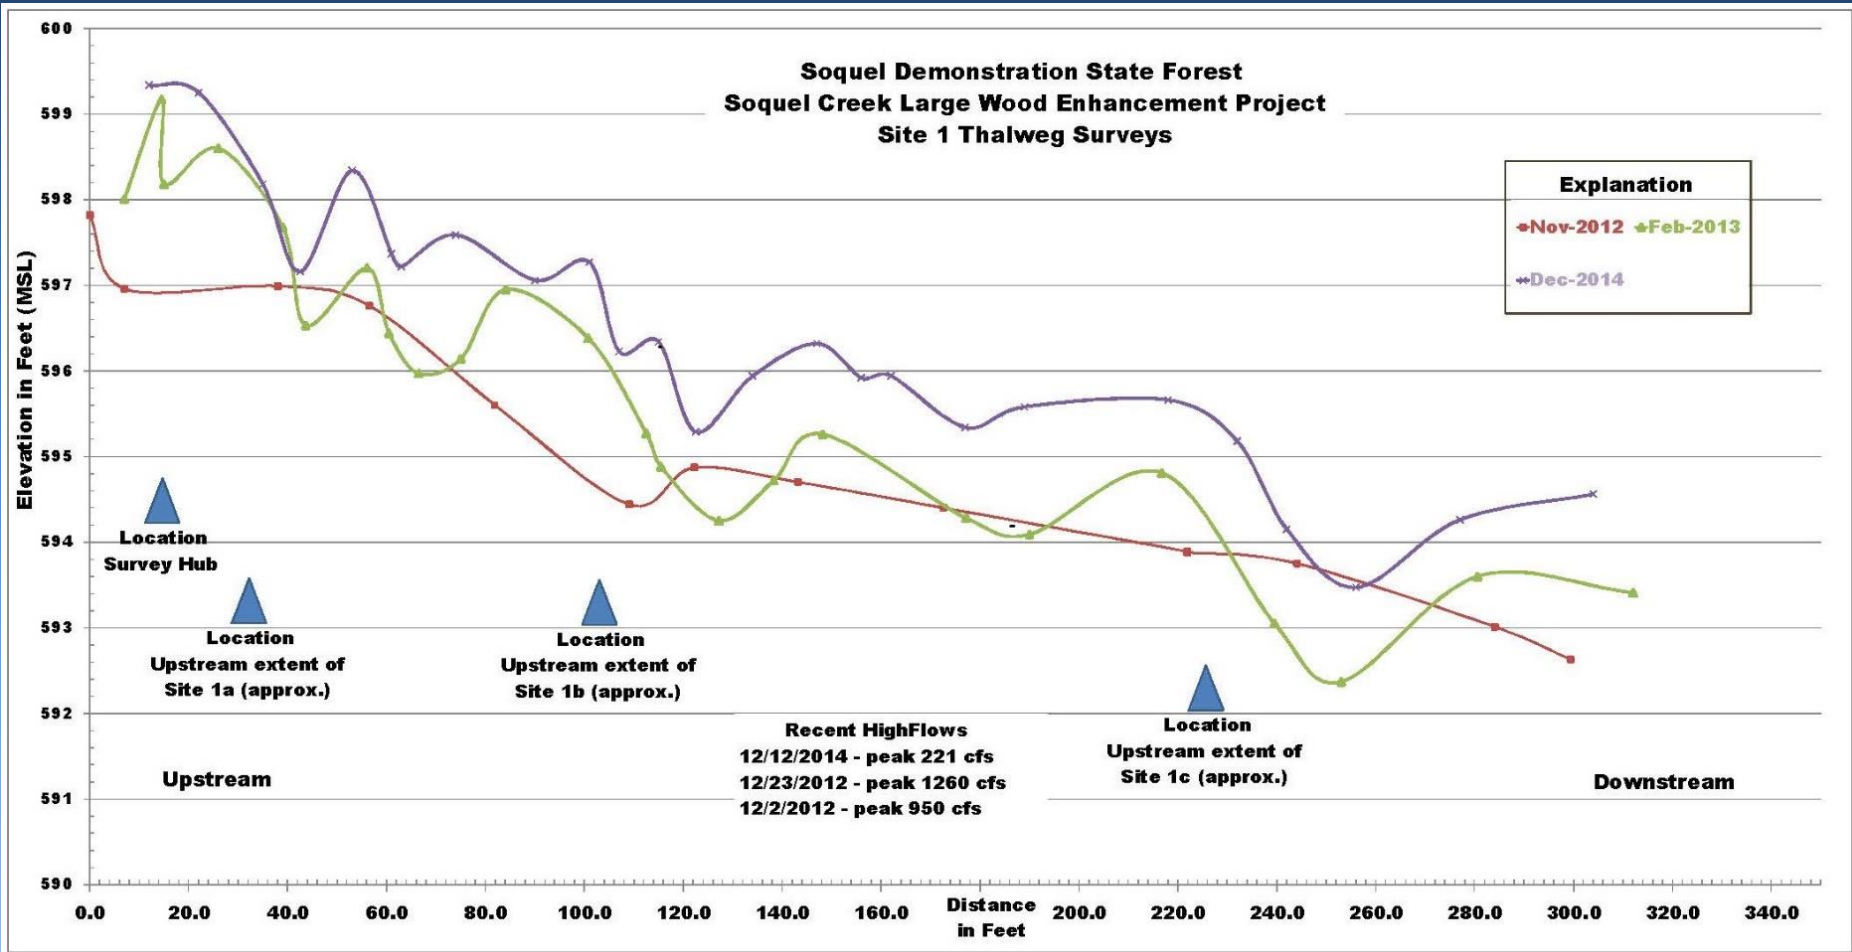
Site 1: Thalweg Surveys

- Incipient pools (depth < 1 foot) increased from 1 to 5
- Pools (depth > 1 foot) increased from 0 to 2
- Channel appears to have locally aggraded approximately 1 ½ feet through project reach

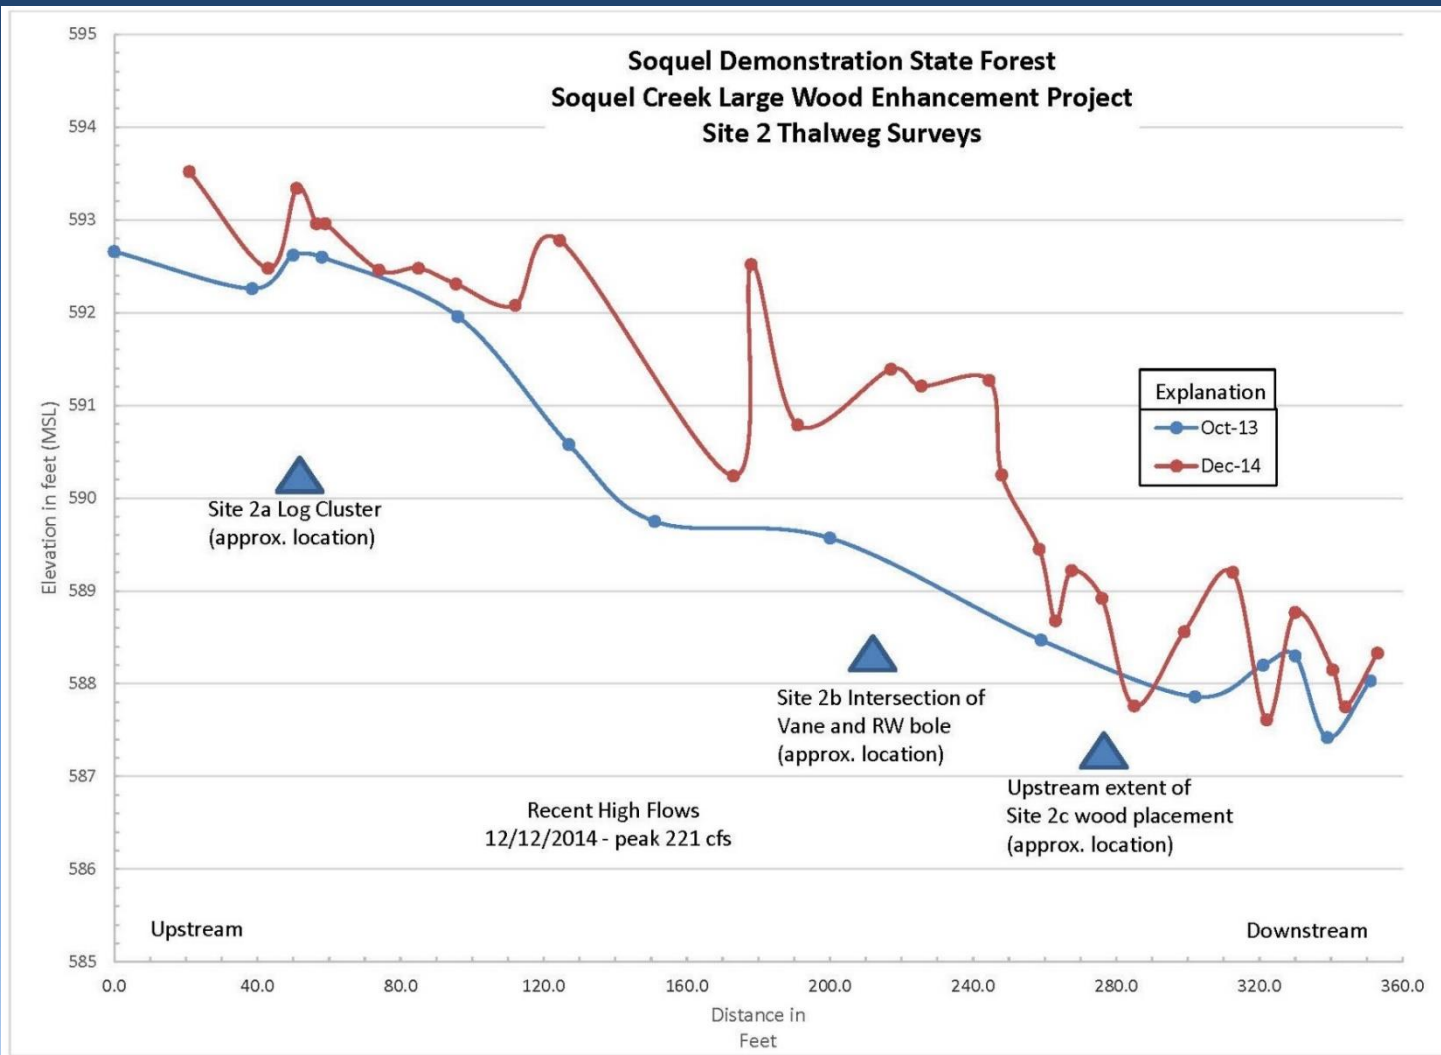
Site 2: Thalweg Surveys

- Incipient pools (depth < 1 foot) increased from 3 to 5
- Pools (depth > 1 foot) increased from 0 to 3
- Channel locally aggraded from 2c and extending approximately 200 feet upstream
- Scour pool (2+ feet deep) created at 2b log vane

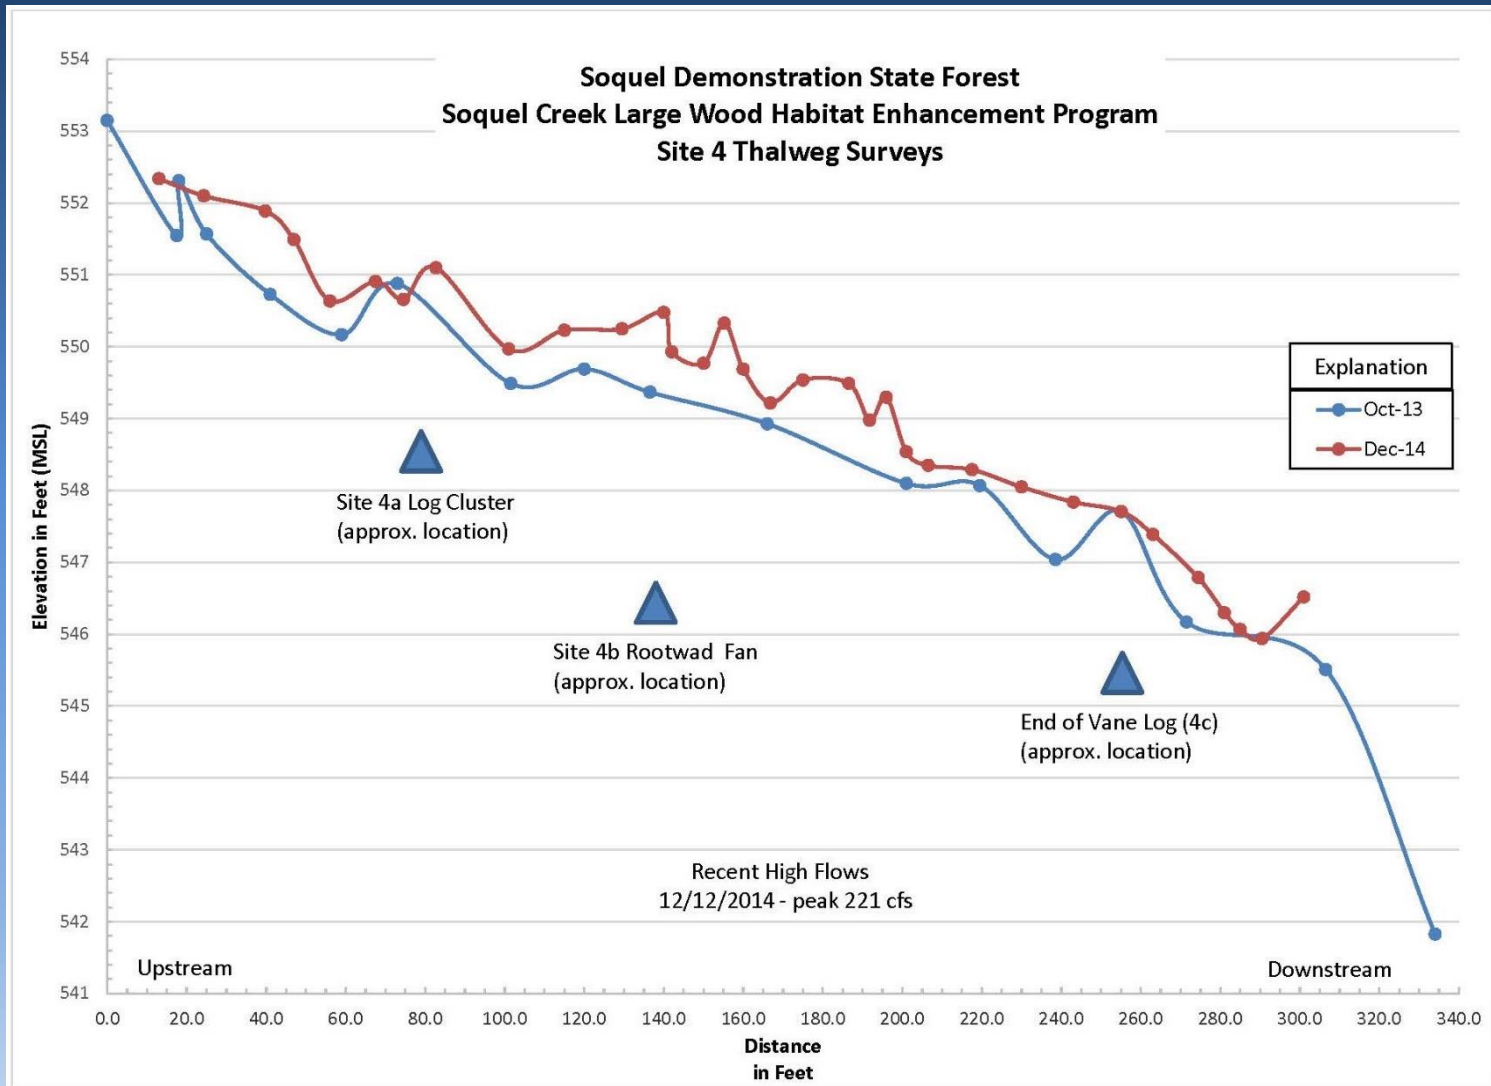
Site 4: Thalweg Surveys

- Incipient pools (depth < 1 foot) increased from 4 to 6
- Channel locally aggraded approximately ½ to 1 foot through most of reach

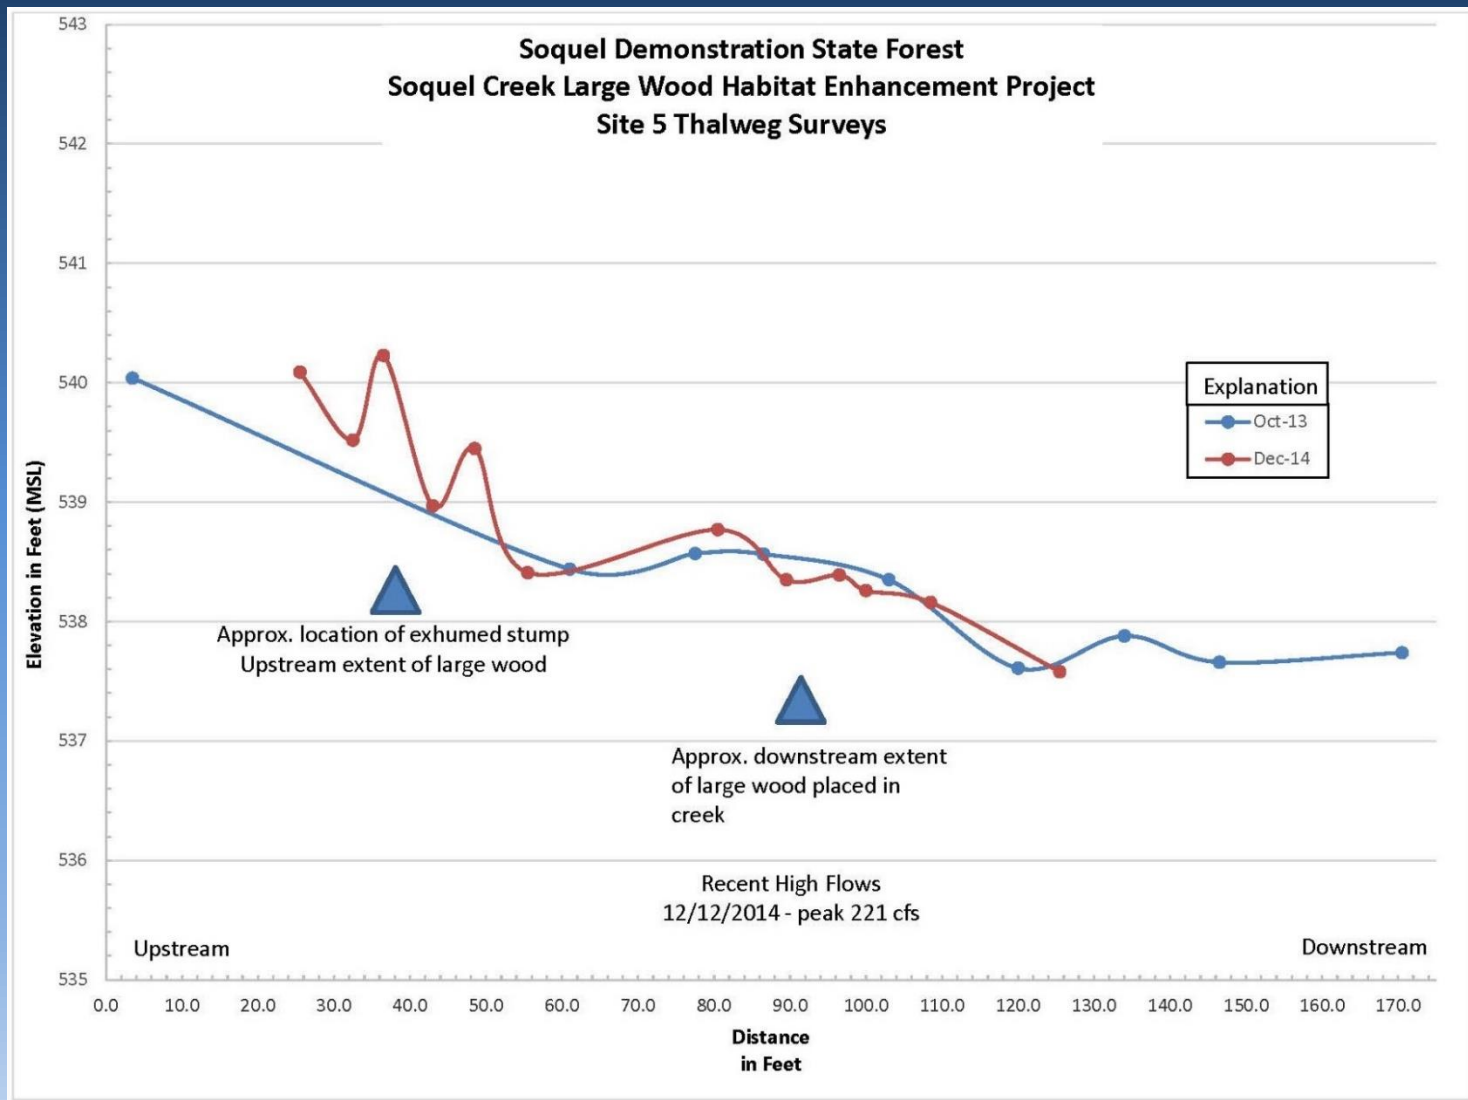
Site 5: Thalweg Surveys

- Incipient pools (depth < 1 foot) increased from 2 to 3
- Local channel aggradation of approximately ½ to 1 foot extending 25 upstream of log cluster
