*Restoration and Resilience-Building of Riparian and Wet Meadow Habitats
in the
Upper Gunnison River Basin, Colorado*

**Annual Performance/Progress Report (Project #L14AC00115)
Bureau of Land Management**

**The Nature Conservancy and the Gunnison Climate Working Group
July 18, 2017
For Period 7/1/2016-6/30/2017**

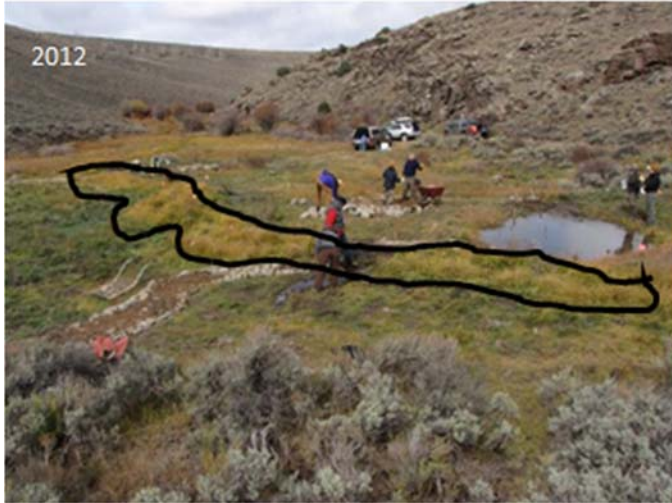
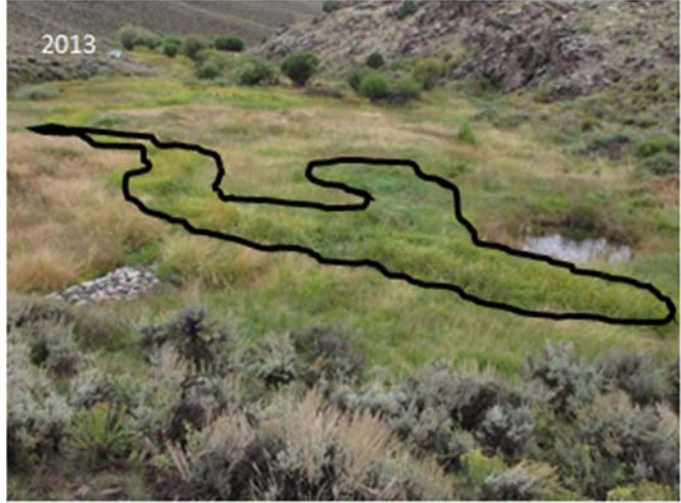
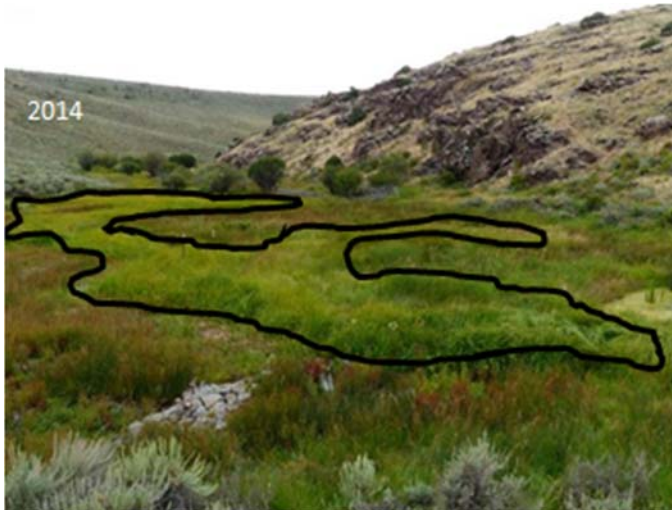
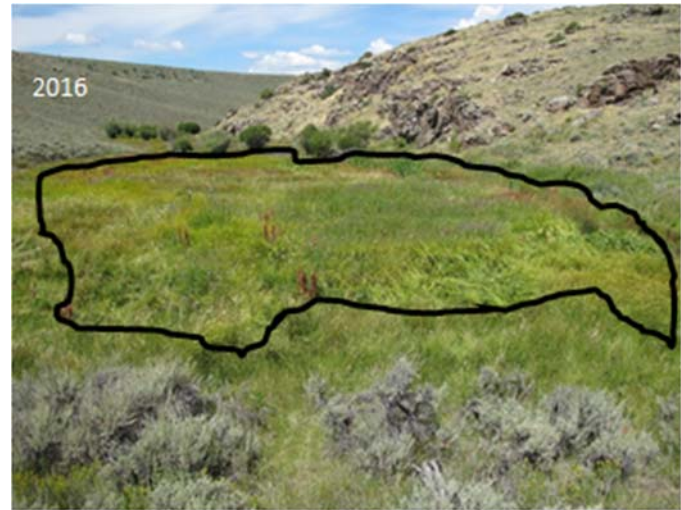
Figure 6. Kaichen State Habitat Area, Wolf Creek Private: Fast response to Media Luna Structures

Wetland area increased from 25% to 80% of floodplain between 2012 & 2016 at CPW's Kaichen State Habitat Area.

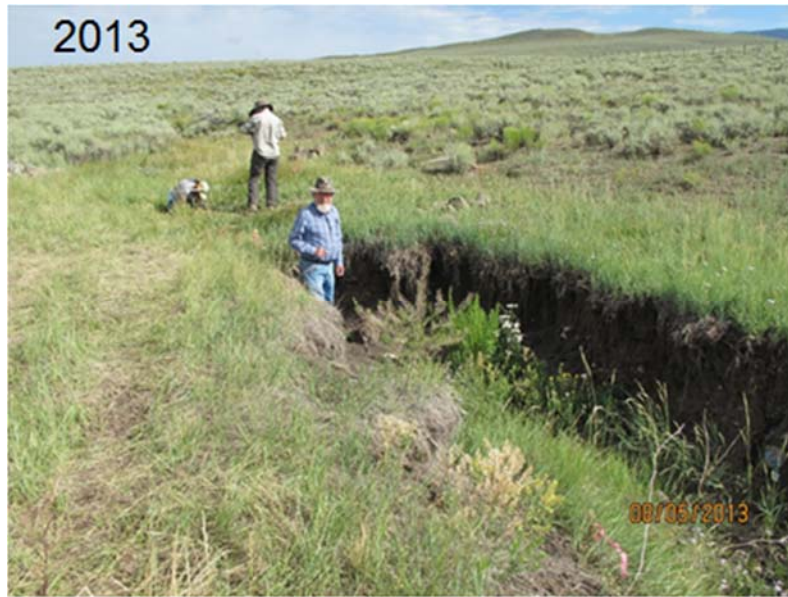
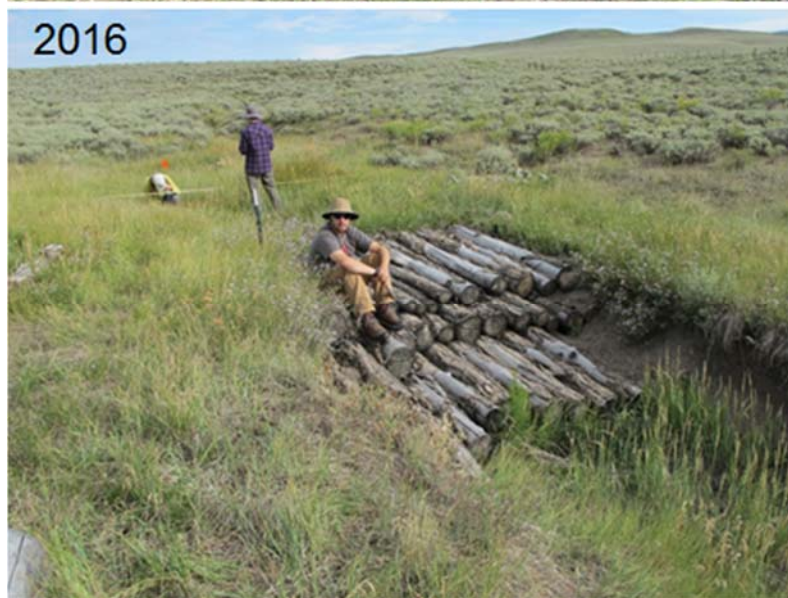
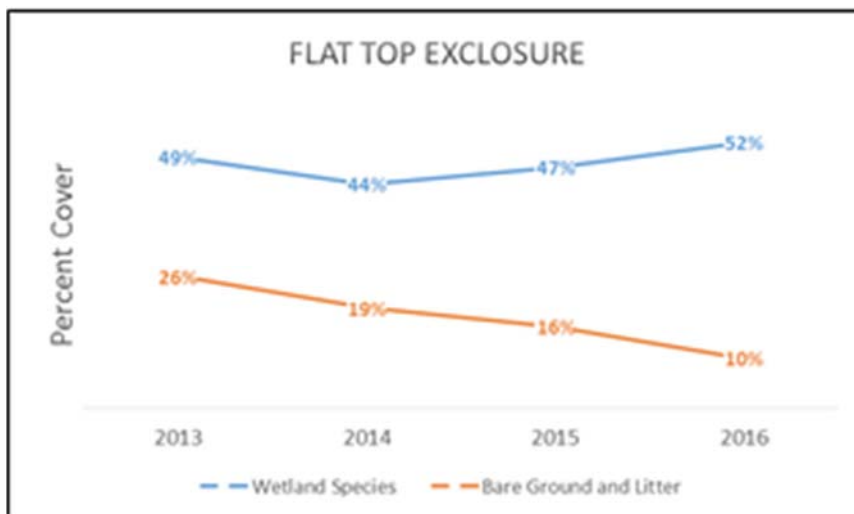
Figure 7. West Flat Top Exclosure (USFS): Before and after installation of Log and Fabric Structure to control headcut. Photos by Renee Rondeau, CNHP.

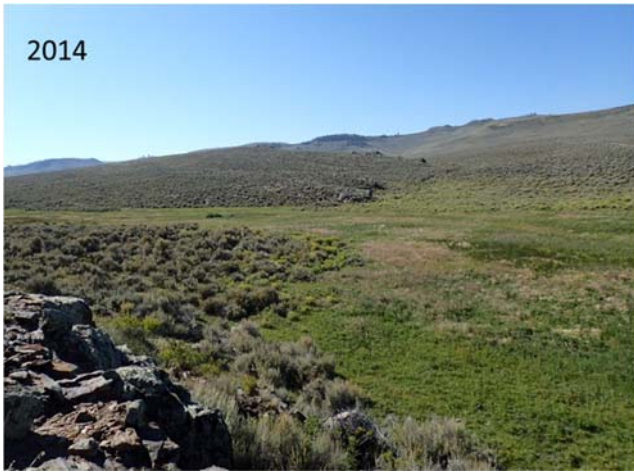
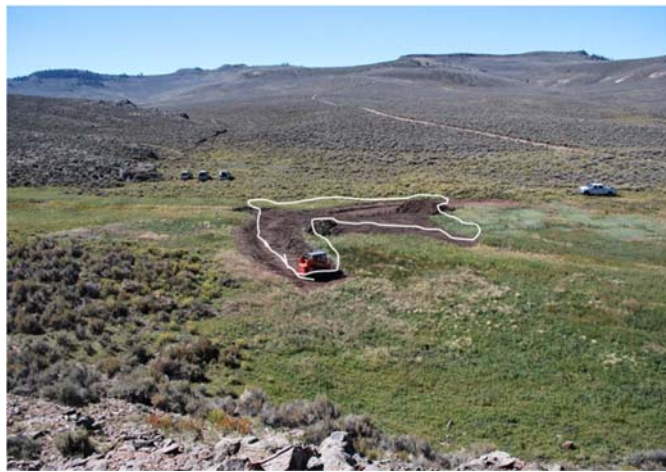
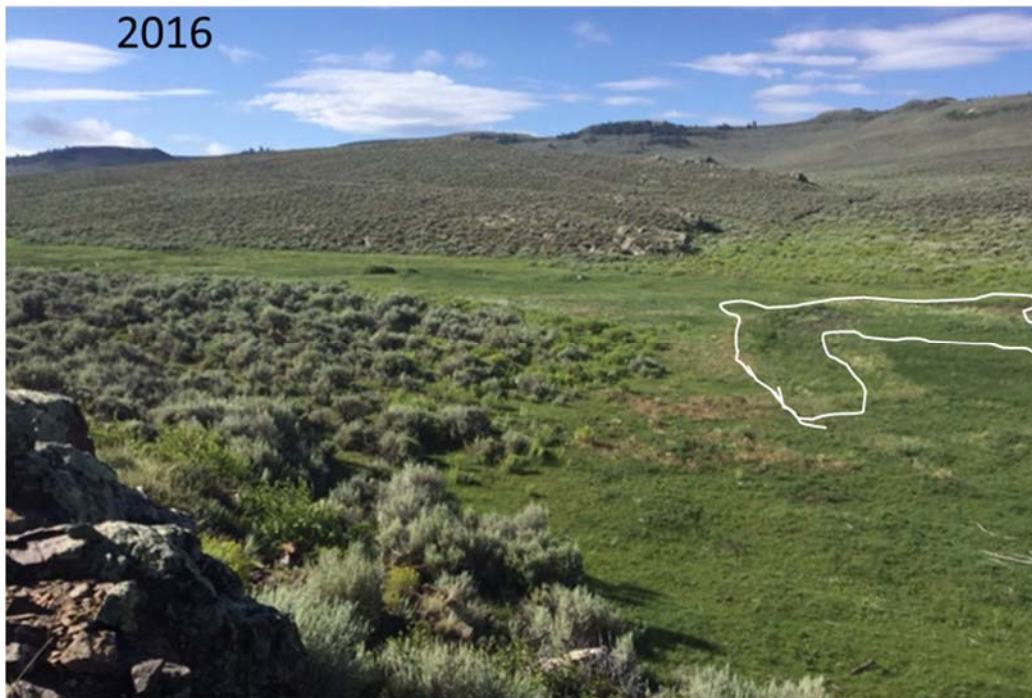
Figure 8. Kezar Basin Private: Before, during and post construction of Double Bay Plug and Spread Structure. Photos by Renee Rondeau, CNHP (left, lower), and Betsy Neely, TNC (right).

The wetland species cover was 12% in 2014 and 30% in 2016, a 150% increase in wetland species cover.

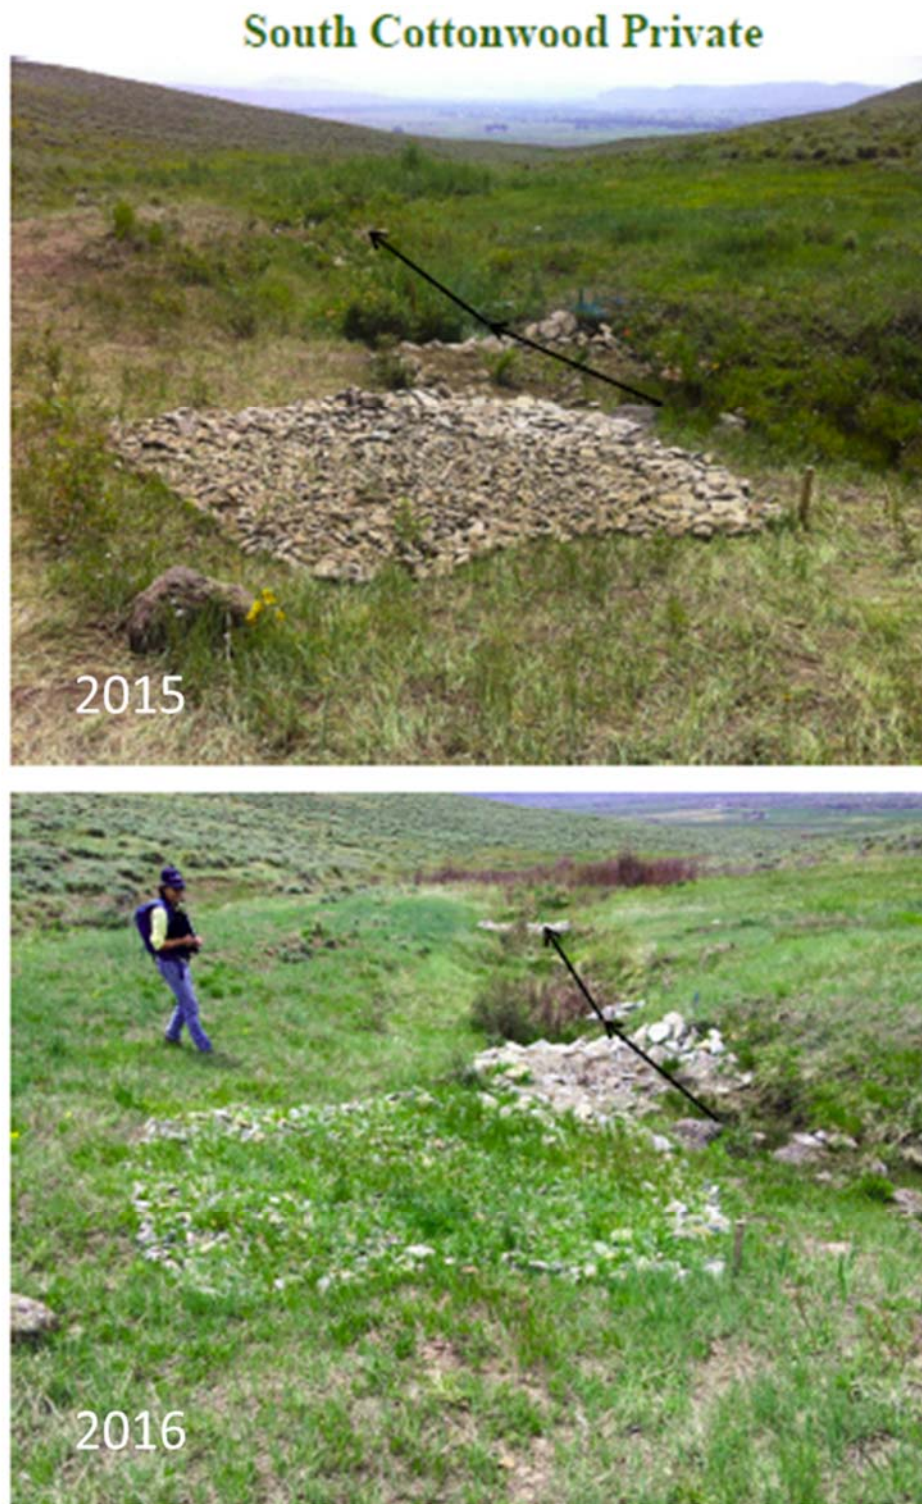
Figure 9. South Cottonwood Private: Vegetative response to a Rock Mulch Structure after one year. Photos by Matt Vasquez, USFS.

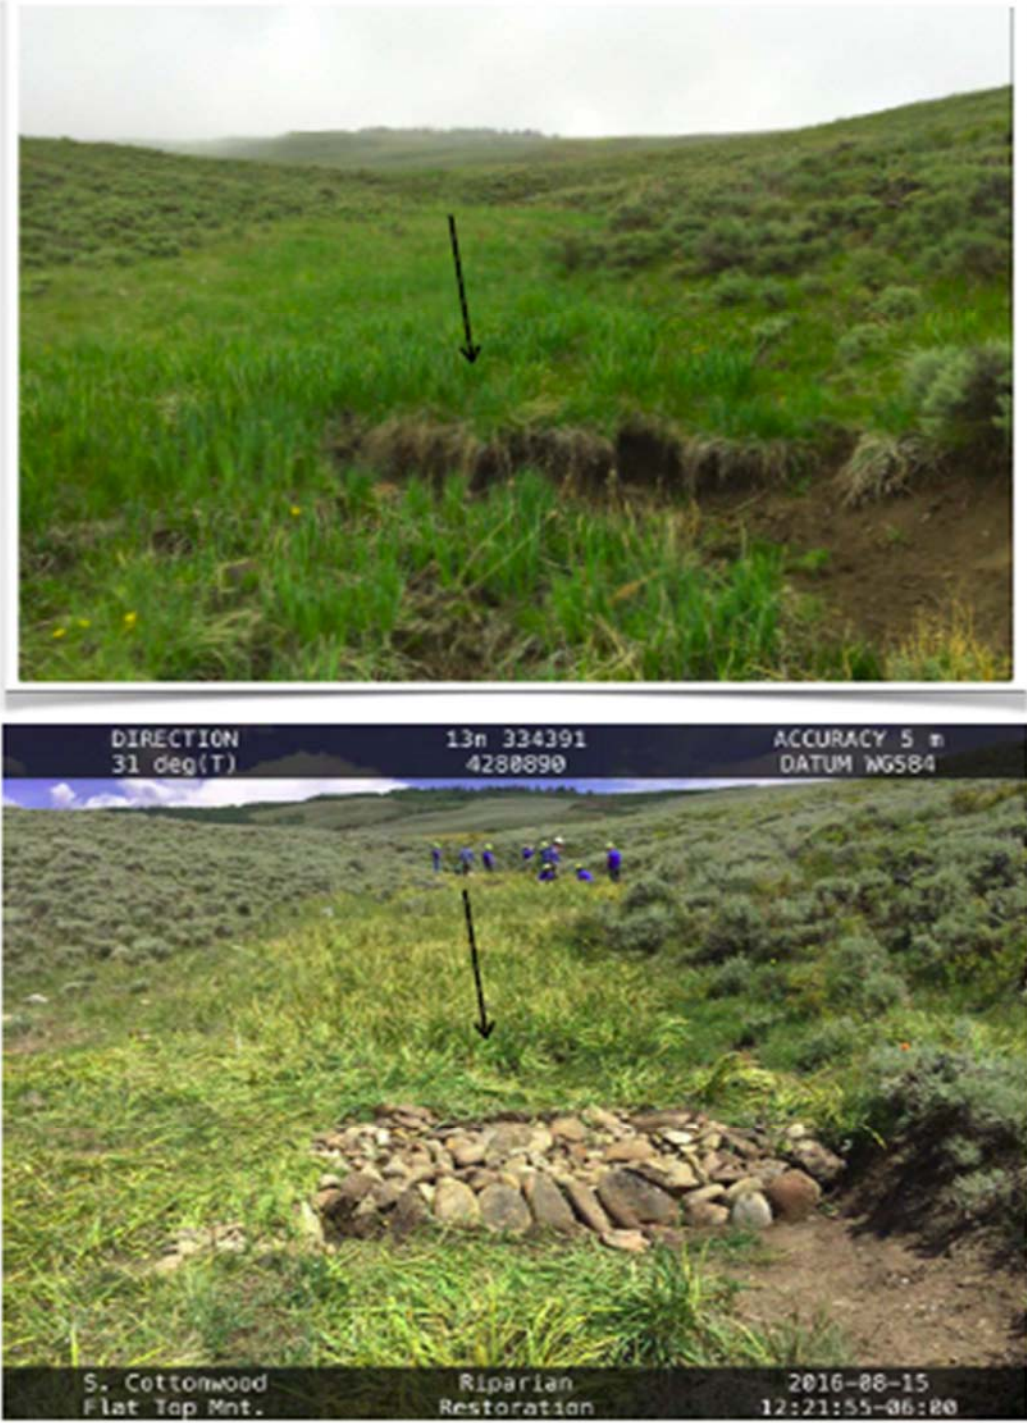
USFS South Cottonwood Upper

Figure 10. Upper South Cottonwood (USFS): Pre-and post-construction of a Layback Structure to control the headcut. Photos were taken during the same year (2016) by Matt Vasquez, USFS.

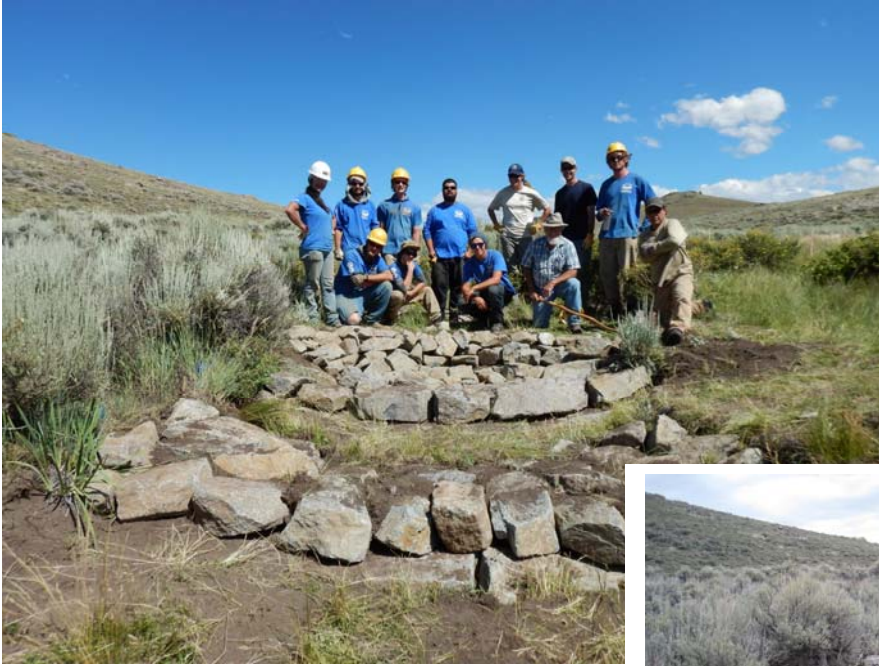
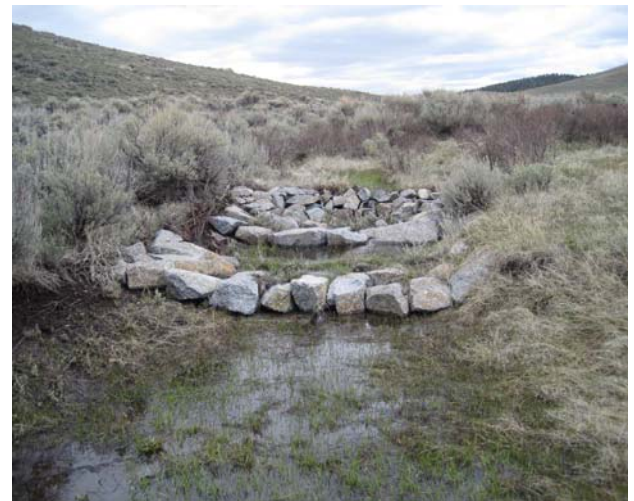
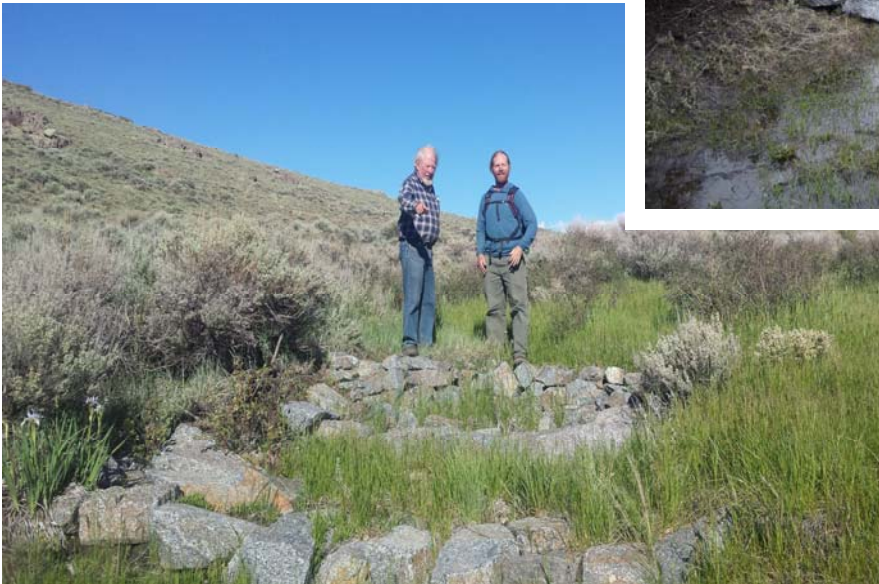
Figure 11. Zuni bowl and one rock dam at Chance Gulch after construction in 2014 by Western Colorado Conservation Corps crew and team members. Top and middle photos by Andrew Breibart, BLM) and lower in June 2017 by Shawn Conner, BIO-Logic, Inc.

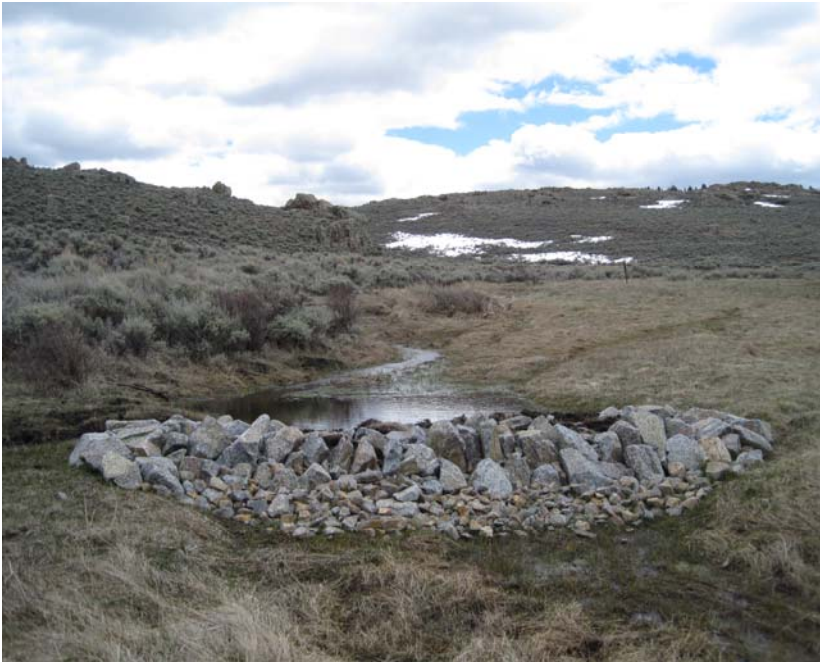
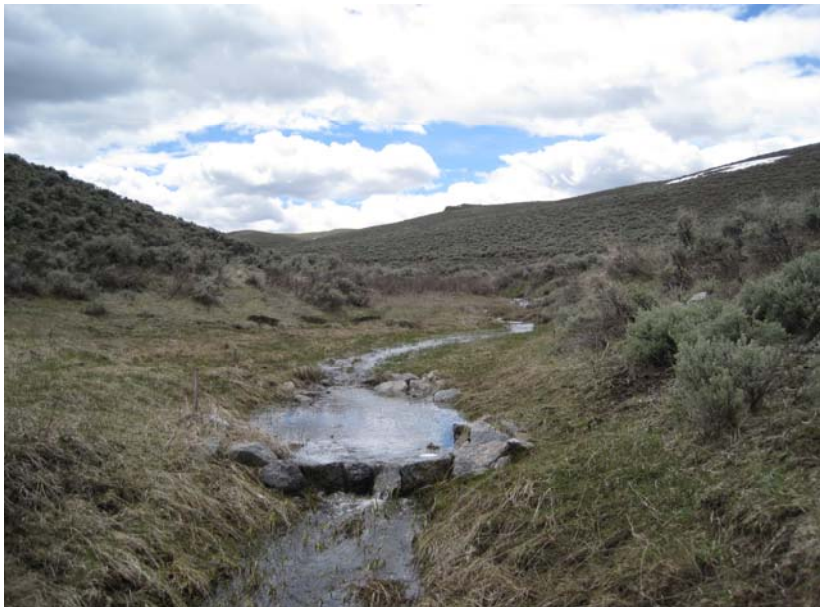
Figure 12. Filter dam at Chance Gulch (top) and one rock dam at Chance Gulch (bottom). Both photos by Andrew Breibart, BLM.

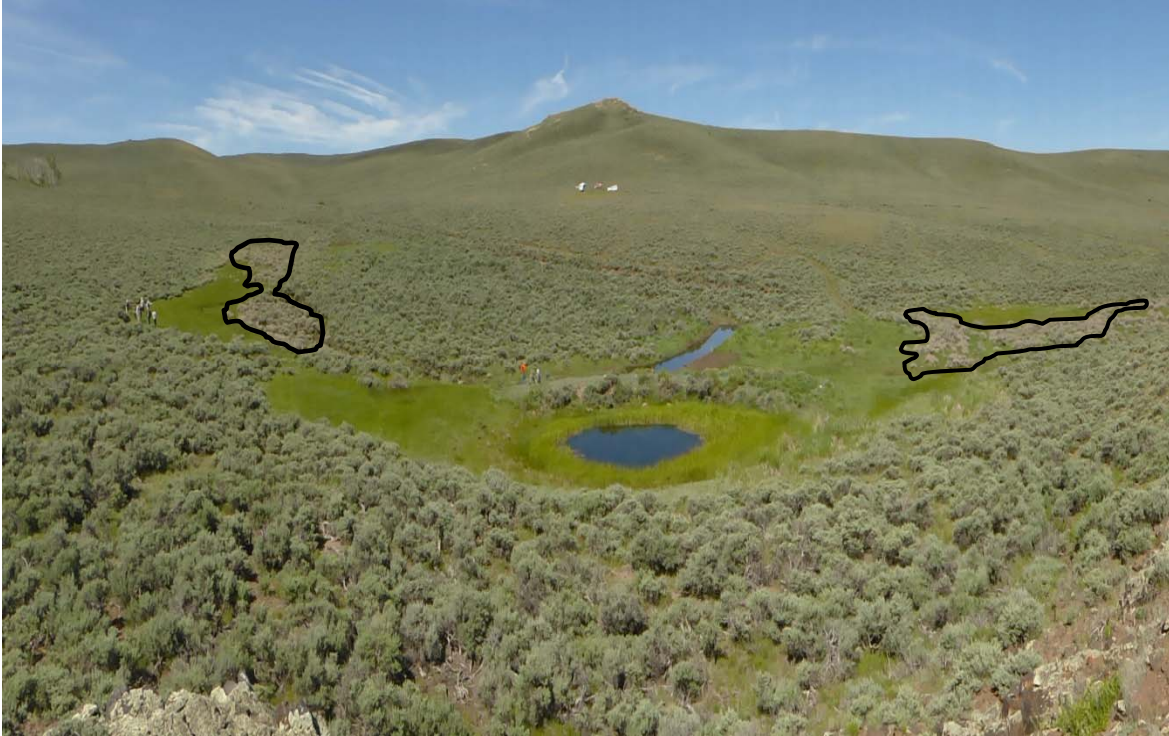
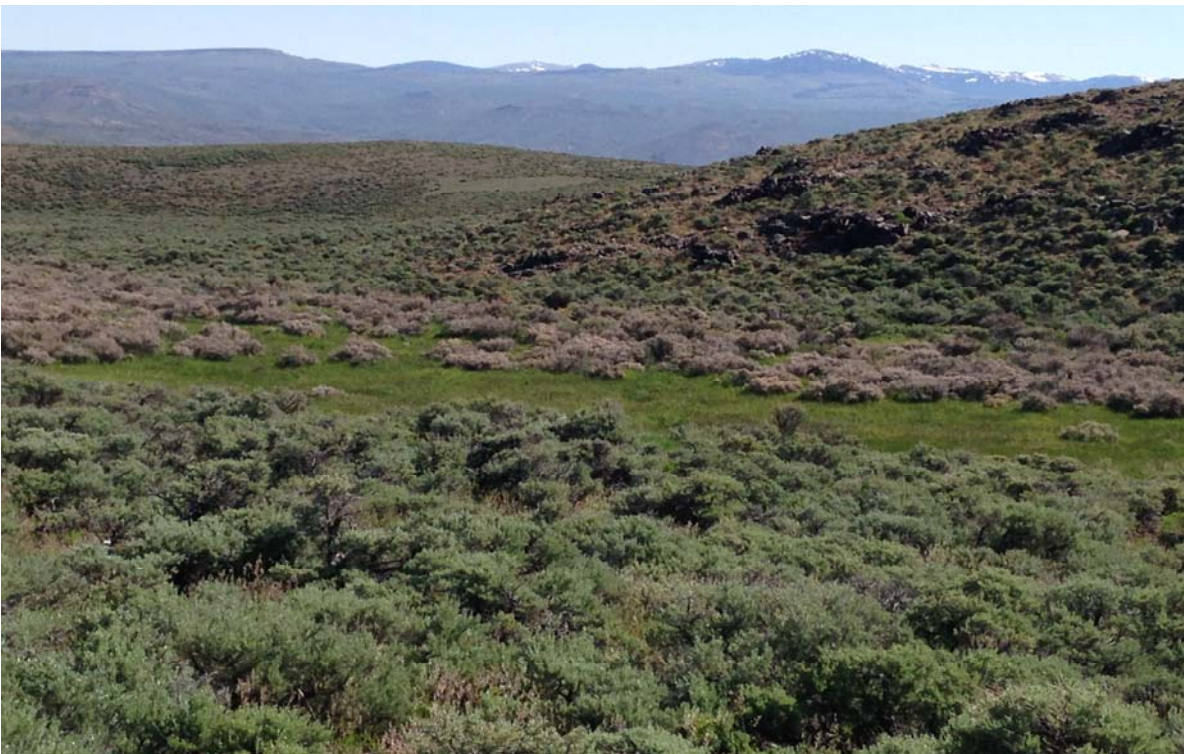
Figure 13. Lower Chance Gulch. Vegetation response to plug and spread structures constructed in October, 2016. Top photo by Renee Rondeau, CNHP, June 2017; black lines indicate extent of sagebrush die-off. Bottom photo: close up of sagebrush die-off in meadow by Betsy Neely, TNC, June 2017.
