**Soquel  
Demonstration State  
Forest**

**Large Wood and  
Habitat Complexity  
Project**

# Soquel Demonstration State Forest Large Wood and Habitat Complexity Project

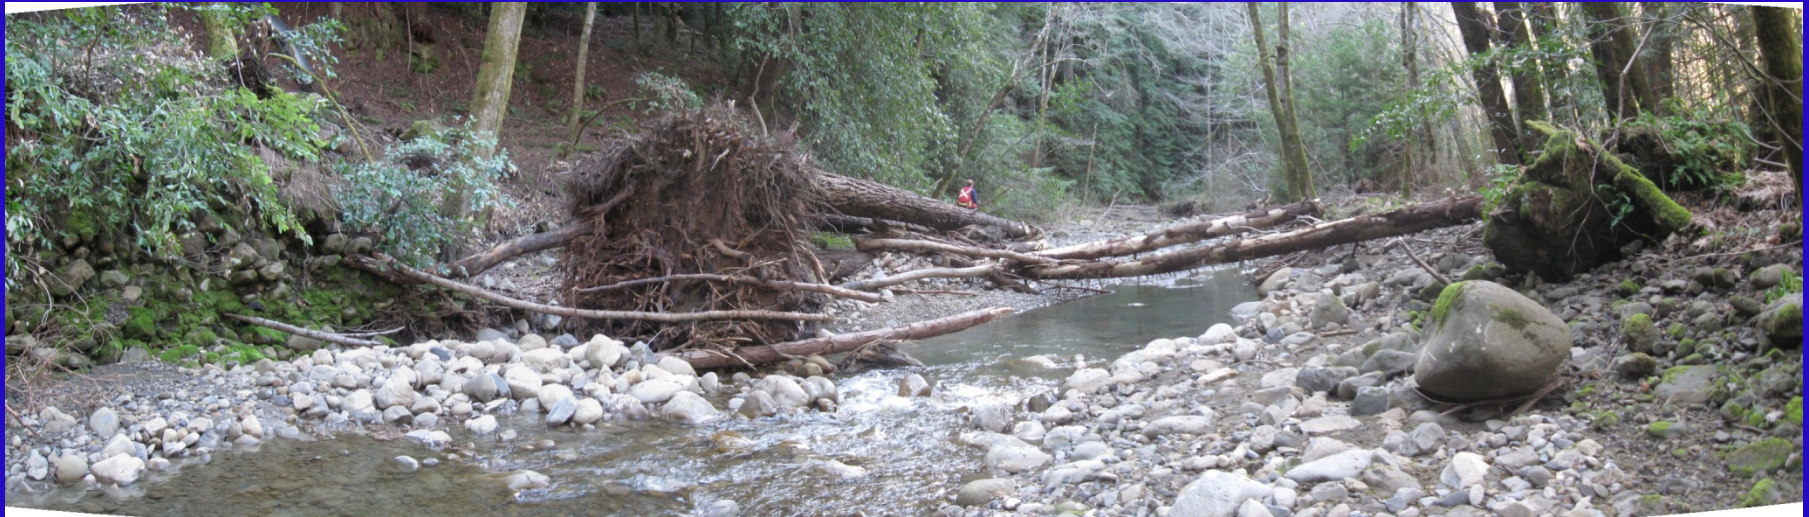
**Site 1; Lowest Redwood Clump  
Before and After 5-yr Return  
Interval Flow Event**

**Pool scoured, lateral bar formed,  
modest increase in channel  
sinuosity**

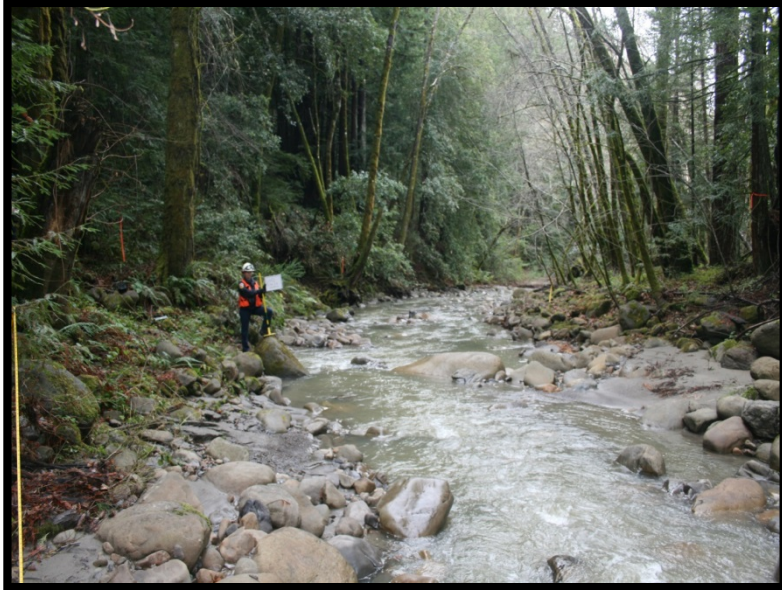
Figure 1a. January 25, 2012

# LWD Site #1- facing downstream to structure 1A

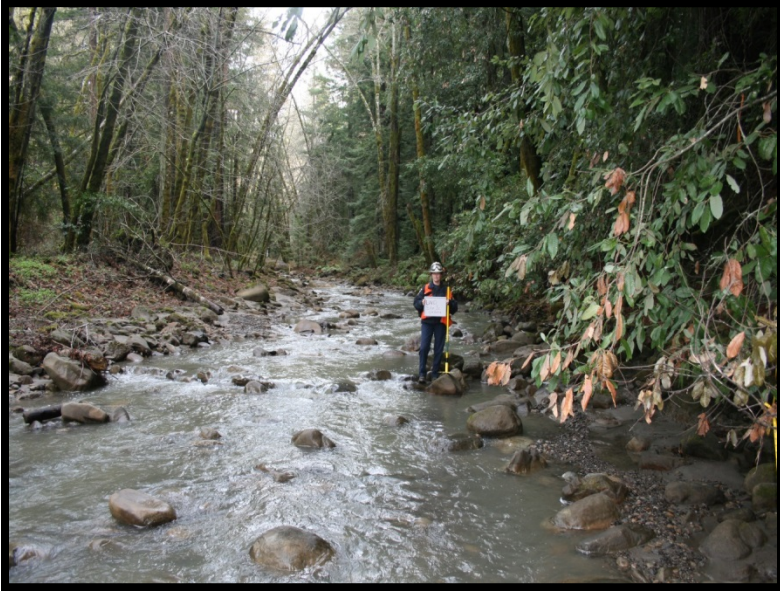
Figure 6a. January 25, 2012

## LWD Site #1- facing upstream to structure 1C

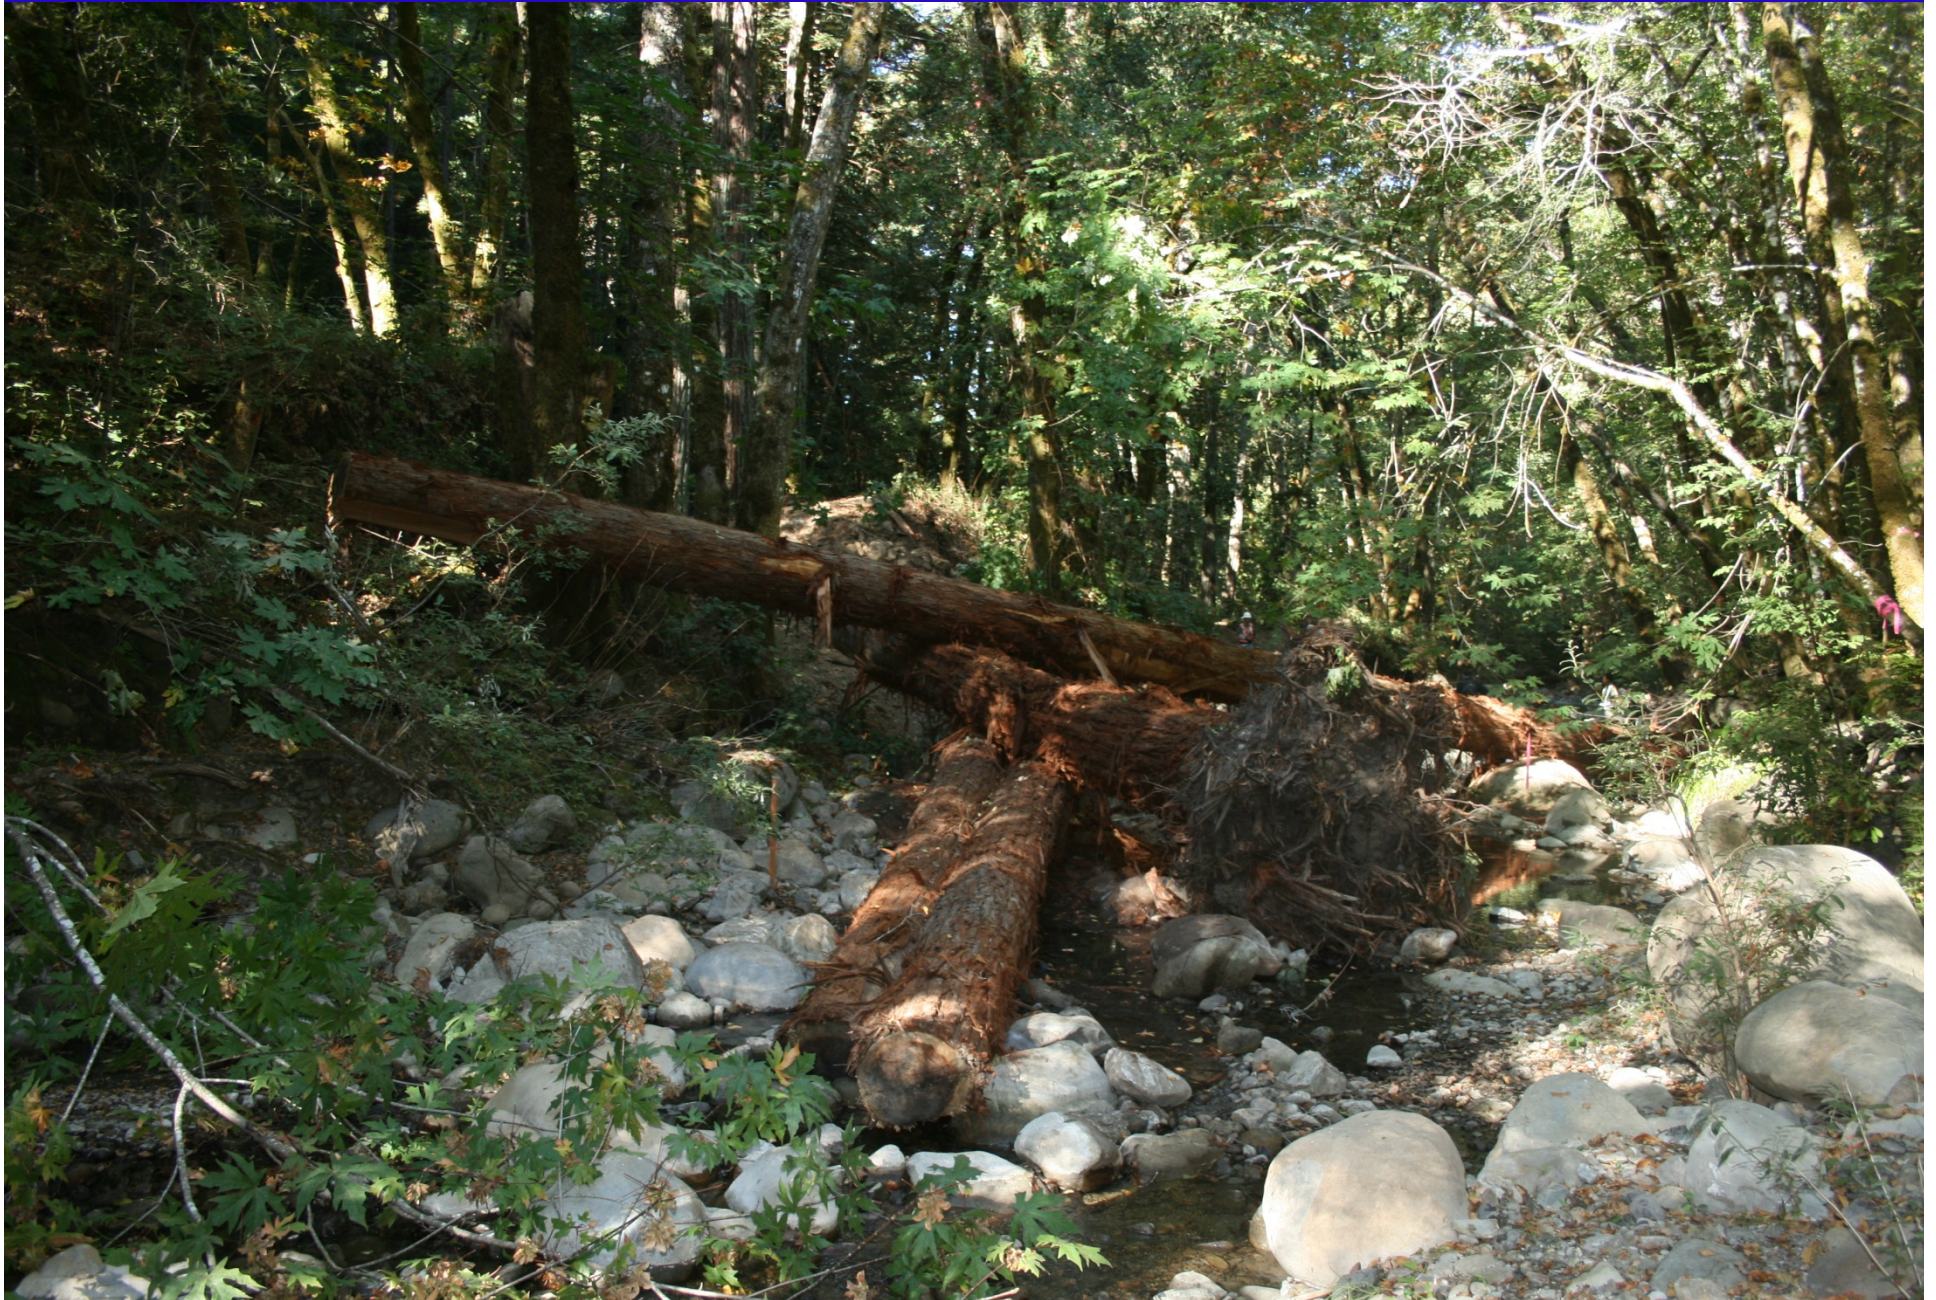
## Log Cluster Structure, upper end of Site 2, August 2013

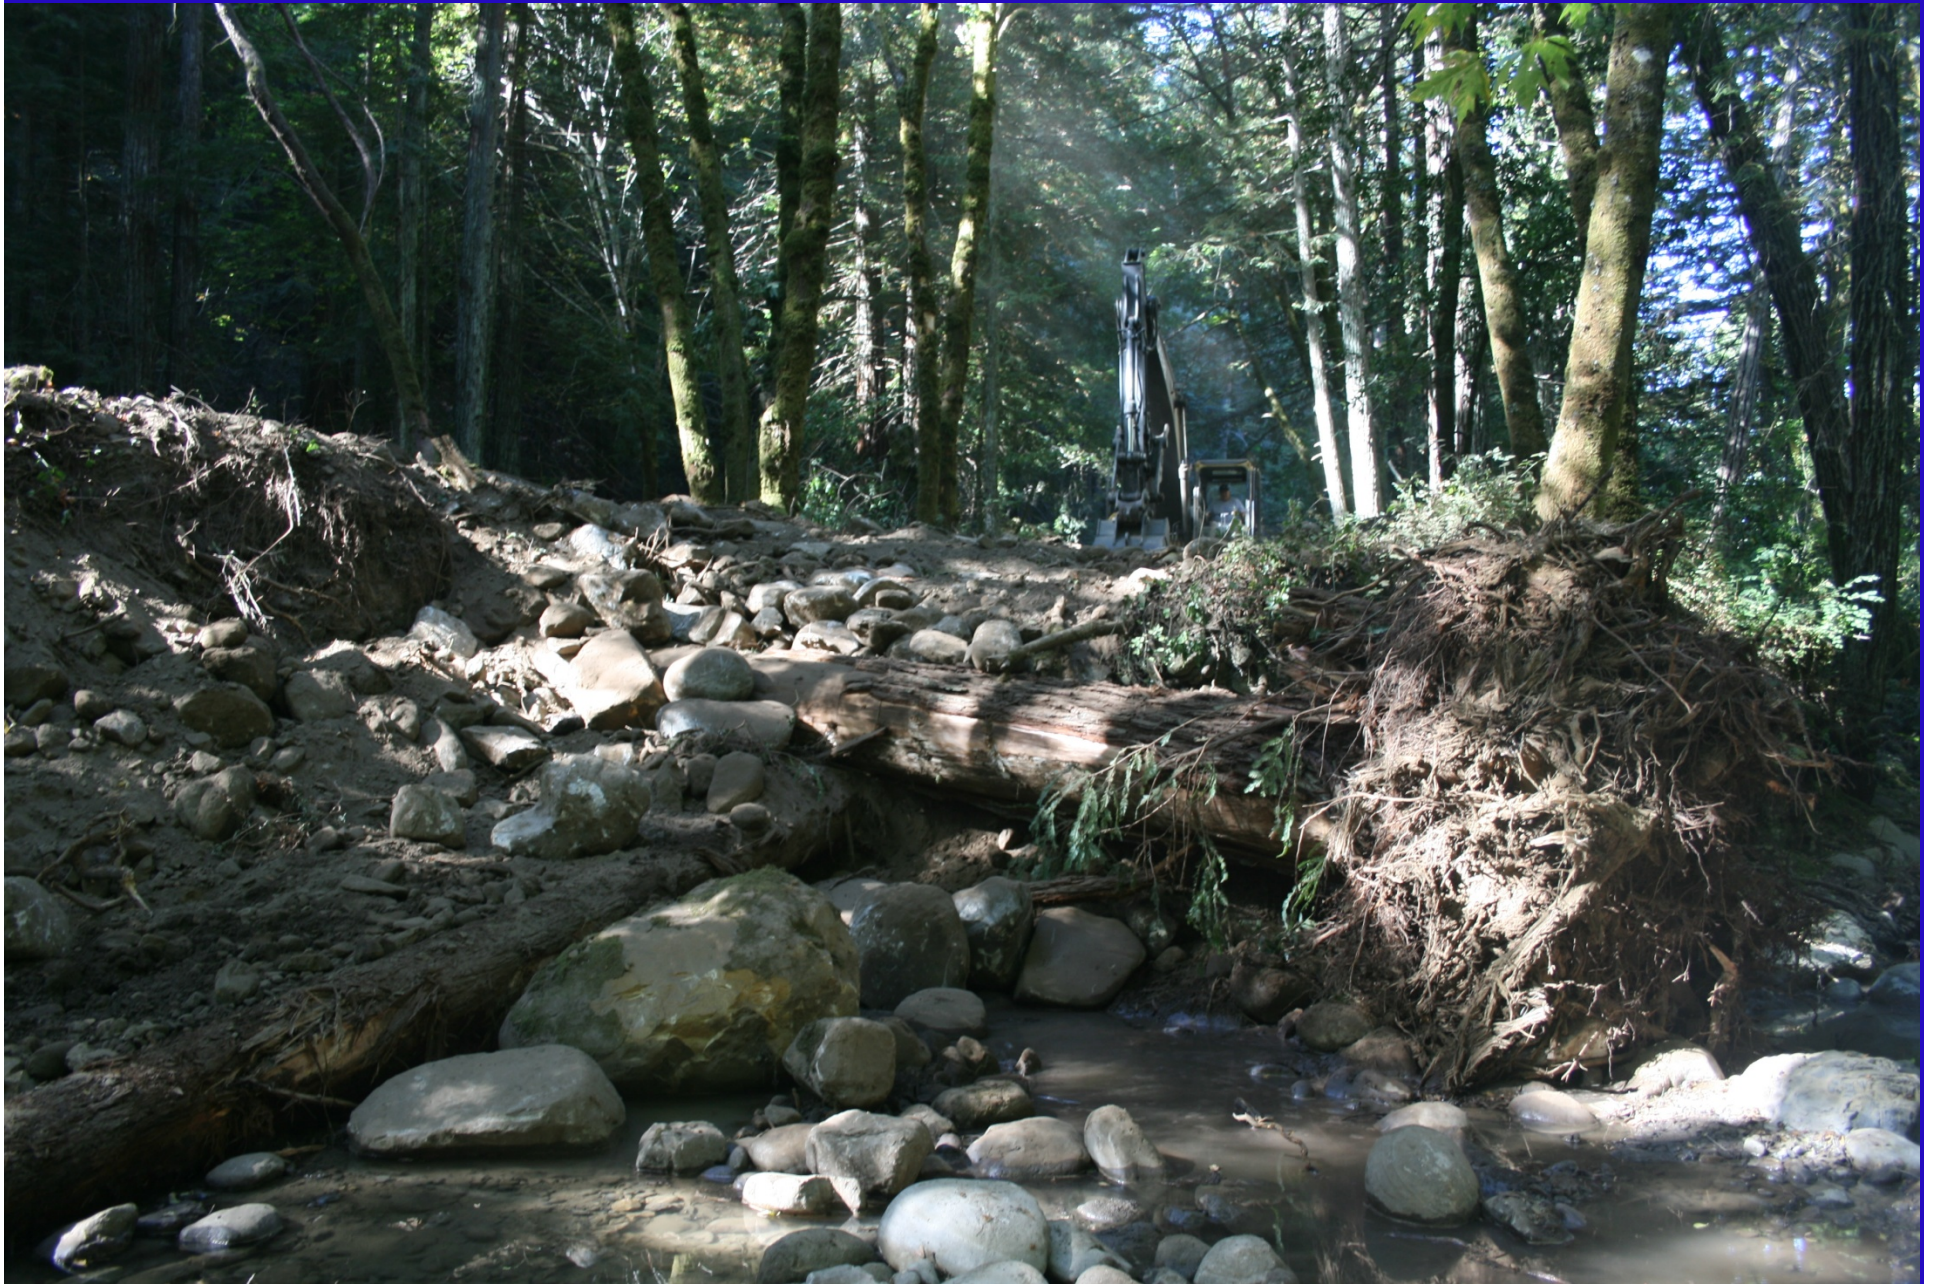
## Log Vane Structure, middle of Site 2, August 2013

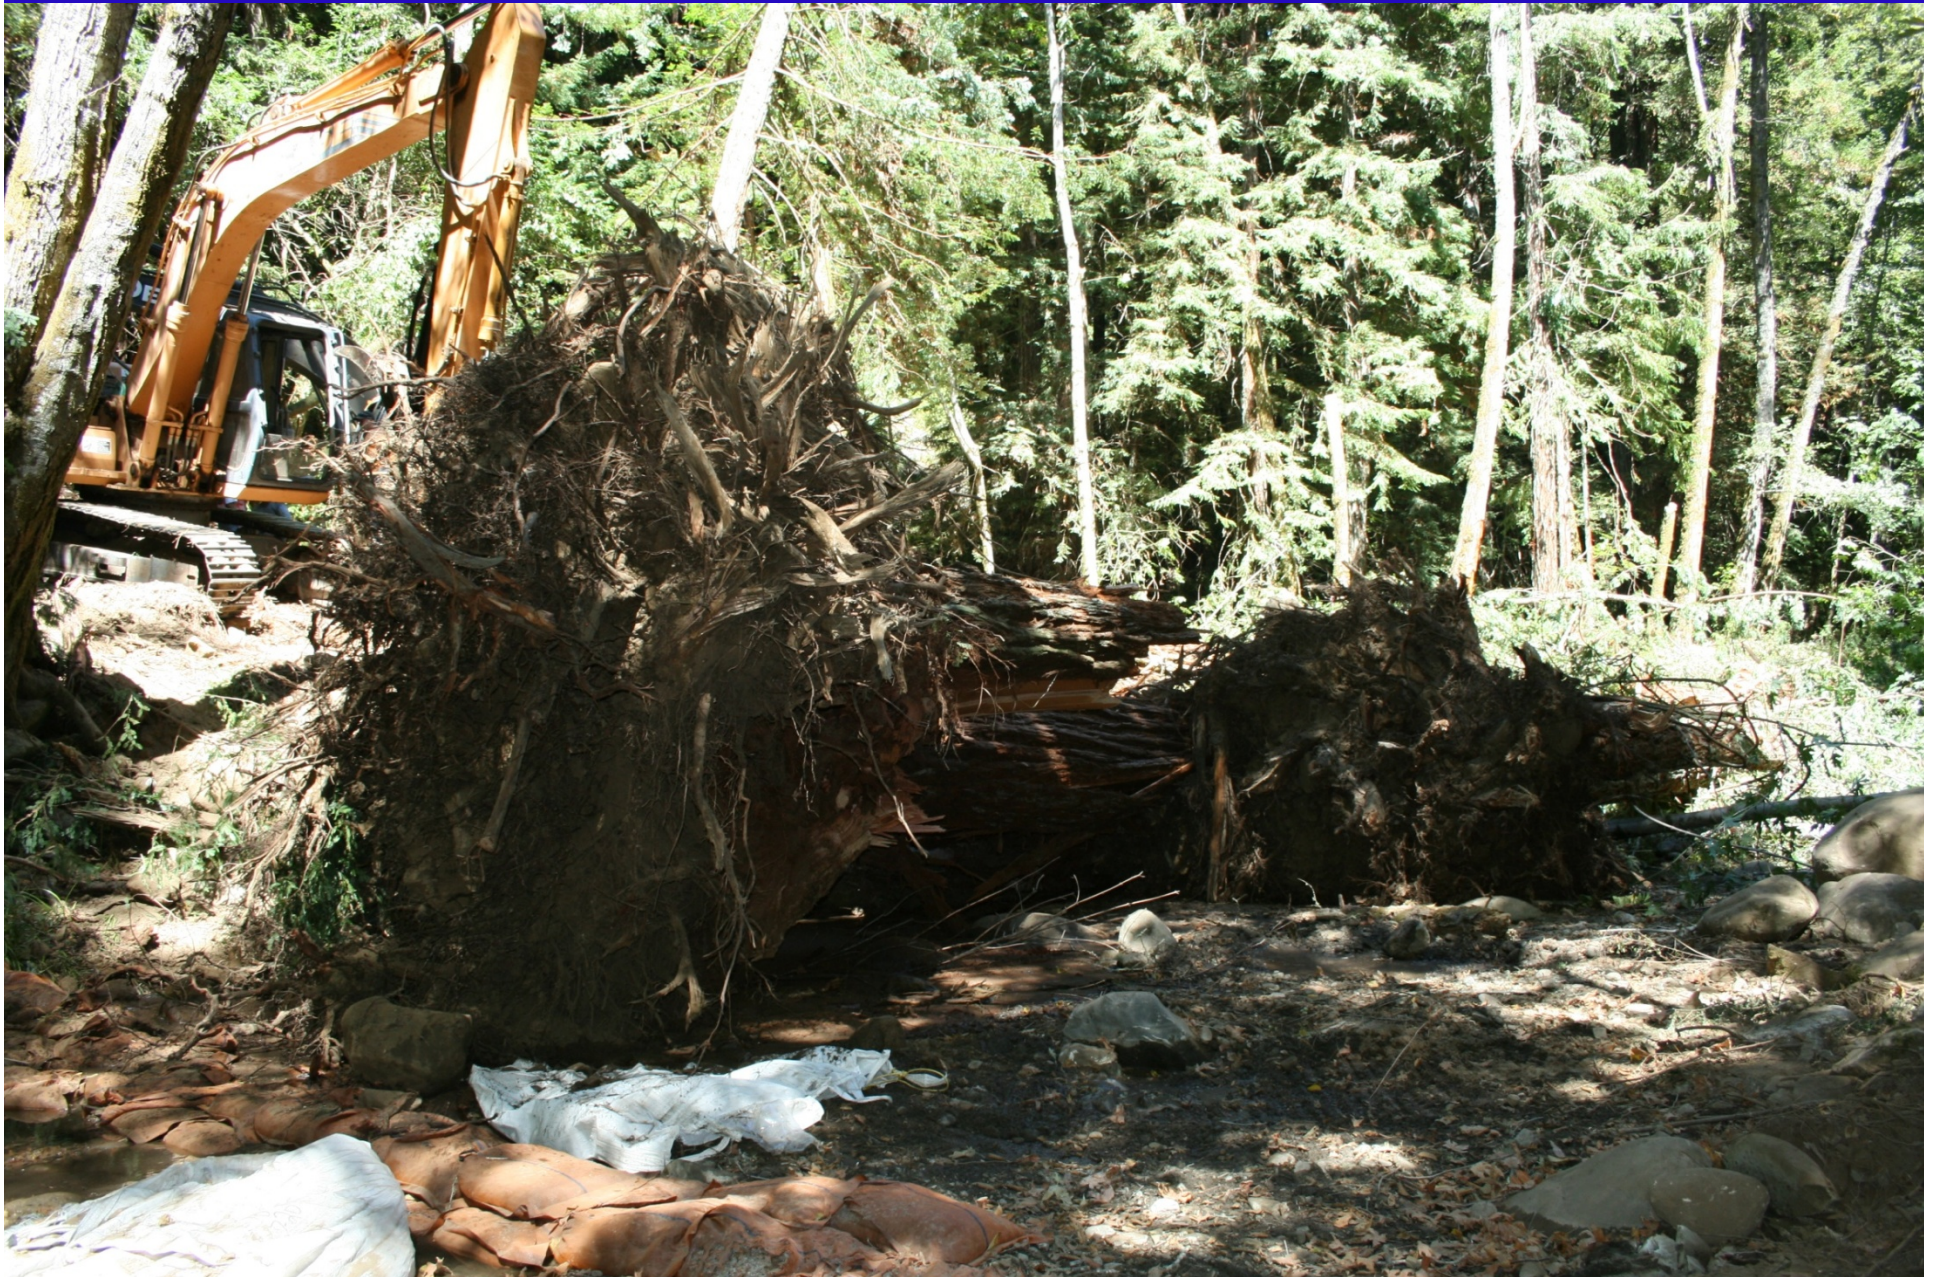
**Rootwad Anchor (2 rootwads present), lower end of Site 2  
August 2013**

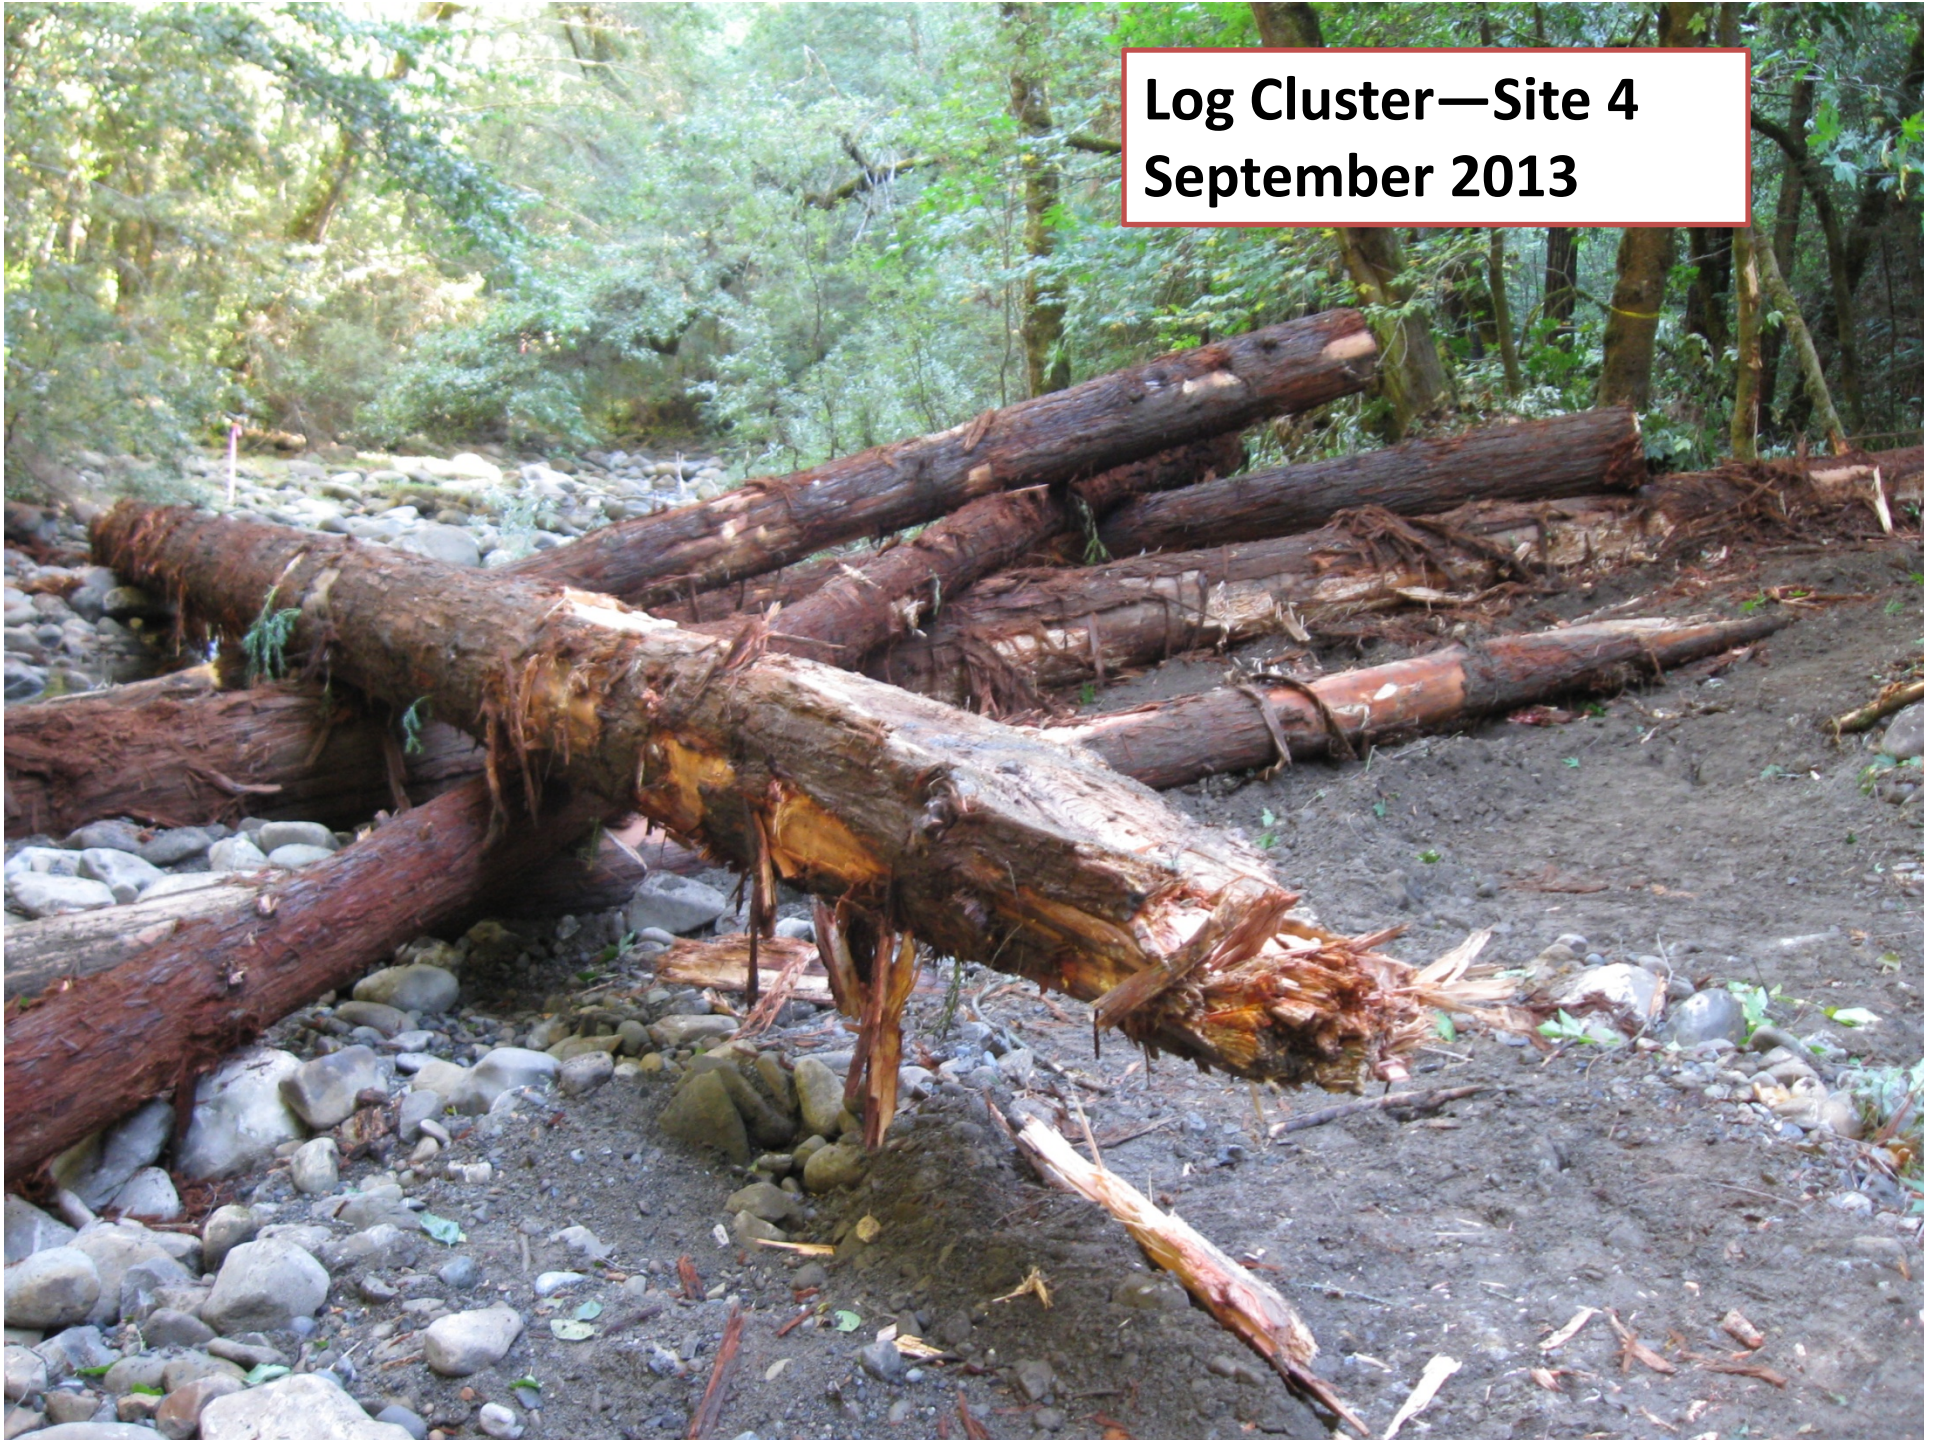
**Log Cluster—Site 4  
September 2013**

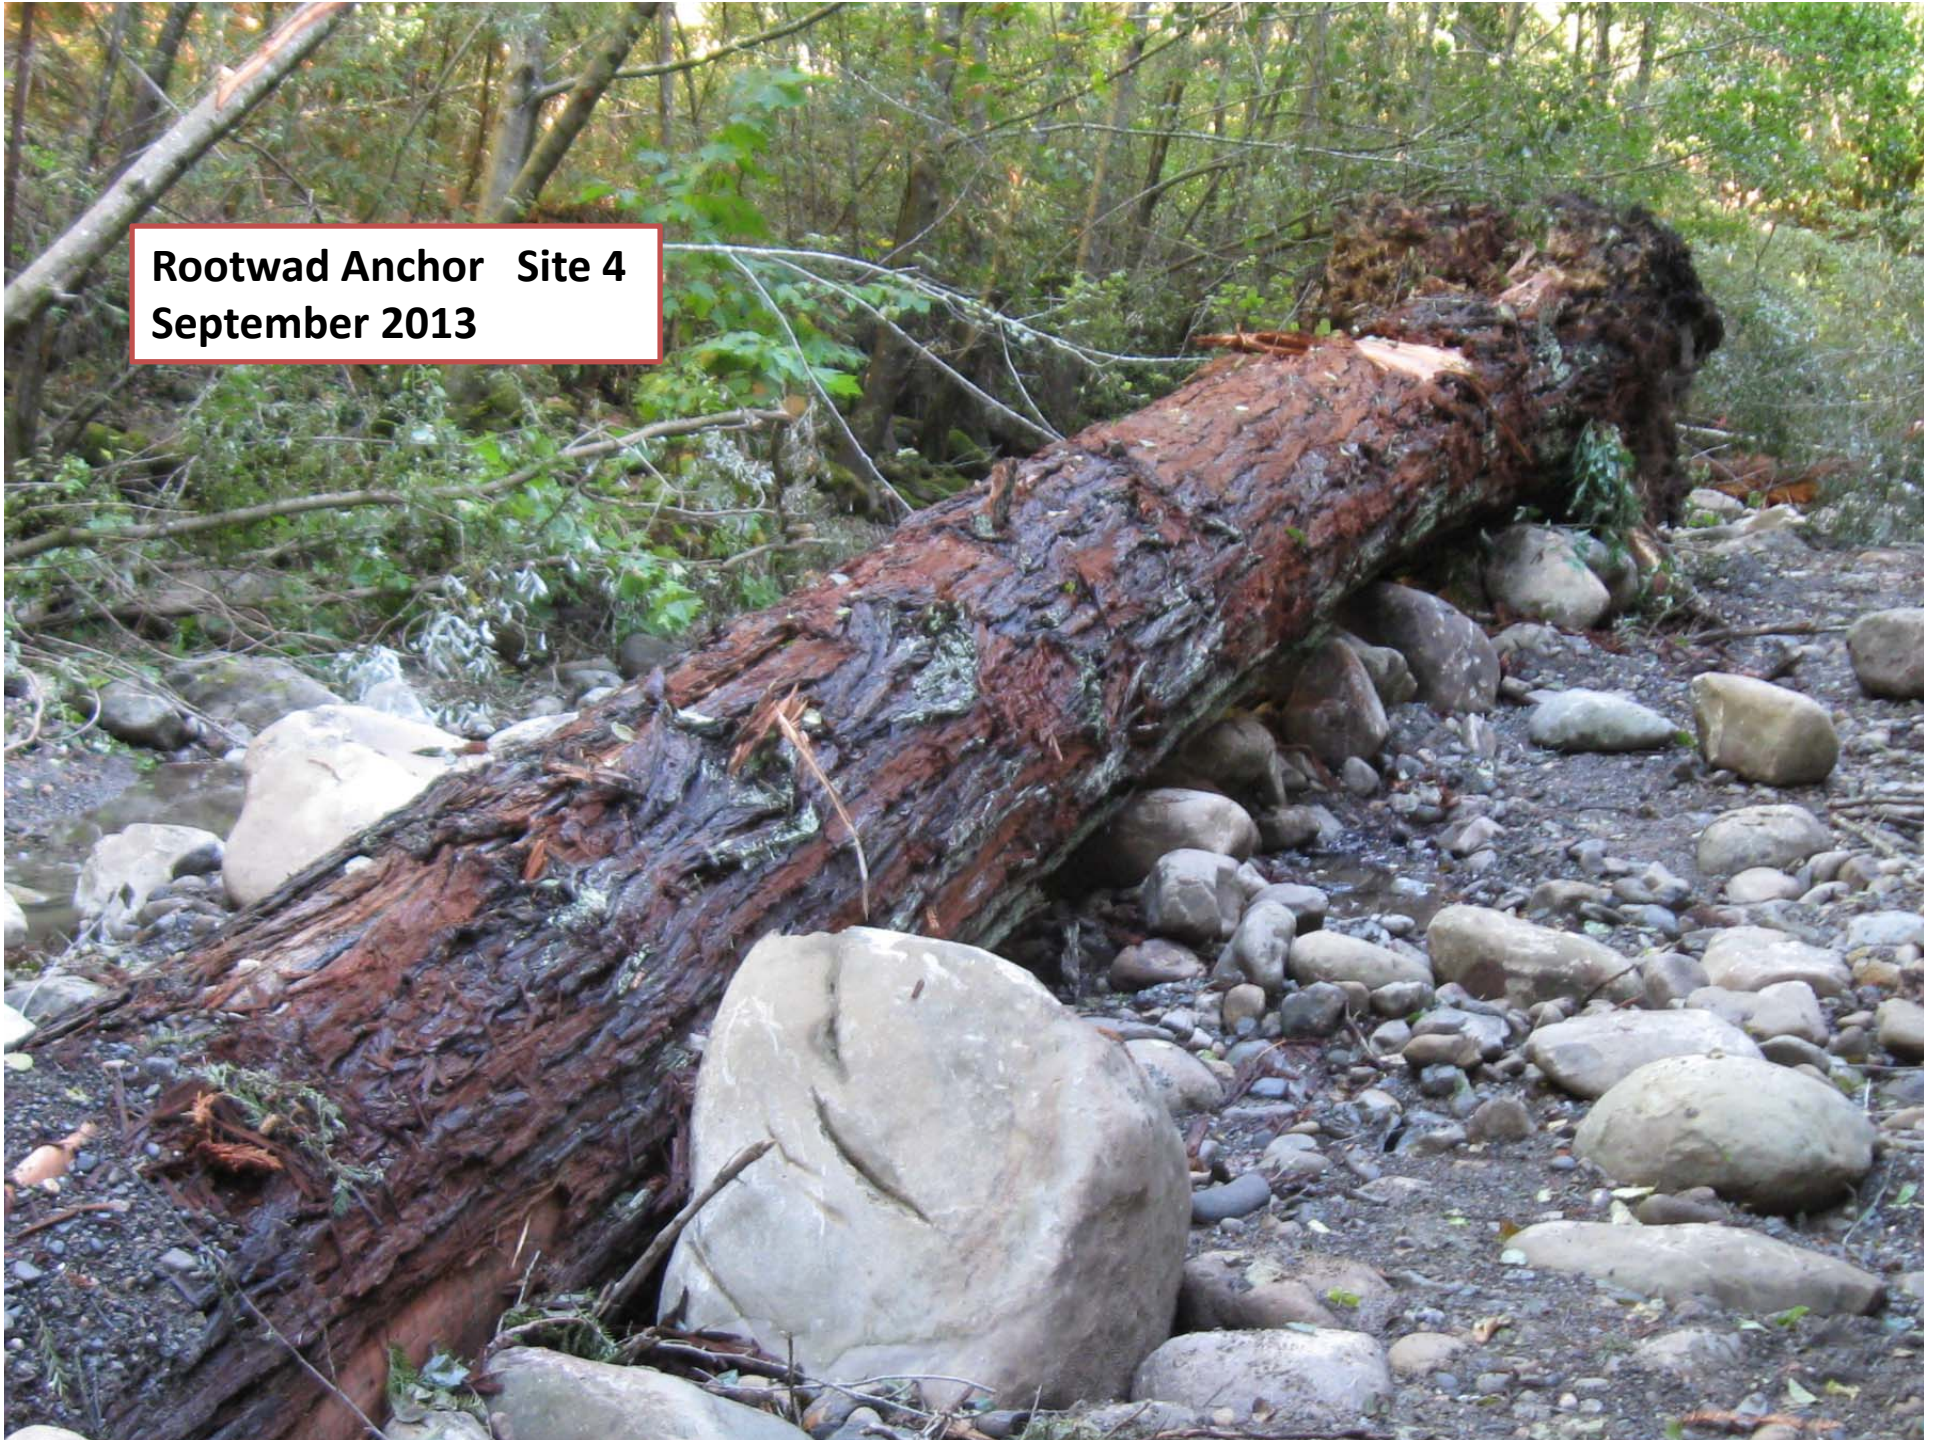
**Rootwad Anchor Site 4**  
**September 2013**

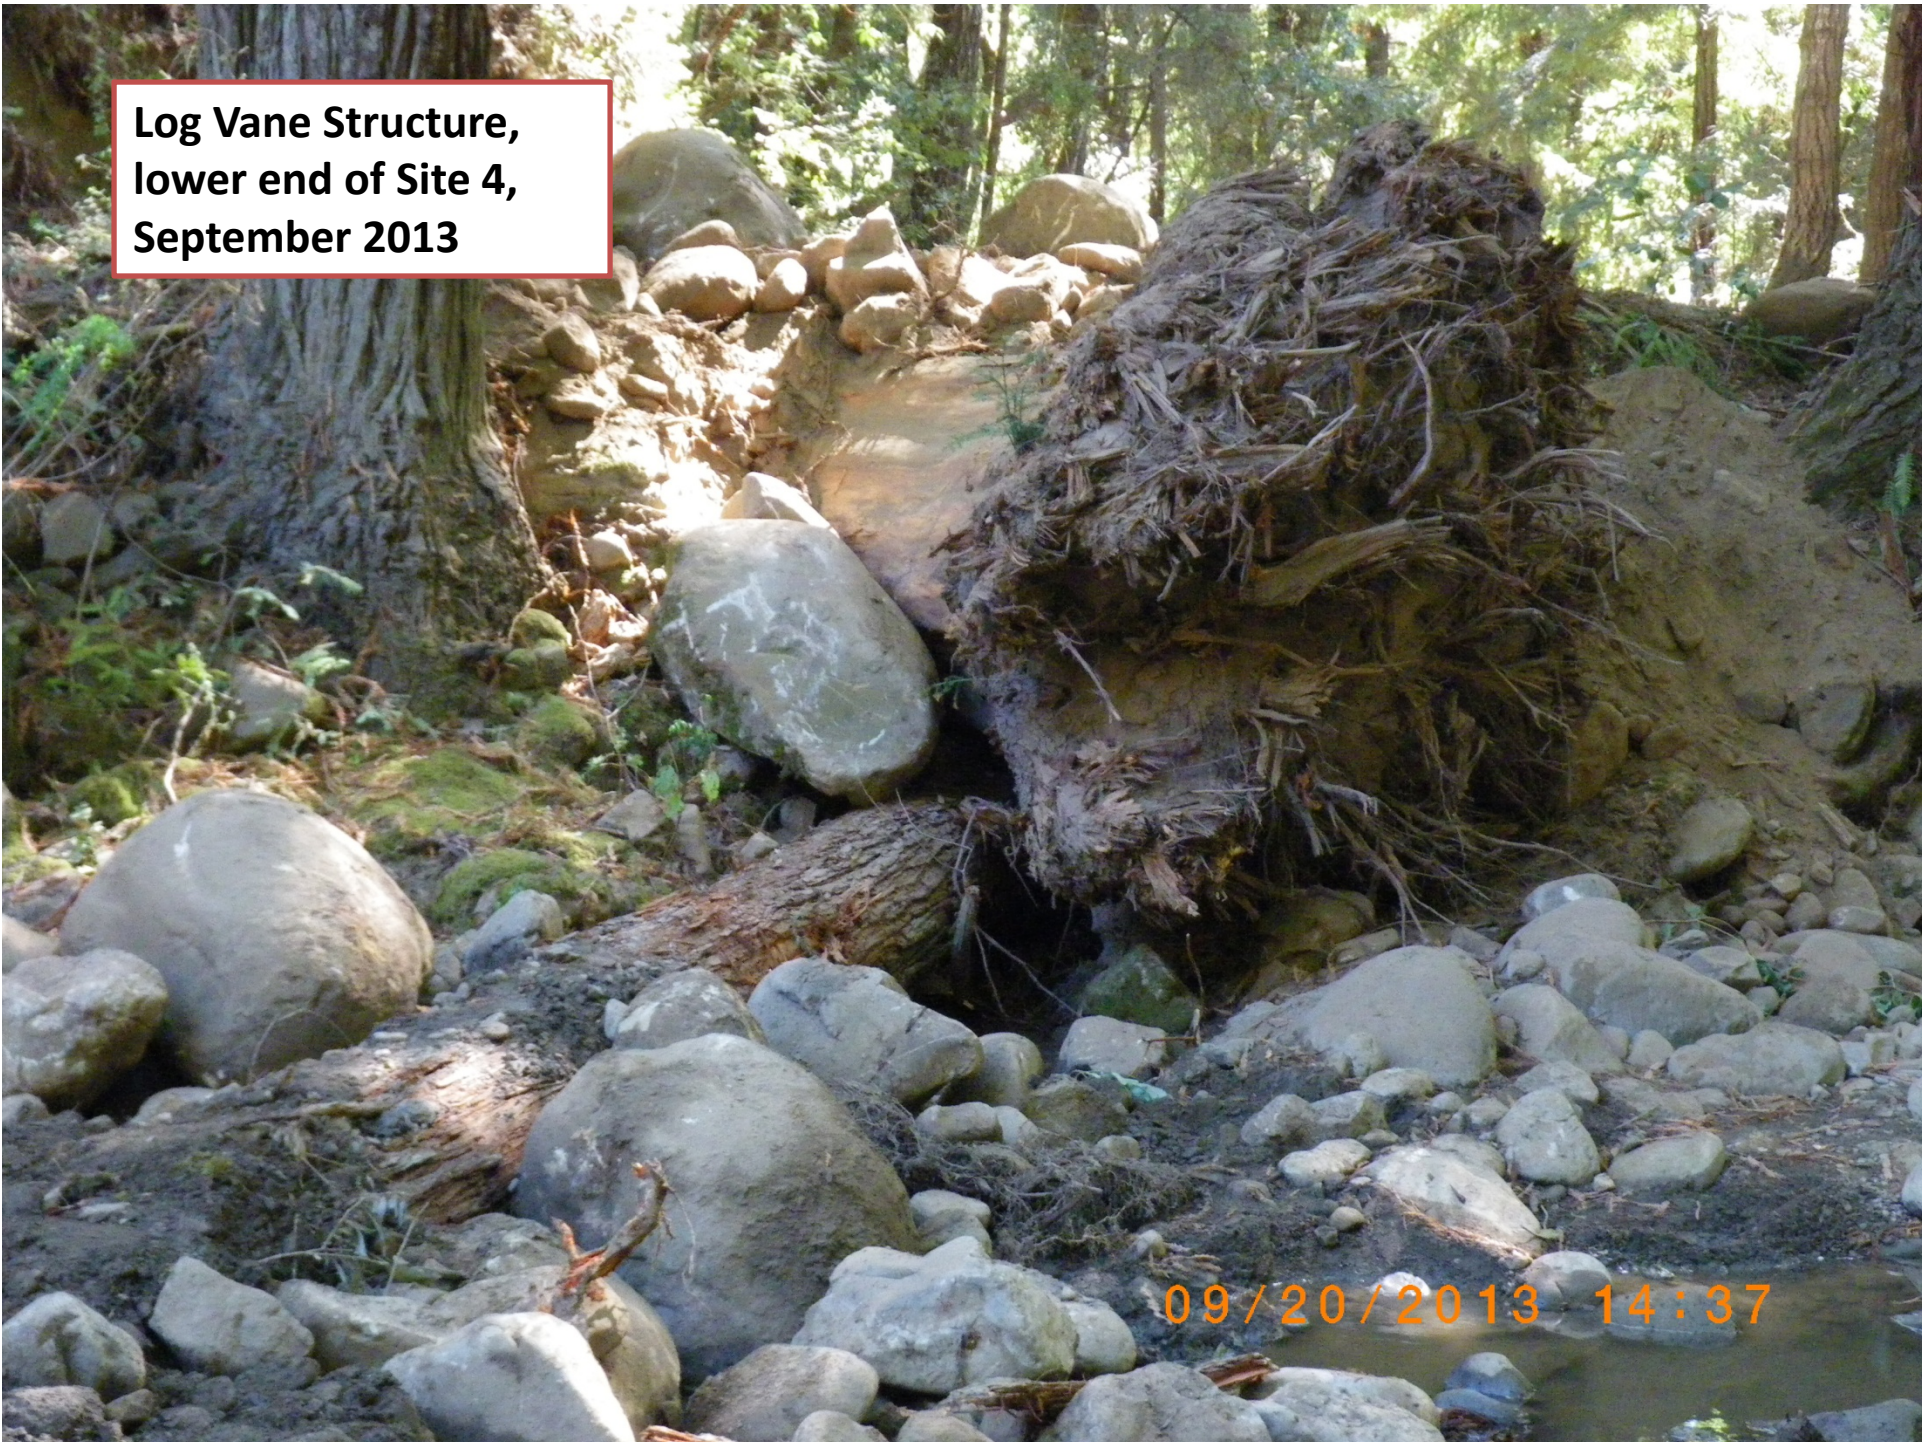
**Log Vane Structure,  
lower end of Site 4,  
September 2013**

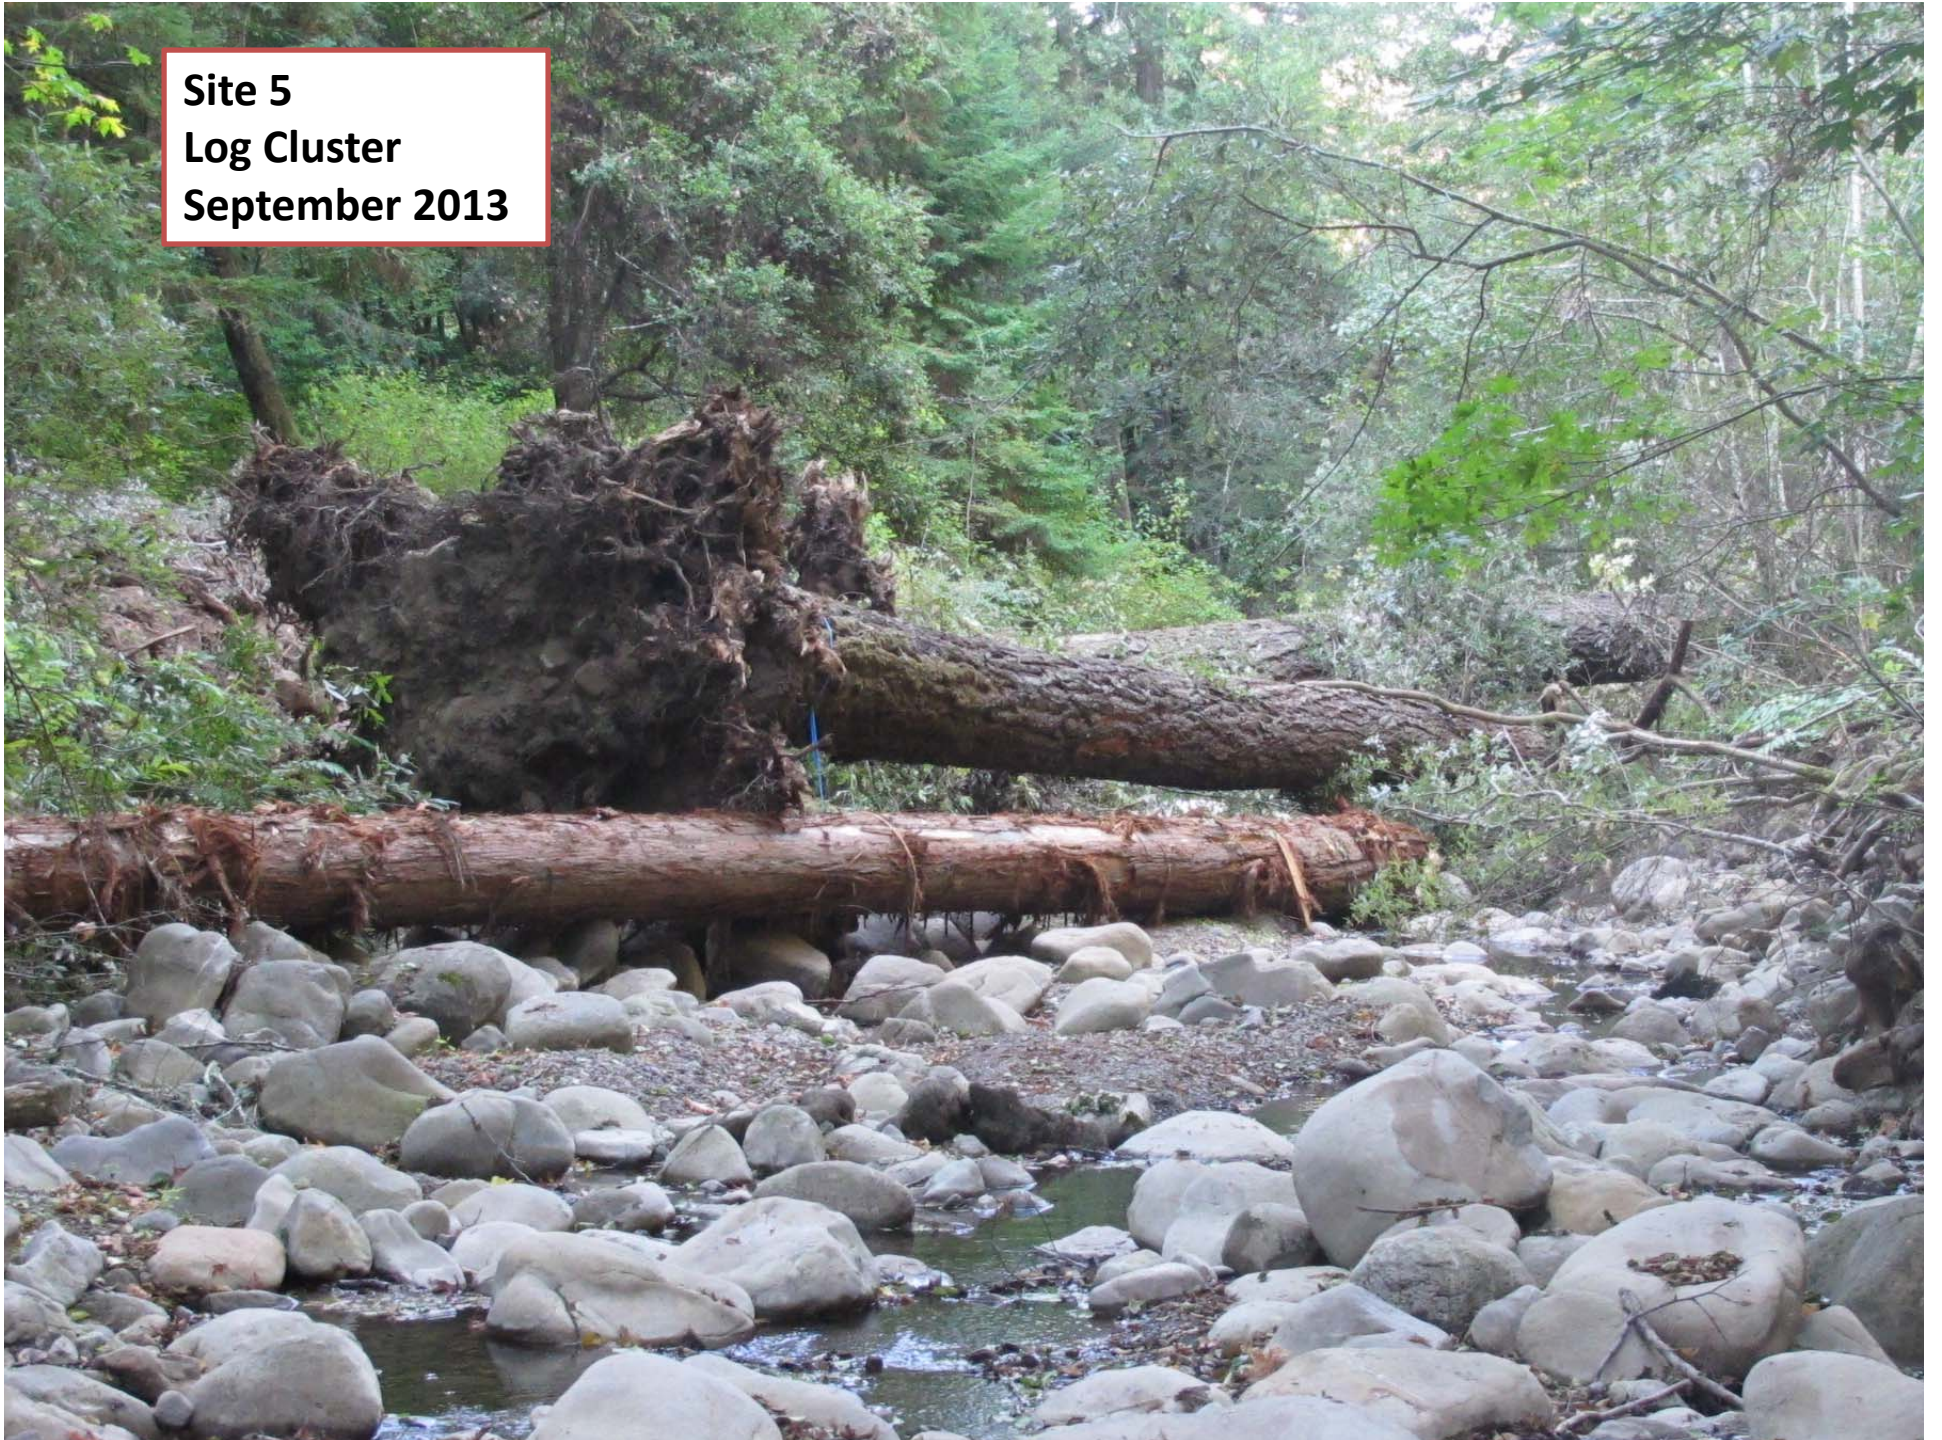
**Site 5**  
**Log Cluster**  
**September 2013**
