Enhancing Resilience of Wet Meadows in the Gunnison Basin, Colorado

Gay Austin (BLM), Claudia Strijek (Strijek Design)

2014 Tamarisk Coalition Riparian Restoration Conference

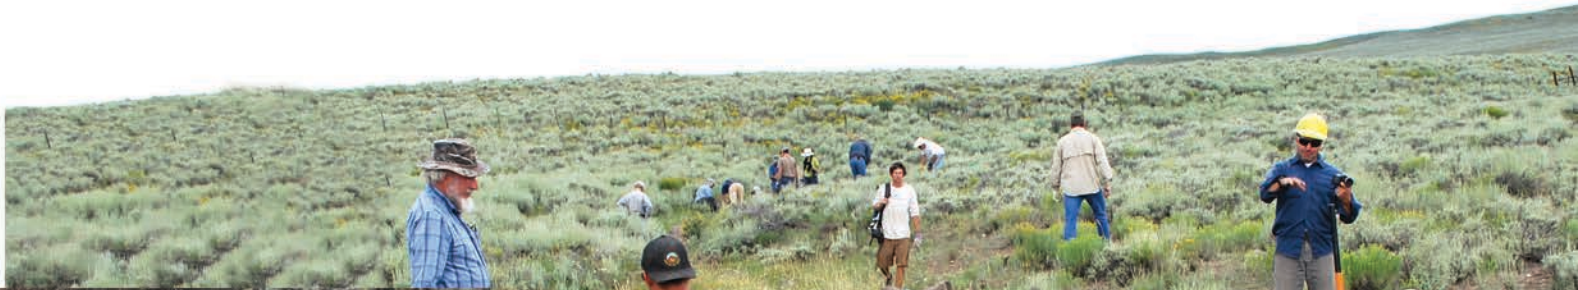
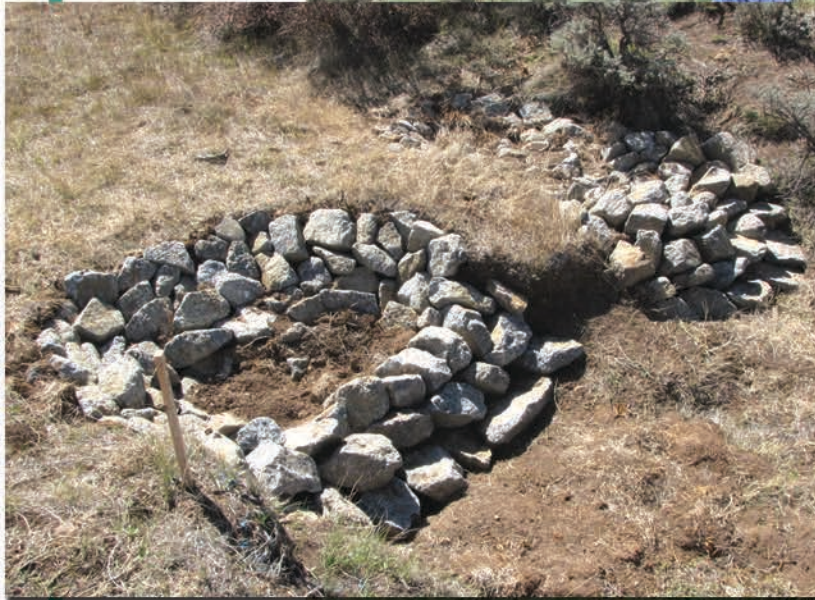
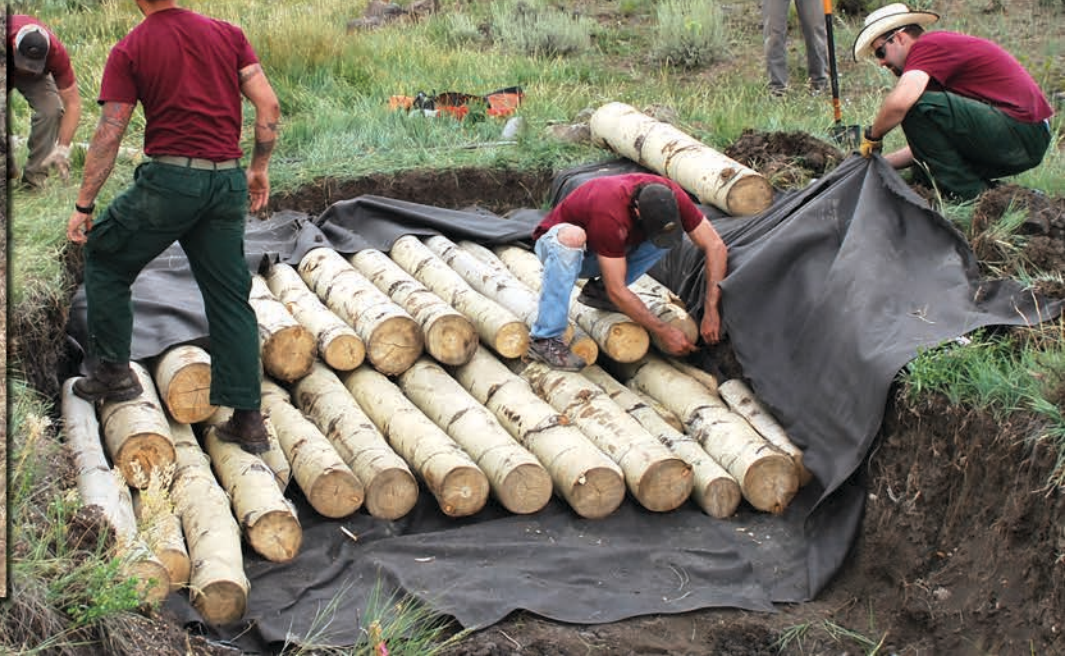
Structures

- One-rock dam, Media Luna, Zuni Bowl, Log Step Fall
- Material type/size important

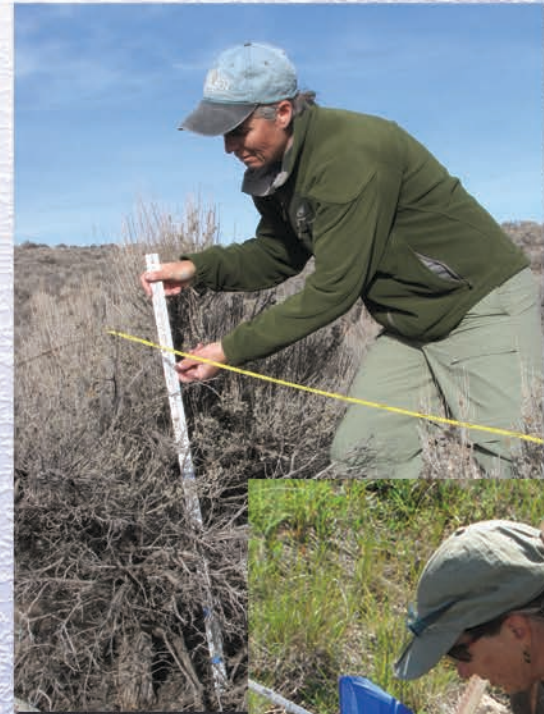
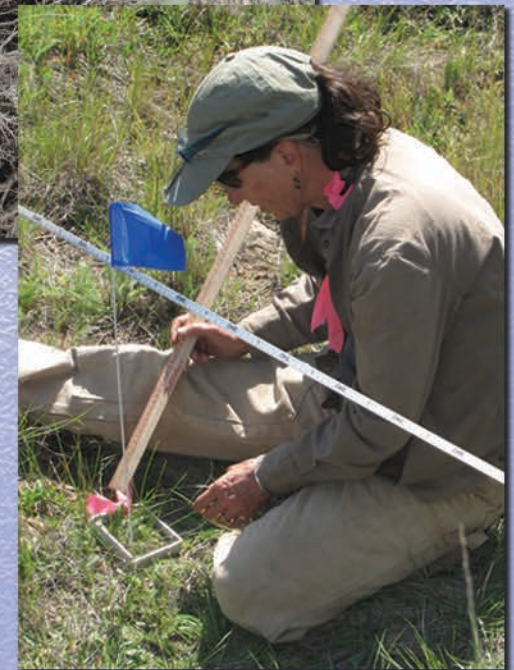
Water Monitoring

- Water wells installed to measure
 - Seasonal water table changes
 - Structures affecting water table
away from stream

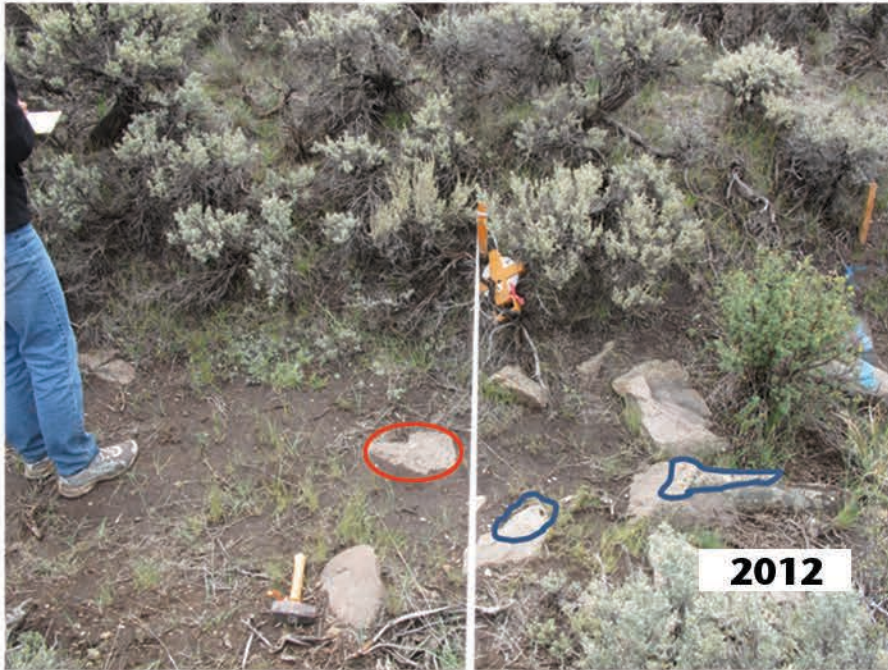
One Rock Dam on Ephemeral Stream

By 2013, sediments partially or completely covered many of the rocks. (Use the hammer to help locate the 2012 rocks and compare to the 2013 photo.)

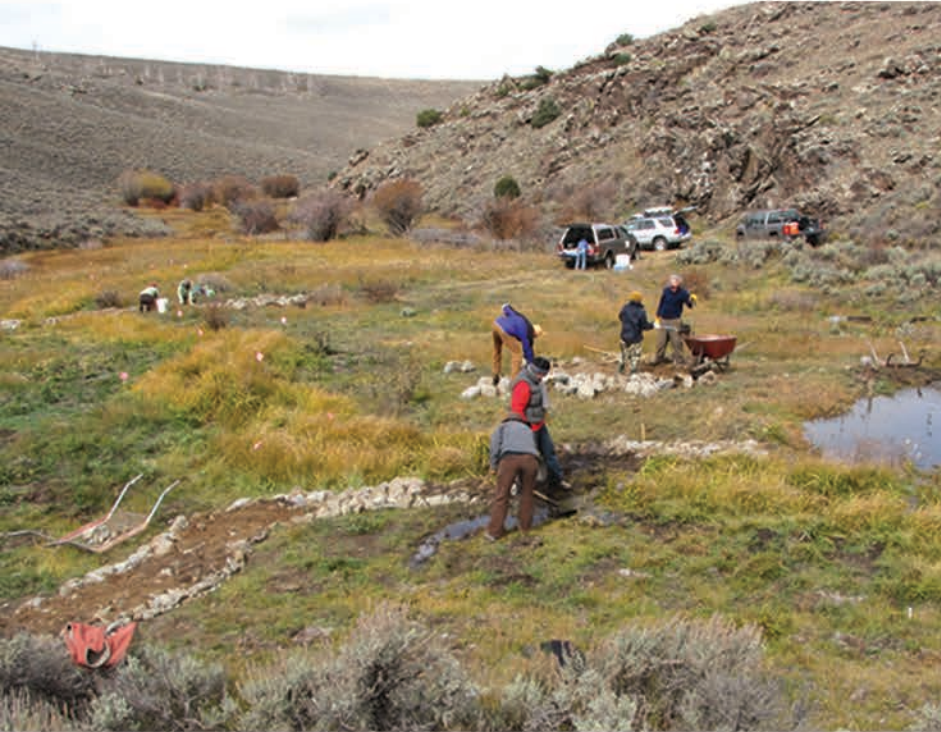
Before photo: 10-13-12

Media Luna results at East Fork - Wolf Creek

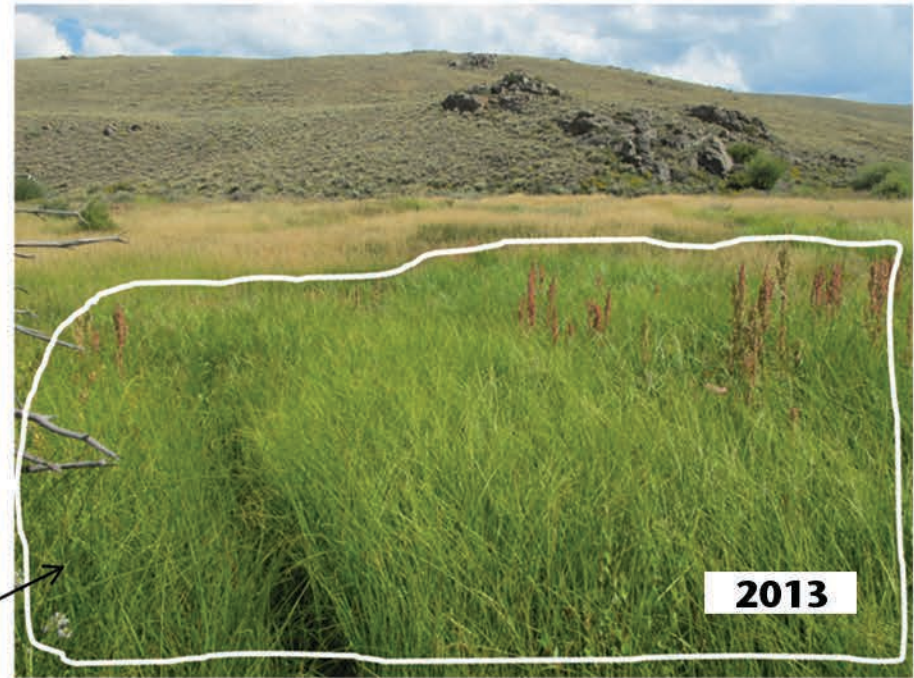
Expansion of Wetland Species

Carex utriculata, an obligate wetland species, expanded in area after the media luna was established.
