*Enhancing Ecosystem Resilience of Riparian/Wetland Habitats in the
Upper Gunnison Basin, Colorado*

**Final Report
Colorado Parks and Wildlife
Colorado Wetlands for Wildlife Program**

**By
The Nature Conservancy and the
Gunnison Climate Working Group
December 15, 2014**

***Enhancing Ecosystem Resilience of Riparian/Wetland Habitats
in the Upper Gunnison Basin, Colorado***
Colorado Wetlands for Wildlife Program Project #593
Purchase Order #1300000249
Period: October 19, 2012 – December 15, 2014
Date of Final Project Completion: December 15, 2014
**The Nature Conservancy and the
Gunnison Climate Working Group**

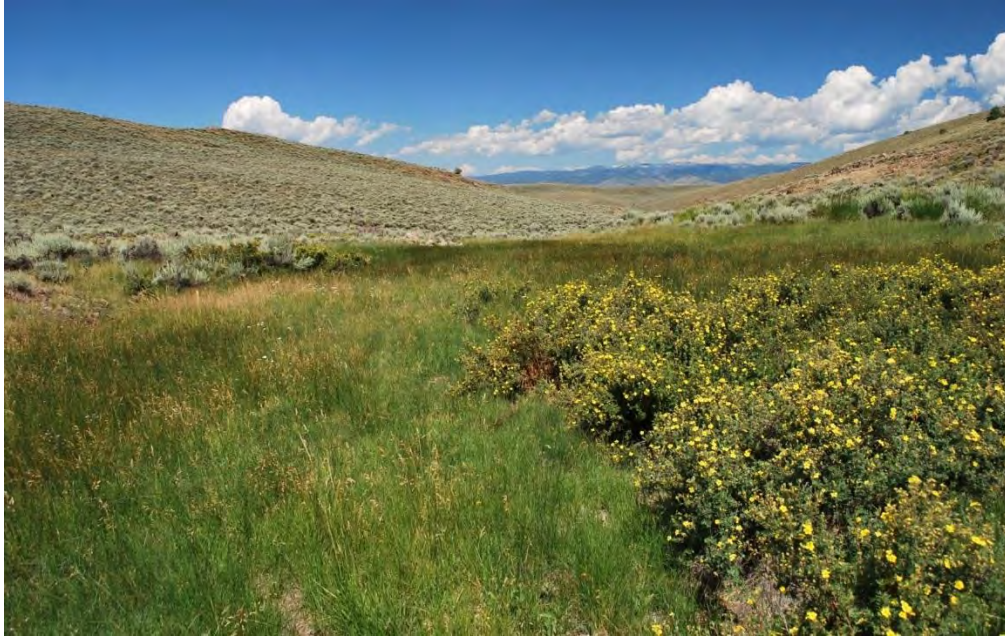
1. CPW Ballantyne State Habitat Area, Chance Gulch, tributary of Tomichi Creek, Gunnison County.

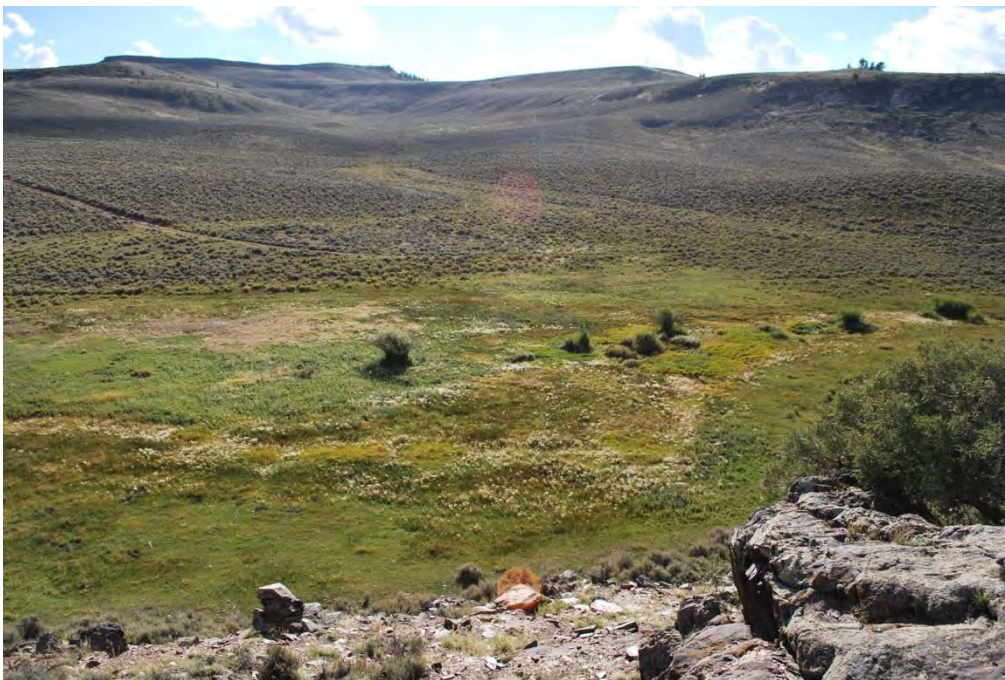
2. Moncrief Ranch, Kezar Basin, along West Smith Creek, a tributary of Cebolla Creek, south of Blue Mesa Reservoir.

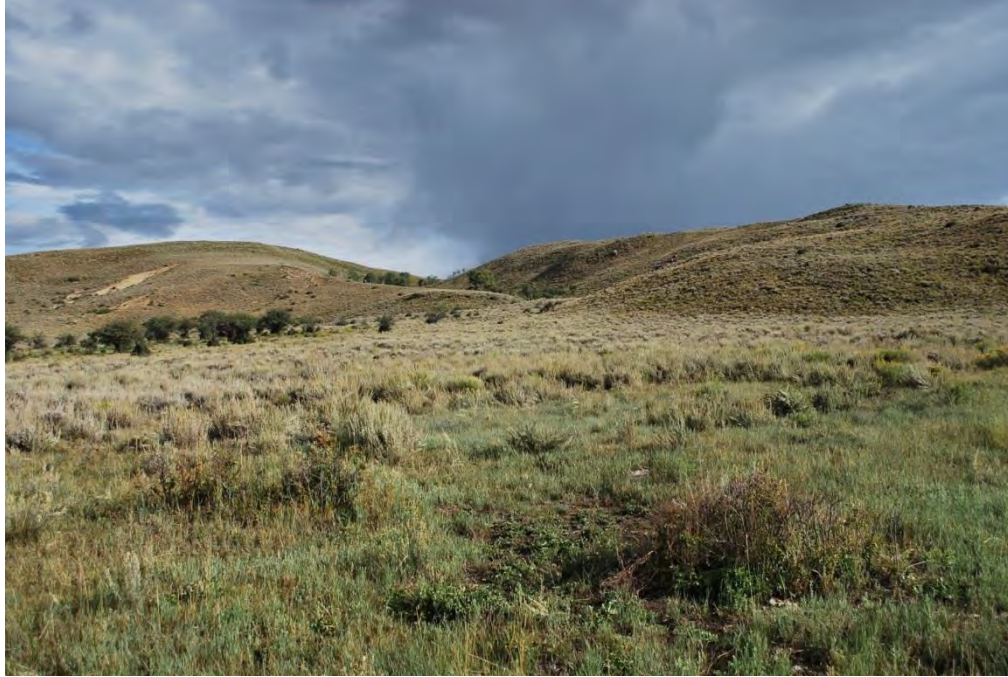
3. Alluvial fan above unnamed tributary of Ohio Creek, West Flat Top Mountain, US Forest Service lands above Redden Ranch, August 2014.

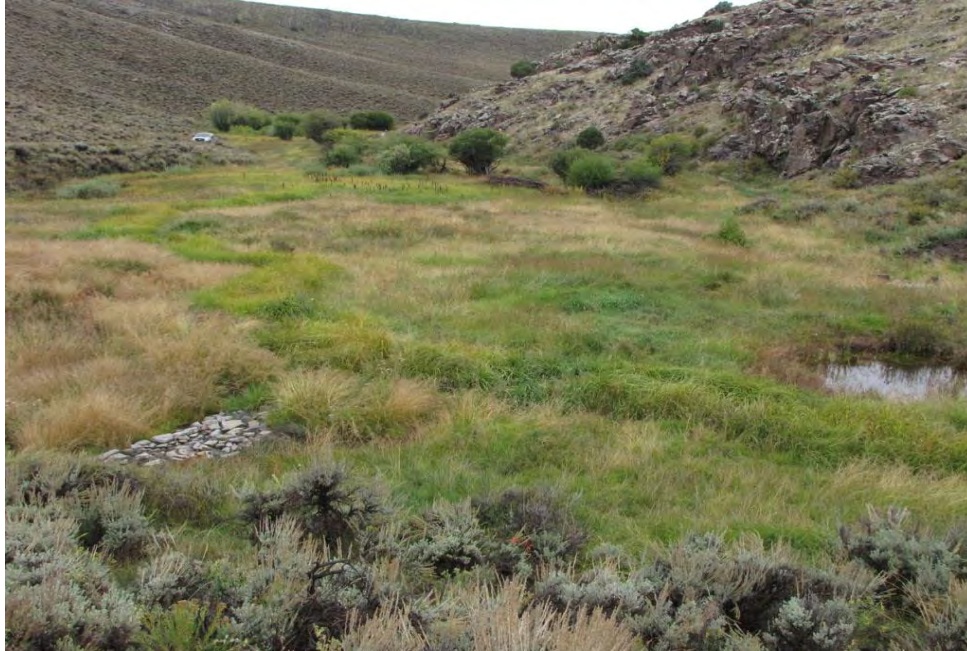
5. Kaichen State Habitat Area, Wolf Creek, tributary of Cebolla Creek (photo by Claudia Strijek).

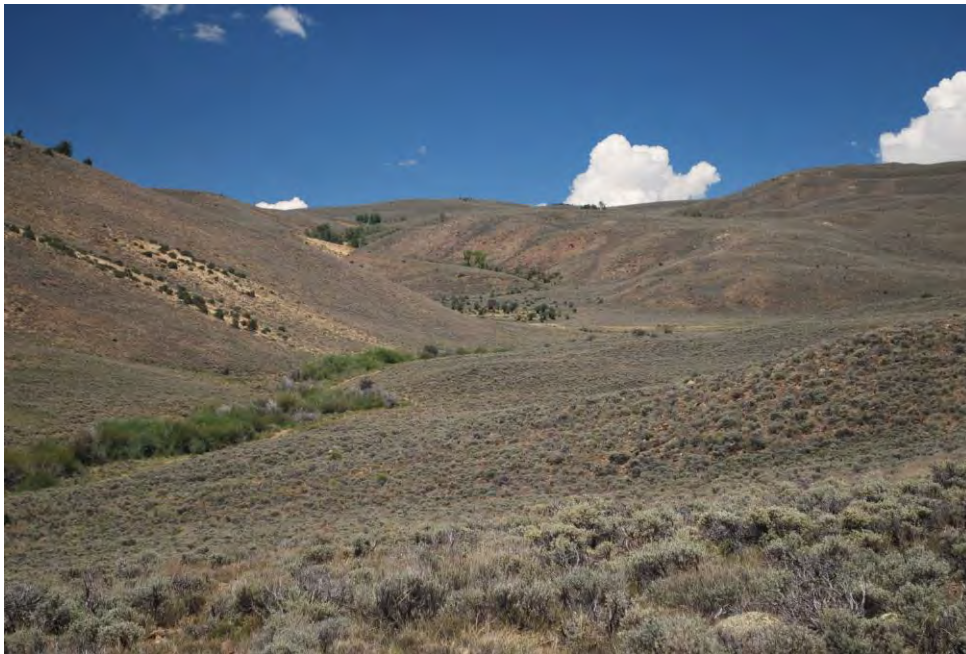
6. Redden Ranch, West Flat Top Mountain, unnamed tributary to Ohio Creek.

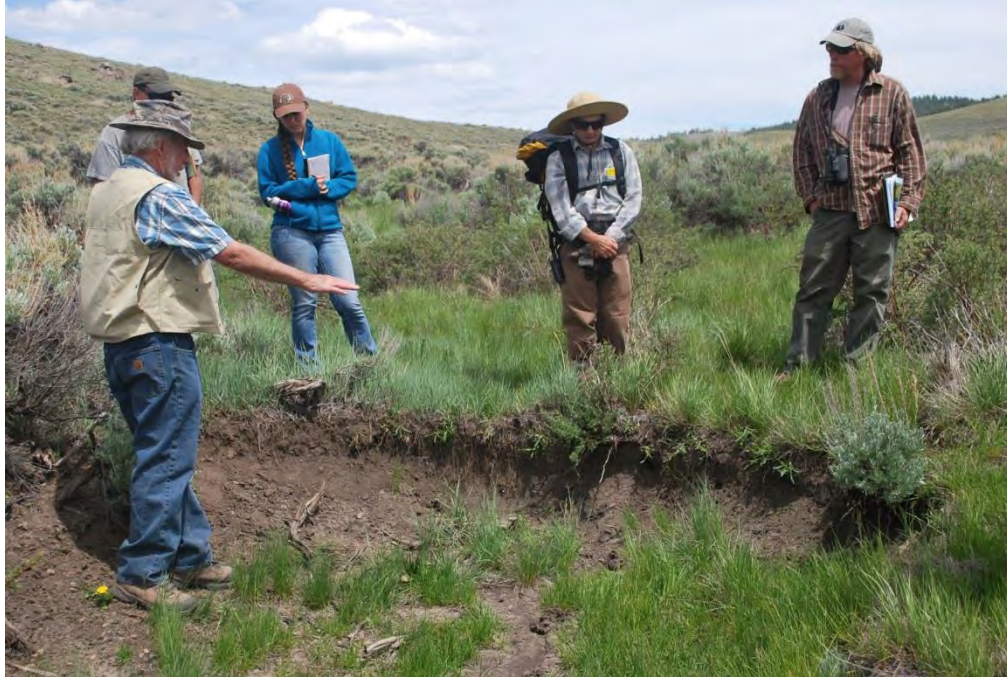
7. Bill Zeedyk evaluating restoration needs to address a head cut at Chance Gulch with BLM, WRV, NRCS and BIO-logic, June 2014

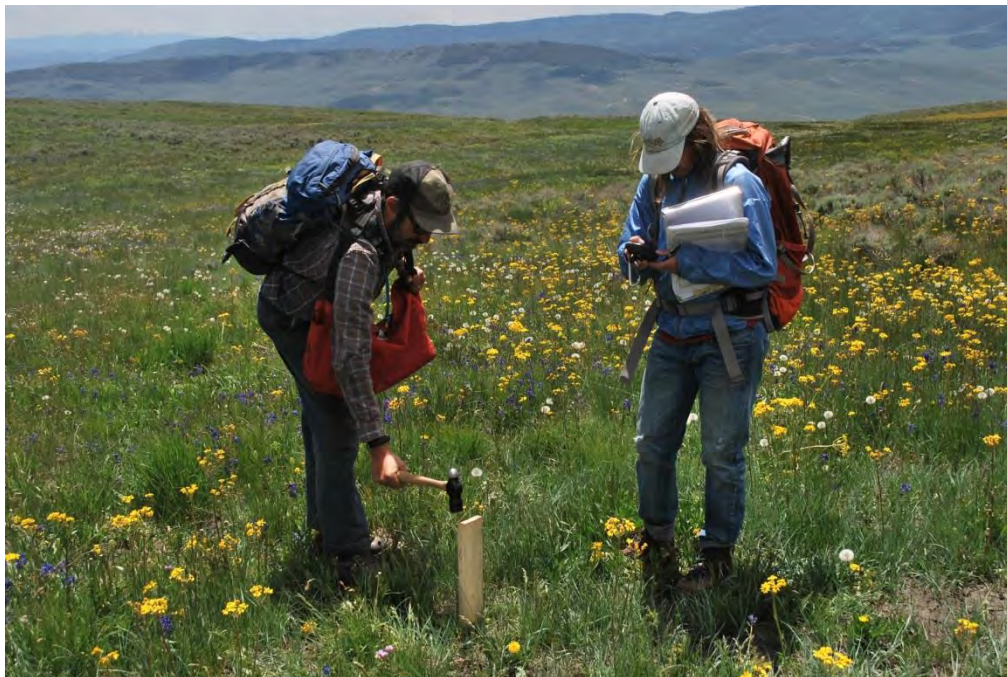
8. Ben Stratton, hydrologist, and Suzie Parker, biologist, US Forest Service, stake location for a one rock dam rock structure at West Flat Top Mountain, June 2014.

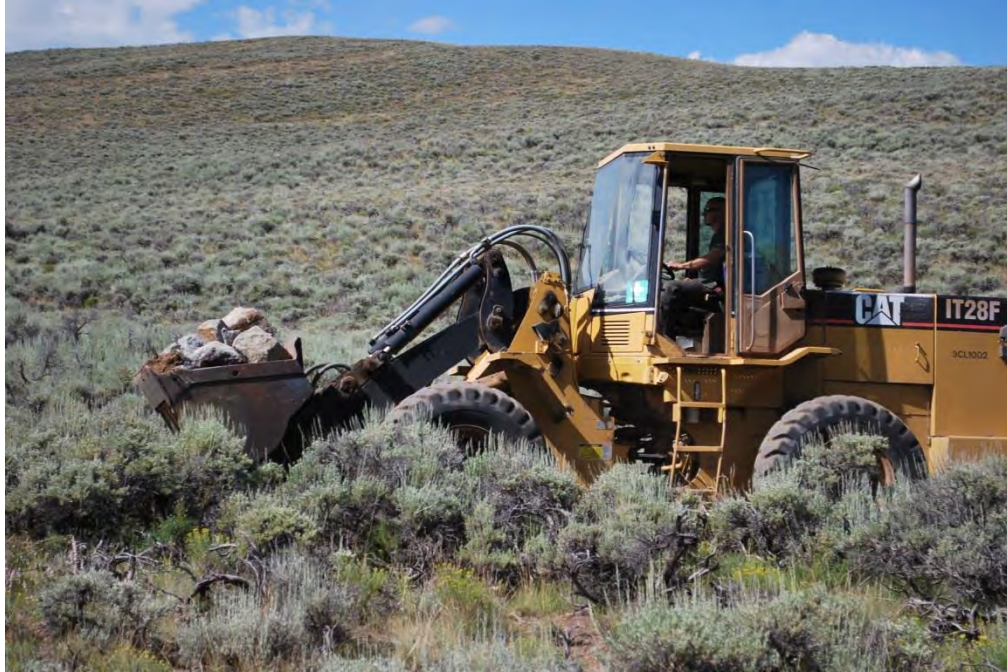
9. Gunnison Gravel delivering rock to staging area at Chance Gulch, July 2014.

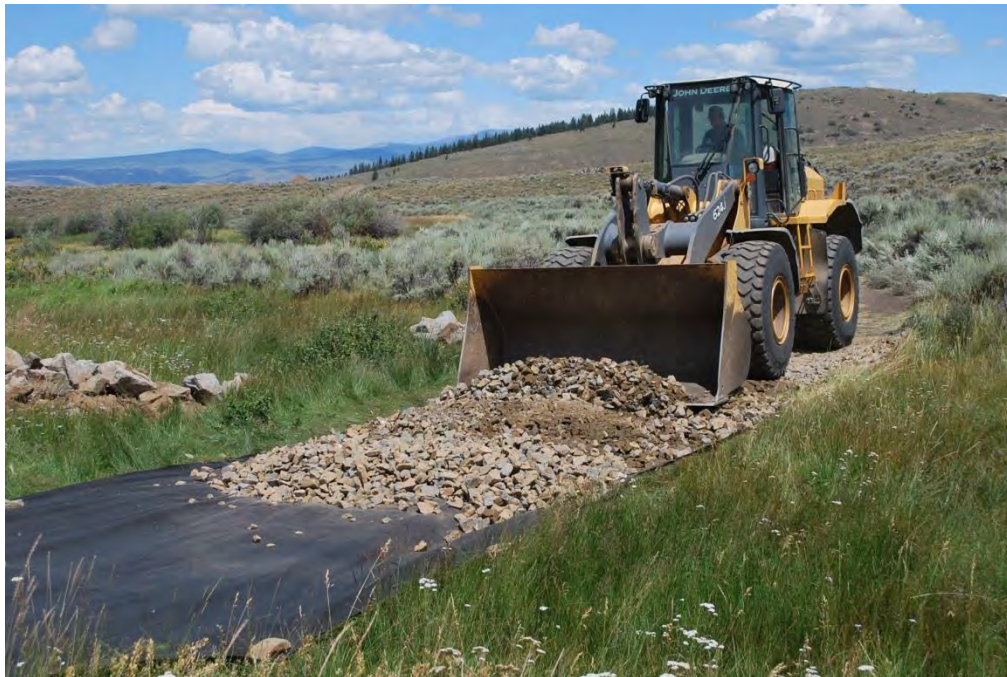
10. Gunnison Gravel front-end loader builds a low water crossing at Chance Gulch, August 2014.

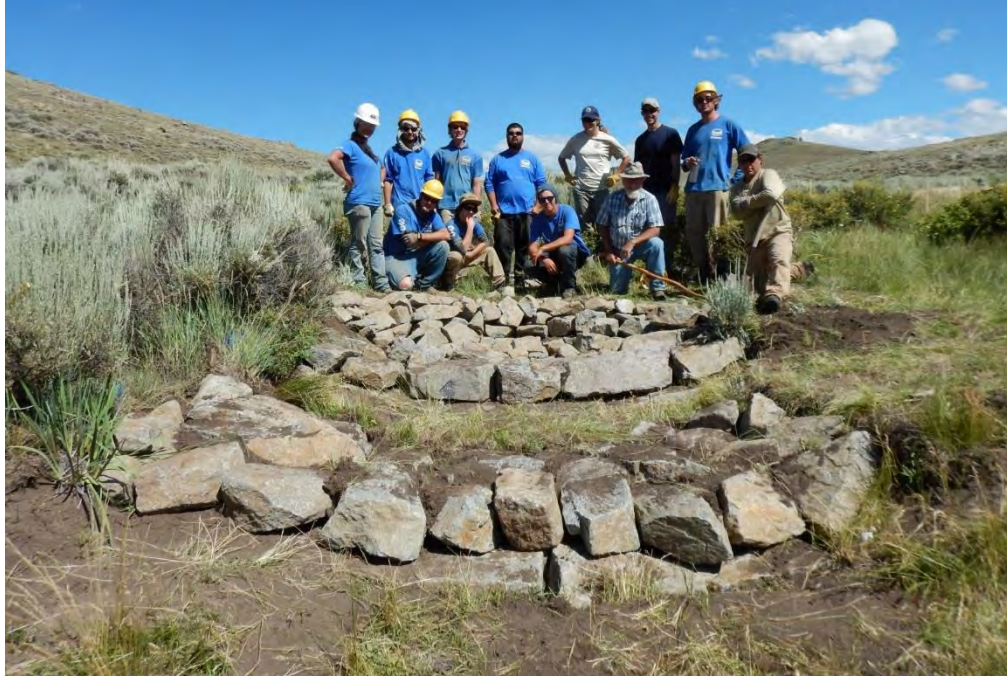
15. Western Colorado Conservation Corps, Nathan Seward, CPW, Bill Zeedyk and Shawn Conner celebrate completion of a Zuni bowl (center) with one rock dam (foreground) at Chance Gulch, August 2014. Photo: Andrew Breibart, BLM.

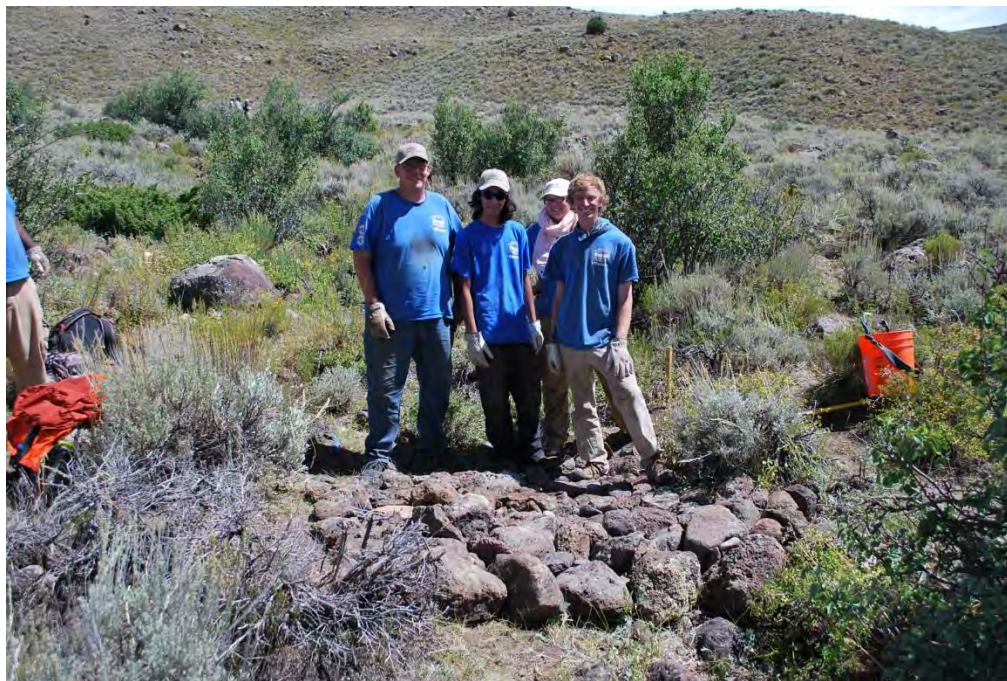
16. Western Colorado Conservation Corps field crew complete one rock dam structure at West Flat Top Mountain on US Forest Service lands above Redden Ranch, consisting of locally collected volcanic rock, August 2014.

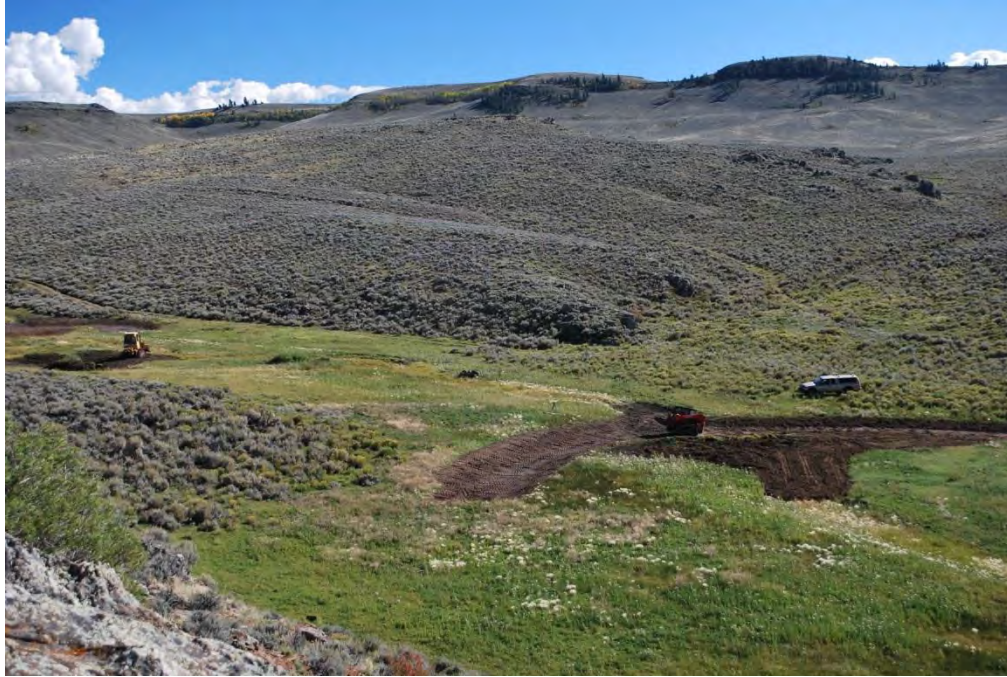
17. Stonefly Earthworks builds a “double bay plug and pond” structure at Moncrief Ranch, Kezar Basin, to rewet a meadow and reduce invasive species. NRCS planted native seed on the disturbed soil, September 2014.

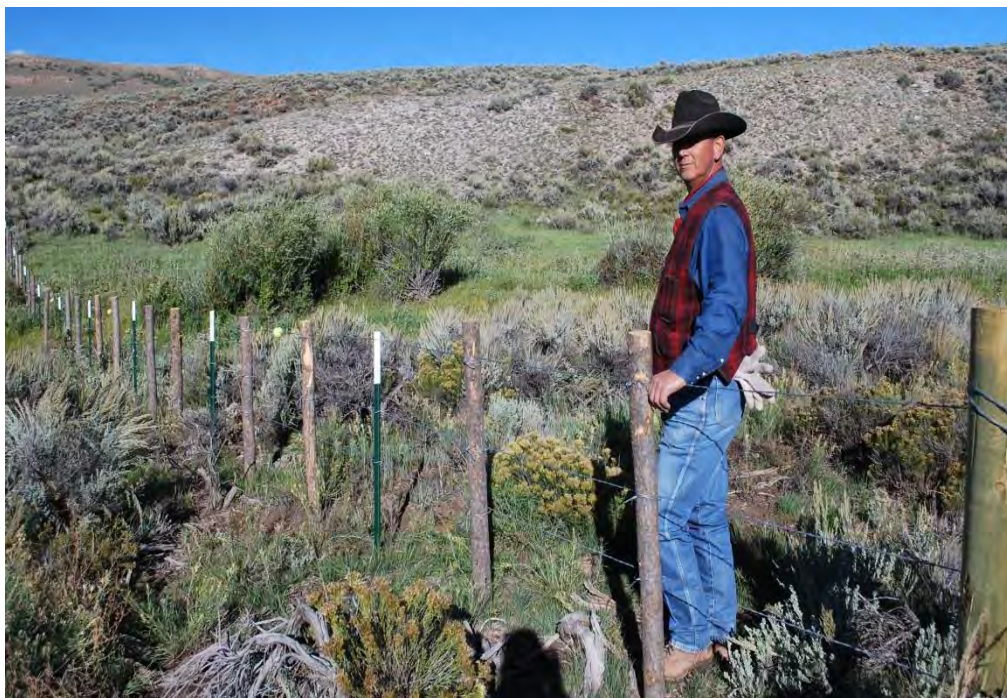
18. Ted Harter, Ranch Manager, Moncrief Ranch, inspects a drift fence, a line of fence placed across the stream channel, to reduce trailing and soil compaction by livestock and wildlife.

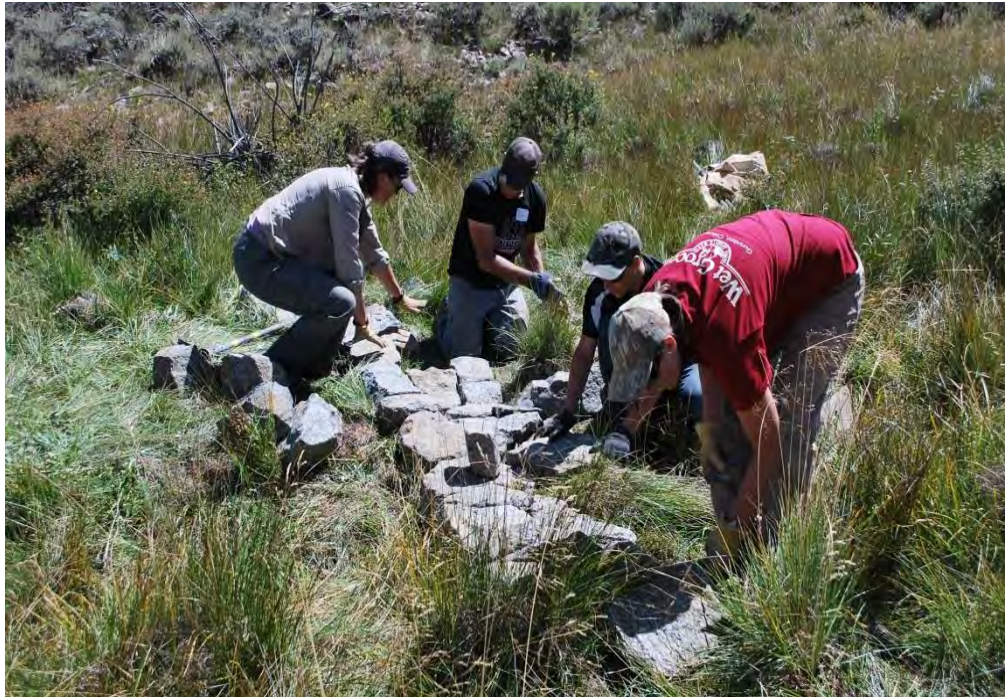
19. Gunnison High School Biology Class students and teachers build a one rock dam at Chance Gulch, Wildlands Restoration Volunteer event, September 2014.

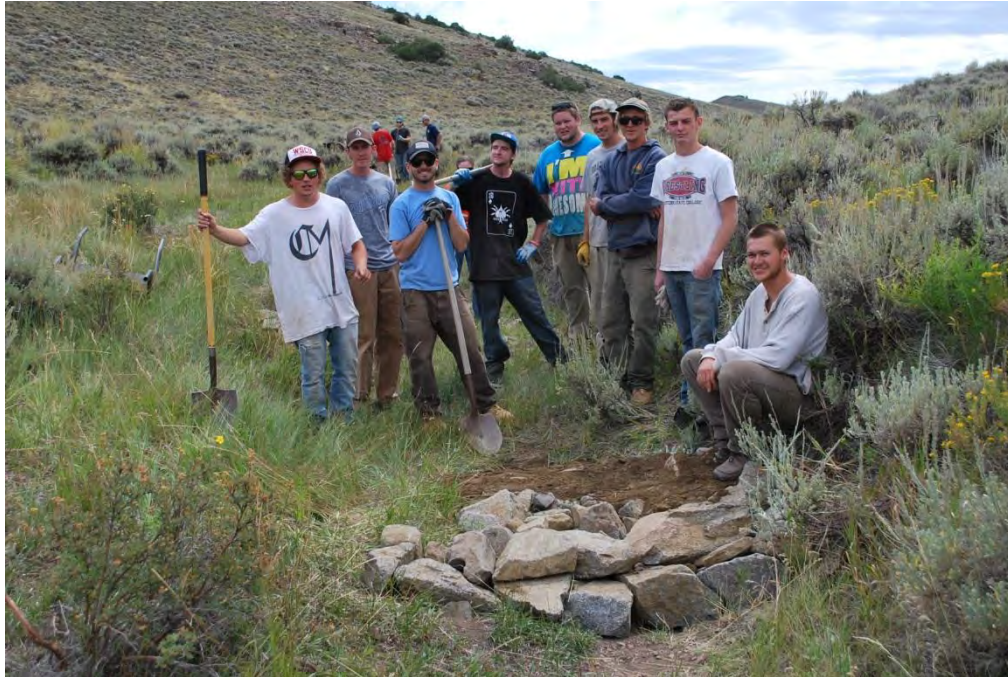
21. Western State Colorado University Ecological Monitoring class completes a one-rock dam in Chance Gulch, directed by Nathan Seward, CPW (in background).

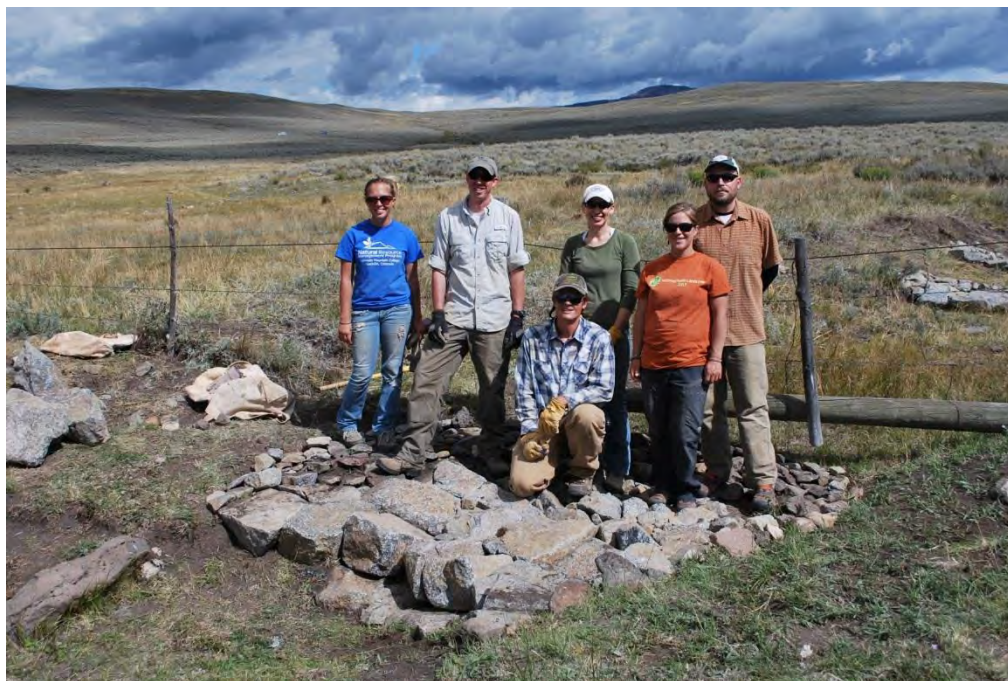
22. Wildlands Restoration Volunteer Crew Leader Clayton BonDurant (low center) and volunteers complete Zuni bowl to control a head cut on West Flat Top Mountain on US Forest Service lands, September 2014.

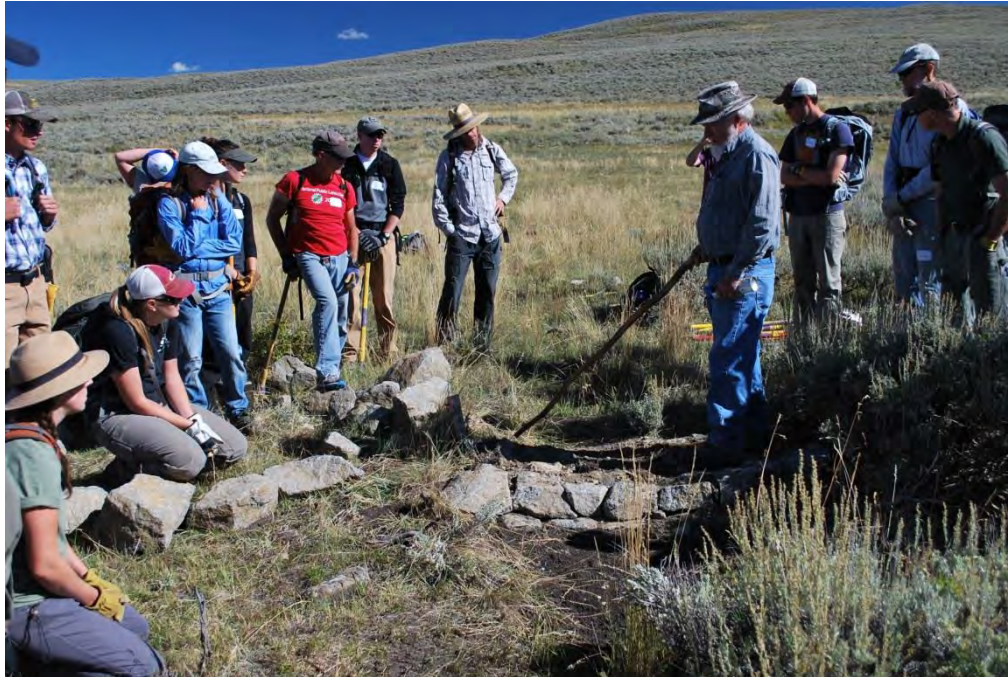
23. Bill Zeedyk explains the function of a one rock dam, a grade control structure, to volunteers and partners at West Flat Top Mountain during the Wildlands Restoration Volunteer five-day volunteer event, September 2014.

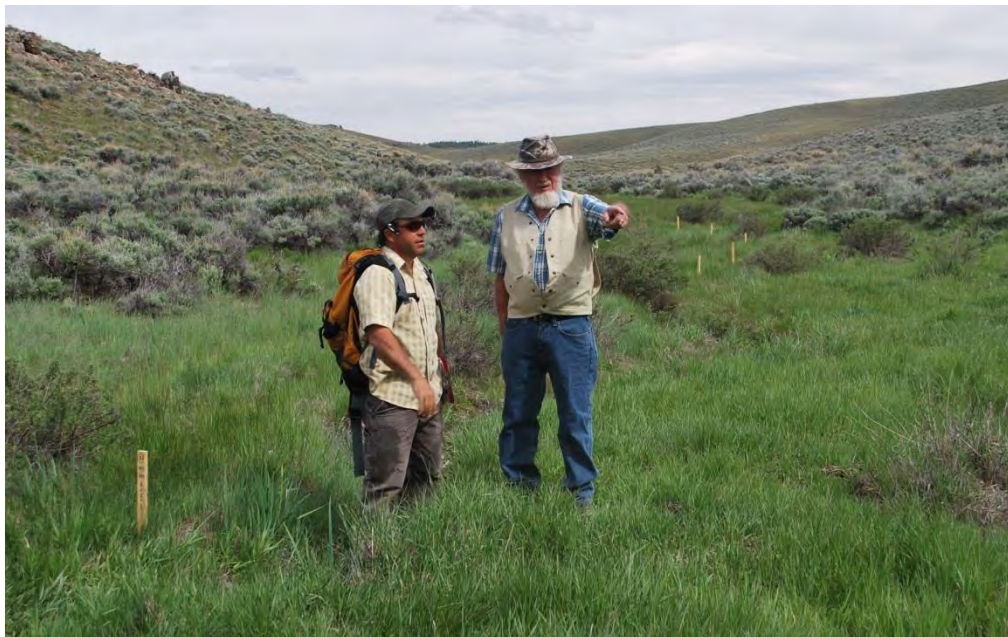
28. Restoration experts Shawn Conner, BIO-Logic, Inc. and Bill Zeedyk, Zeedyk Ecological Consulting discussing placement of rock structures in Chance Gulch.

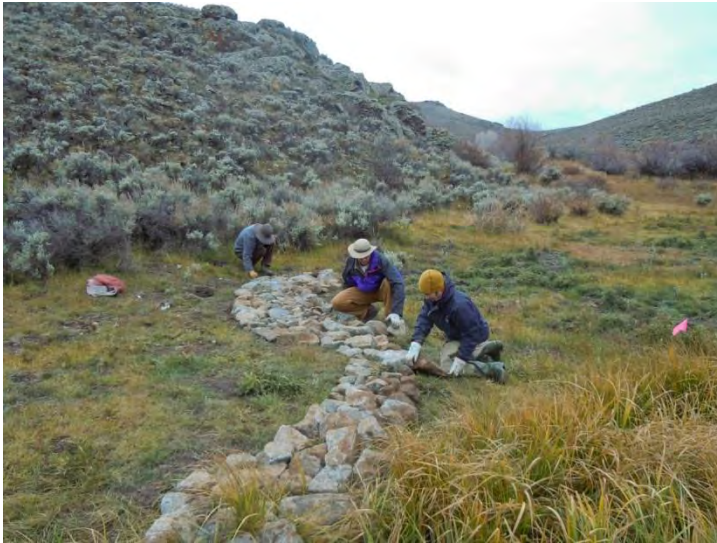
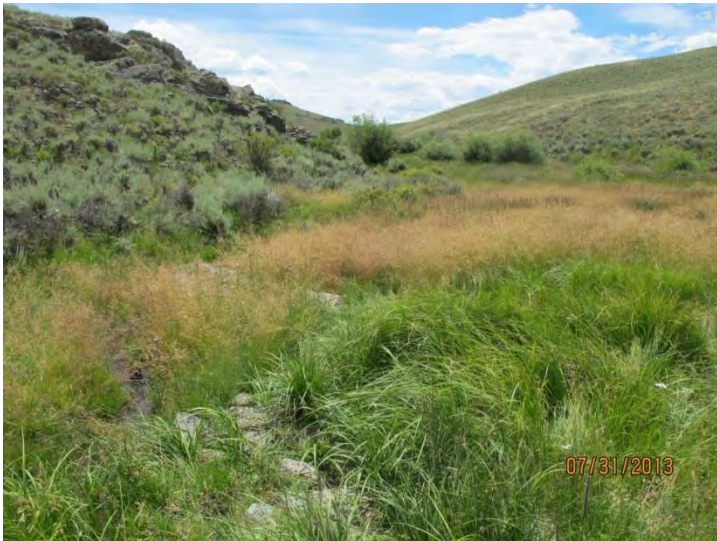
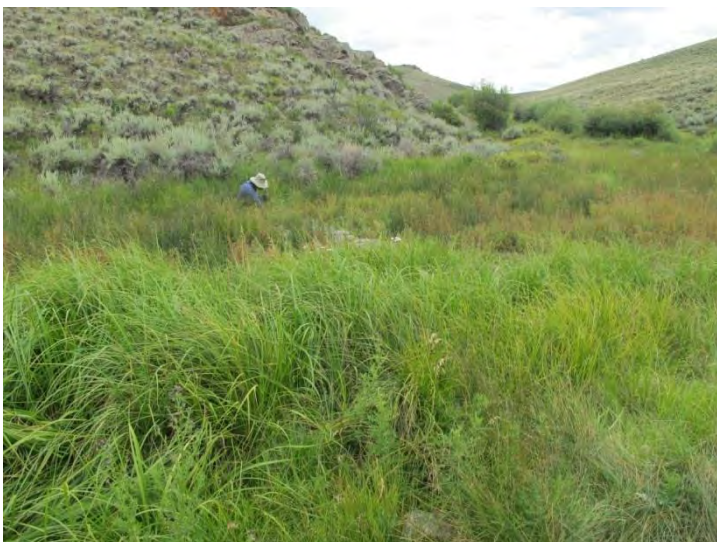
29, 20, 31. Before and after pictures of Kaichen State Habitat Area, Wolf Creek Ranch meadow showing building of media luna, one year later and two years later. The media luna was effective in spreading water across a drying meadow, increasing native wetland plants such as beaked sedge, and reducing invasive species such as Canada thistle. Photographs by Renee Rondeau, CNHP and Betsy Neely, TNC.

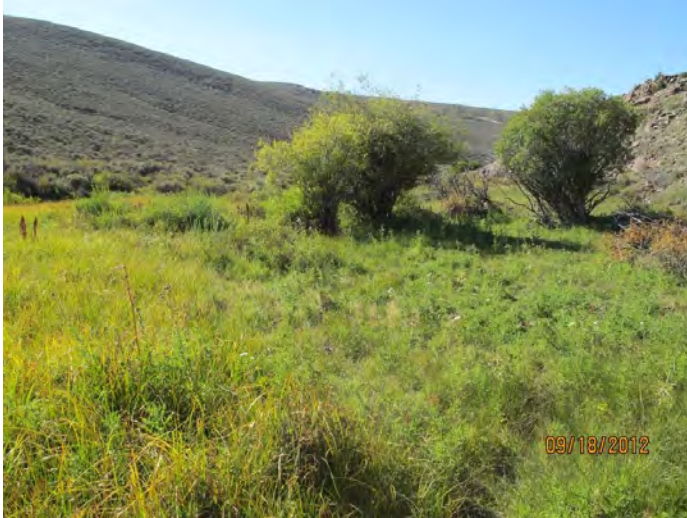
32, 33, 34. Photographs taken about 100 yards below a media luna, Kaichen State Habitat Area, Wolf Creek Ranch, along Wolf Creek, an intermittent tributary of Cebolla Creek. Photographs by Renee Rondeau, CNHP.

2012: Sedges were limited to far left (top)

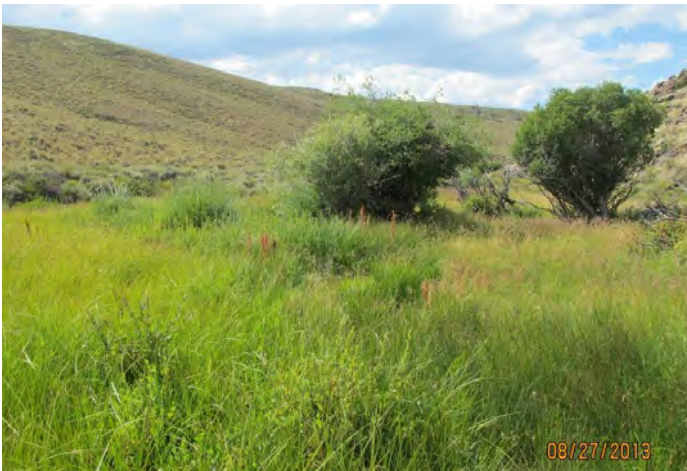
2013: Sedges have increased towards the right (middle)

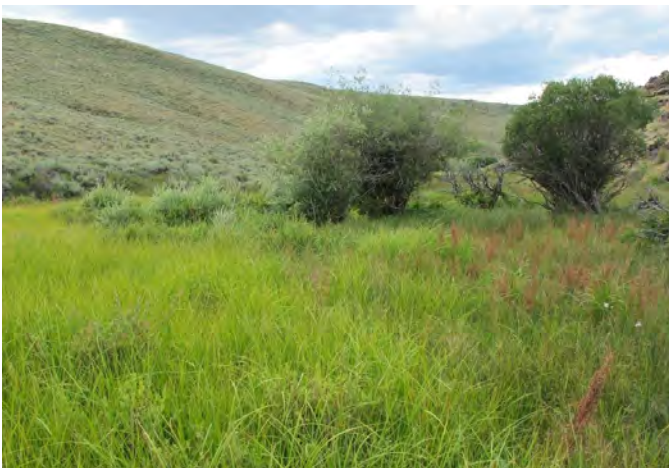
2014: Sedges have increased all the way to the right and standing water was approximately one inch deep or deeper throughout the area (bottom)

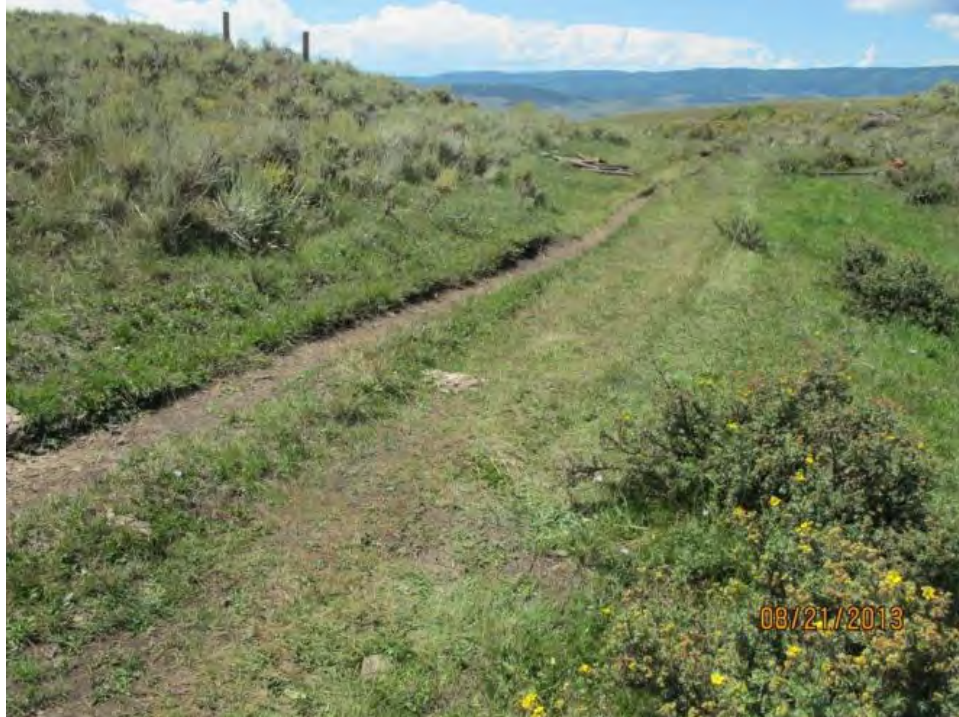
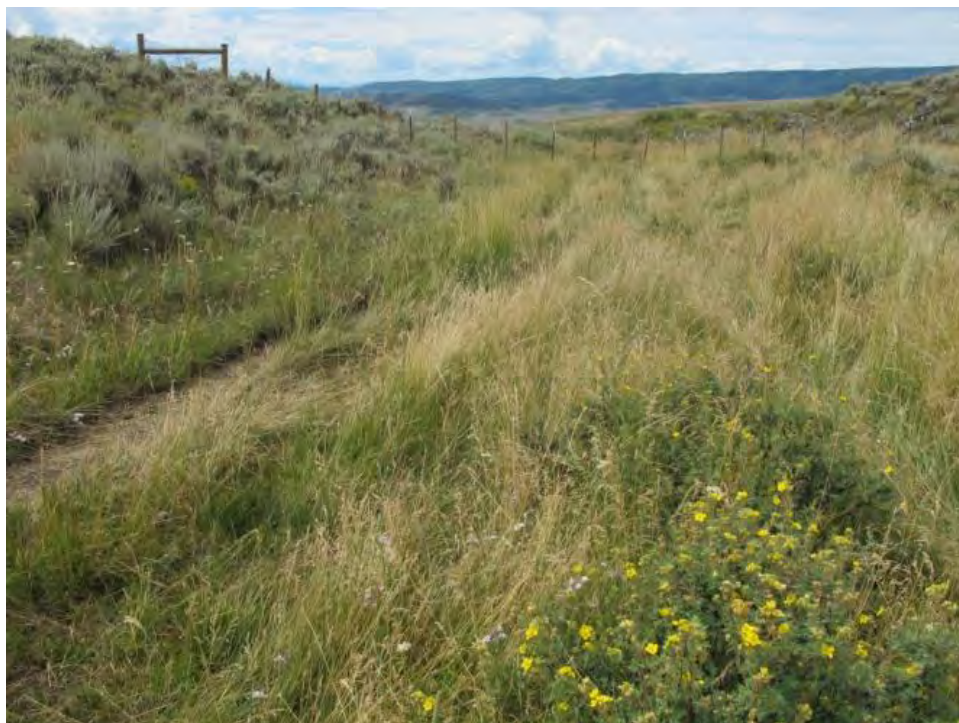
35, 36. Repeat photograph of a meadow with drift fences built in 2013 across a meadow at West Flat Top on USFS lands. Preliminary results indicate that the fences are effective in diverting cattle from their trail, reducing trailing and soil compaction. Renee Rondeau, CNHP.

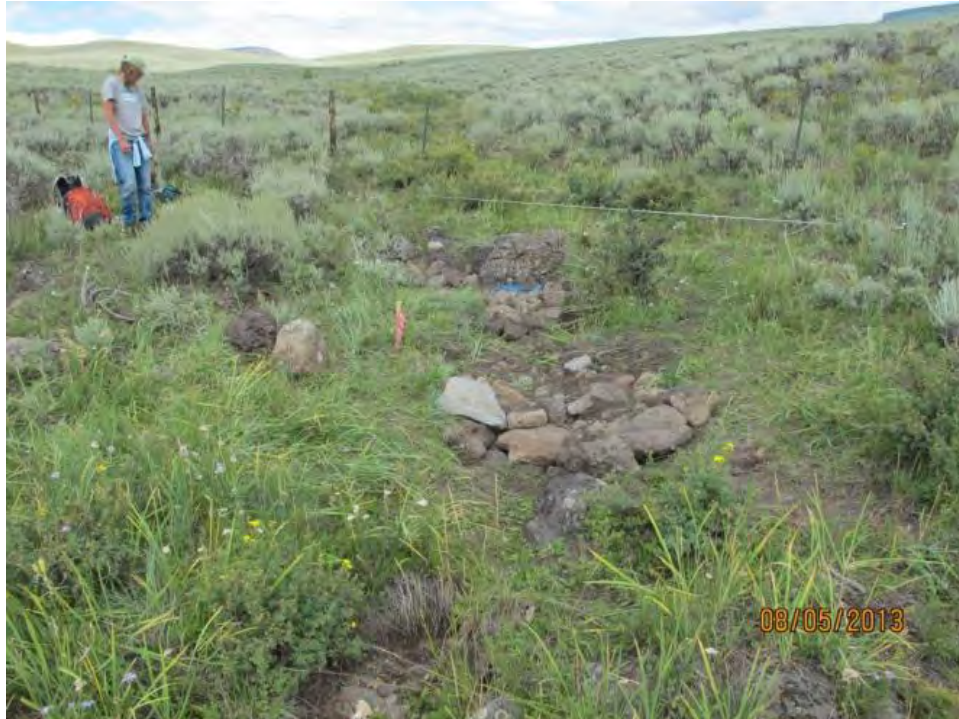
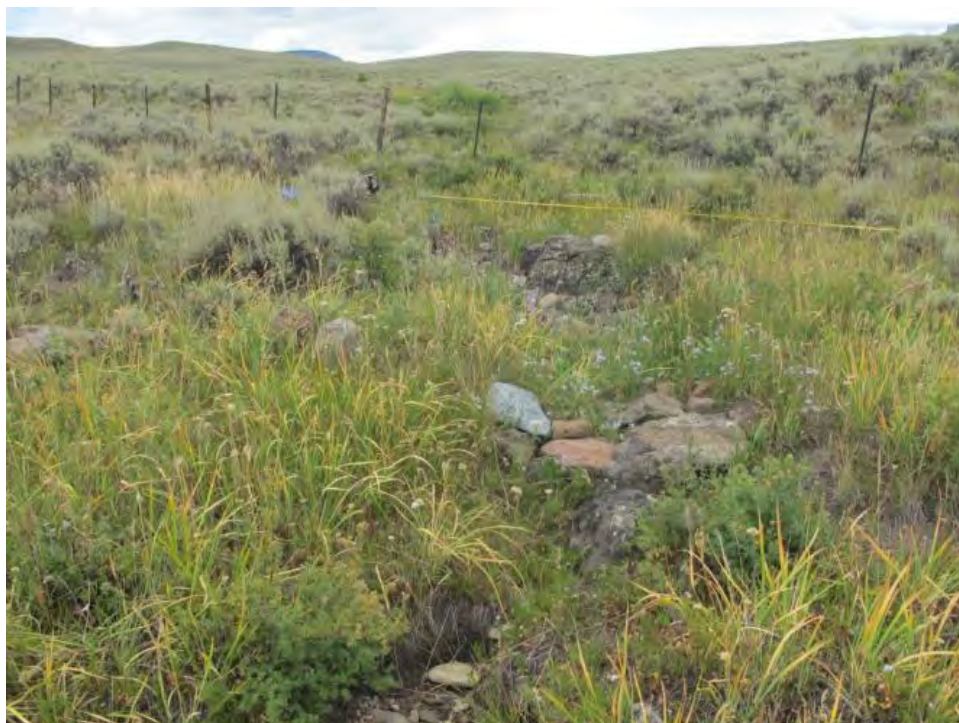
37, 38. Picture taken shortly after installation and one year later showing positive response to a Zuni bowl (above near fence), built to control a head cut, and a one rock dam (below), built to capture sediment to raise the bed of the channel, and recruit vegetation on West Flat Top Mountain on US Forest Service lands. Photographs by Renee Rondeau, CNHP.

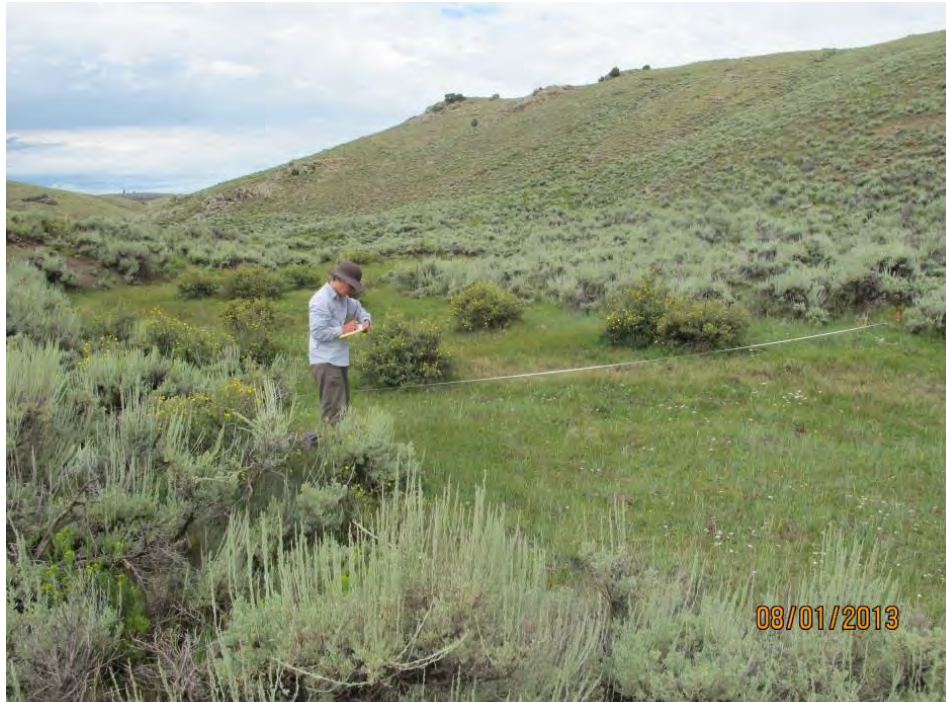
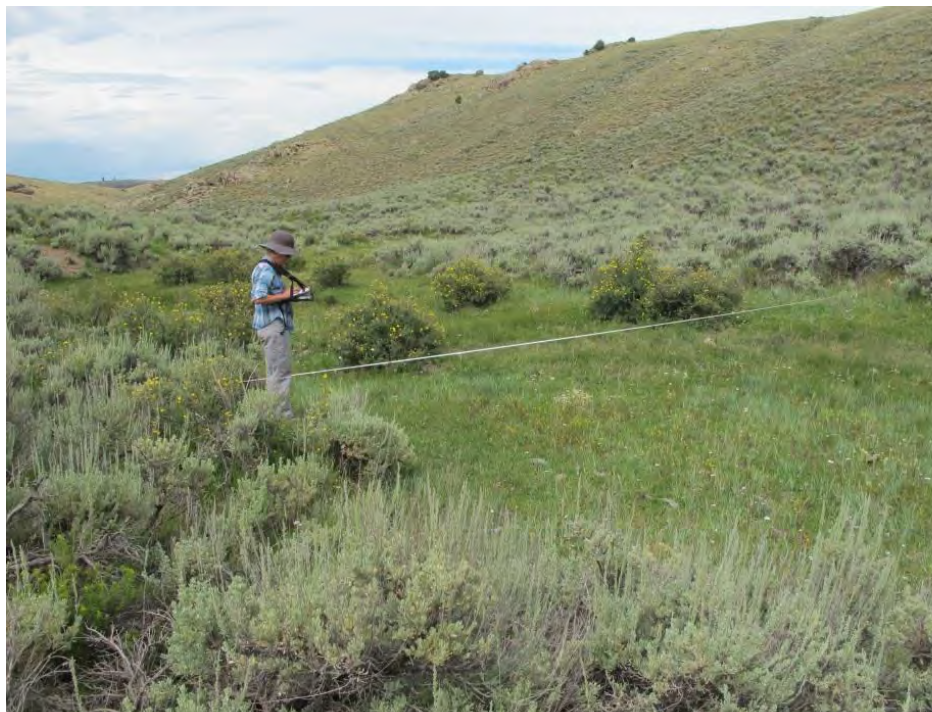
39-40. Control (transect placed above treatment area) on BLM lands at Wolf Creek, a tributary to Cebolla Creek. Photographs by Renee Rondeau, CNHP.

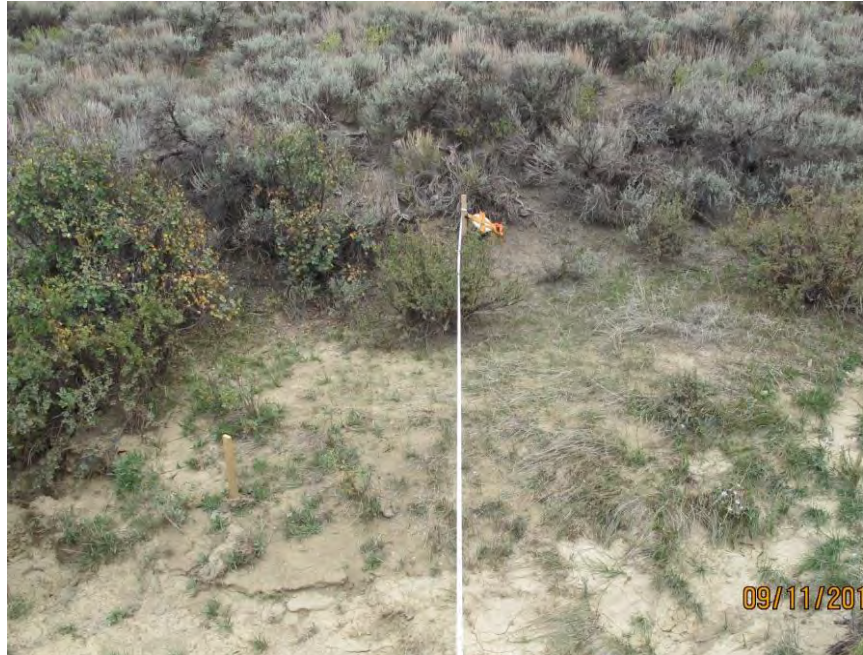
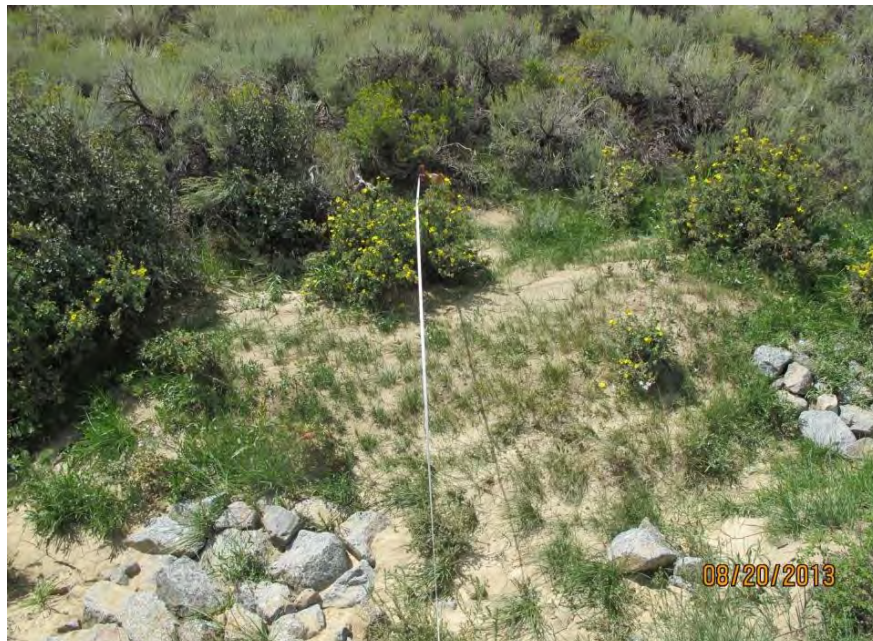
41-42, Redden Ranch: One rock dam before installation and one year later. Note the grasses are filling in above and within the structures. Photographs by Renee Rondeau, CNHP.
