**Klawock River, Salmon Passage and Habitat Restoration Project**  
Grant # NA09NMF4630301

Final Report: July 01, 2009 – September 30, 2012

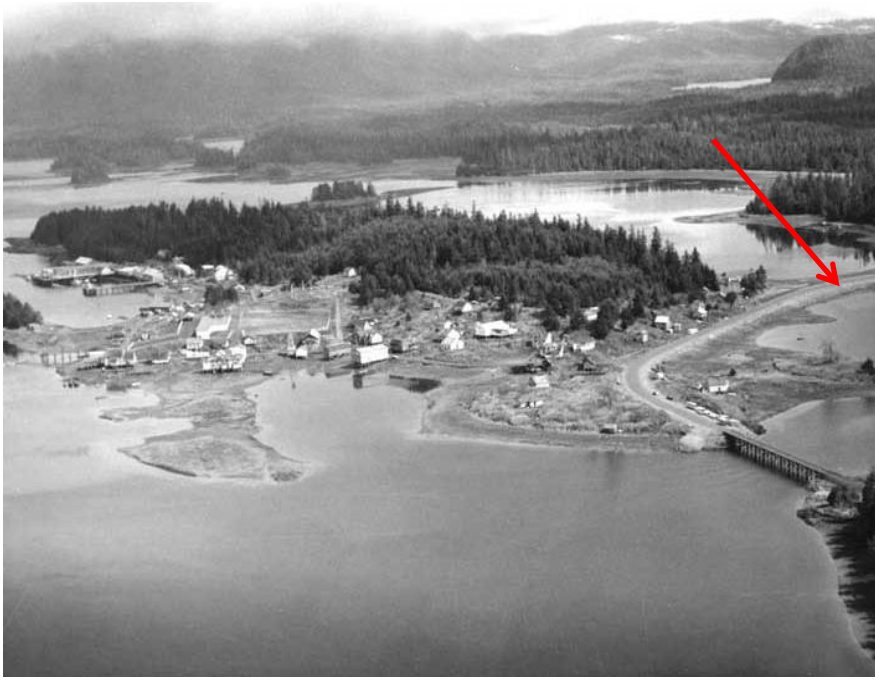
Figure 2: (After) This aerial photograph shows construction of a road in 1964 through the corner of the village, and over a bridge, one of the two exits from the estuary. The previous exit is above and on the right side of the photo, where you can see the road goes along what became a causeway: an elevated road (marked by the red arrow). Photo: Aaron T. Isaacs, 1964

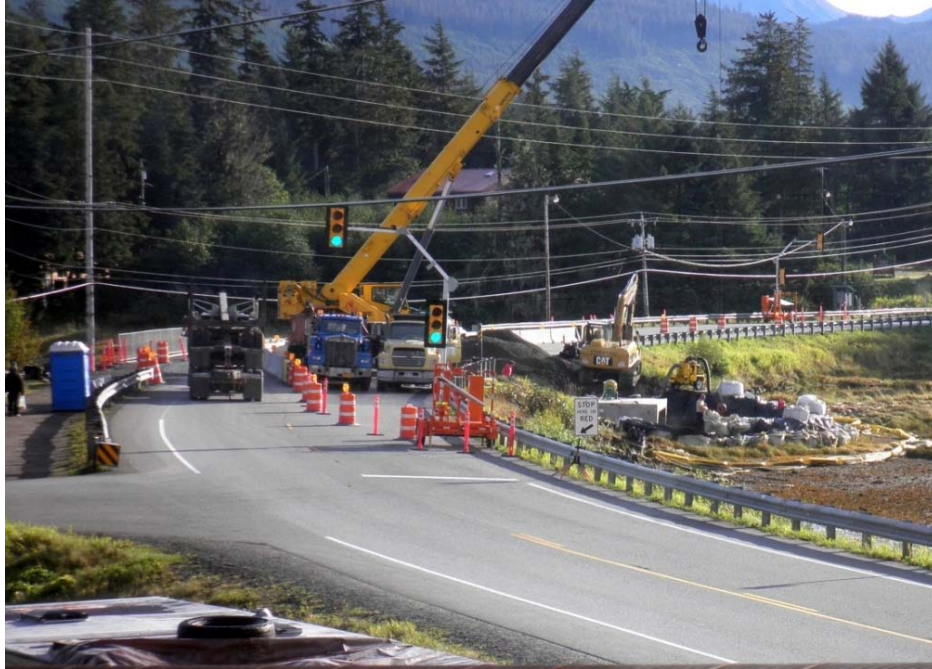
Figure 7: Construction underway on culvert beneath highway. Photo Credit: The Nature Conservancy, 2011

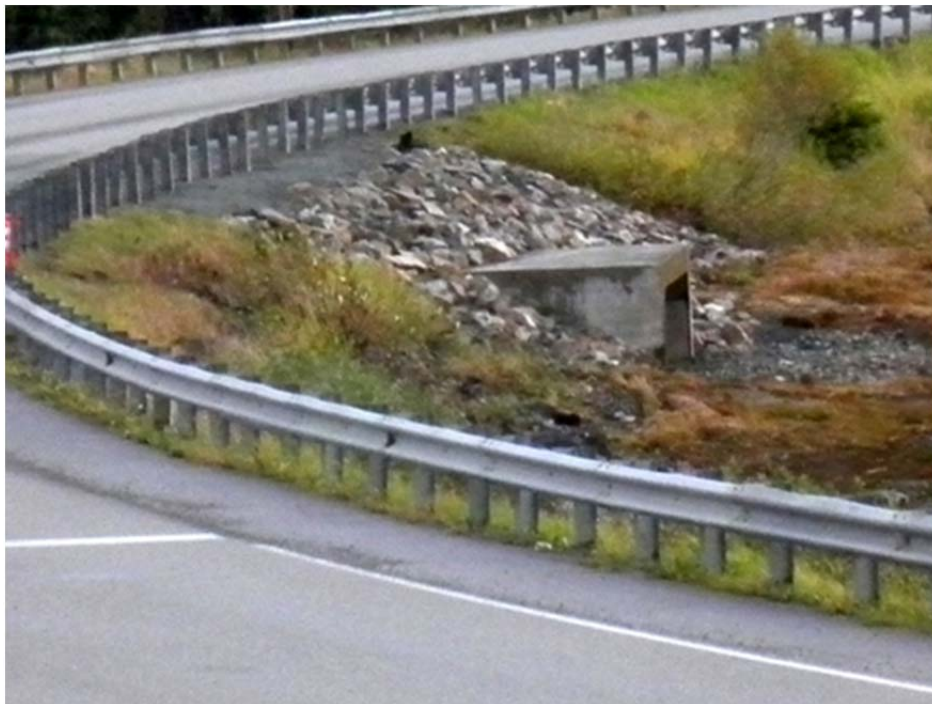
Figure 8: Photo of completed culvert at low-tide. Photo: The Nature Conservancy, 2011

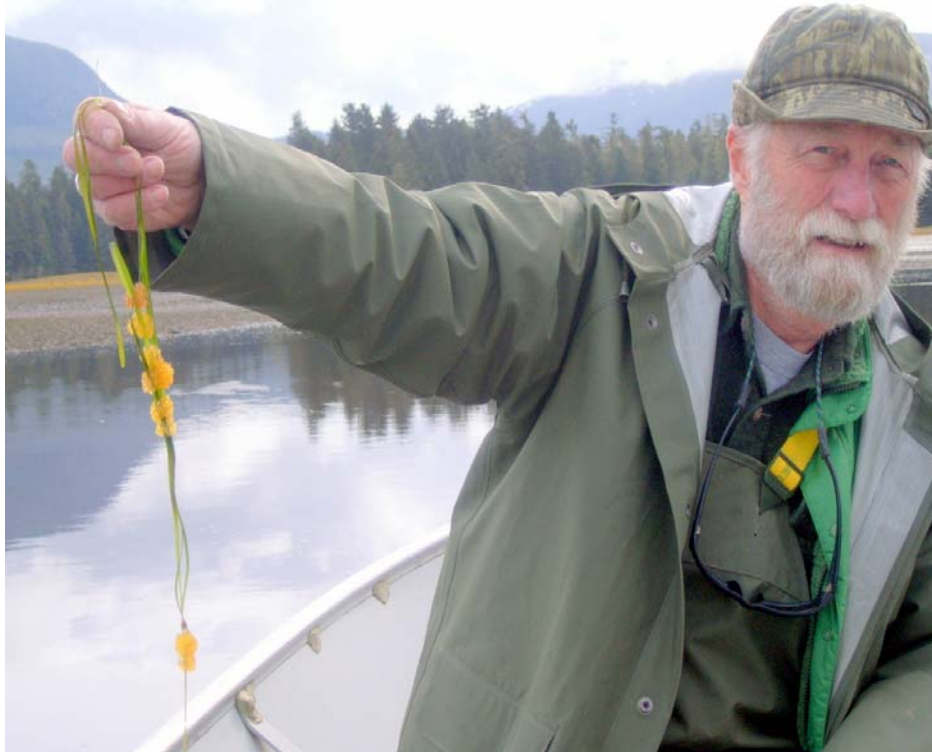
Figure 8: K Koski, Fisheries Biologist, samples eelgrass covered with snail eggs. Photo: The Nature Conservancy, 2010.

Sampling events for fish assemblage took place in May of 2010, August of 2010, April of 2011, May of 2012, and August of 2012. Fish were sampled with a variable-mesh beach seine measuring 2.5 x 20 m. All captured fish were identified to species (when possible) and enumerated. In addition, a subsample of 20 fish of each species were measured to fork length. All fish were placed in a recovery bucket for at least 5 minutes before being returned to the ocean.

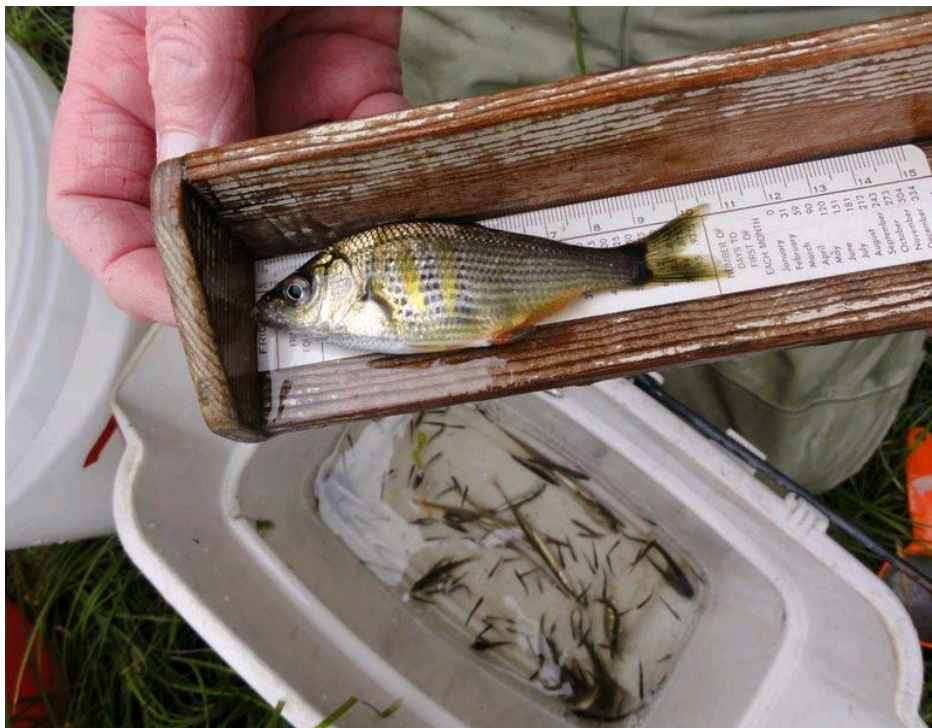
Figure 9: K Koski, Fisheries Biologist, measures the length of a shiner perch. Photo: The Nature Conservancy, 2010.

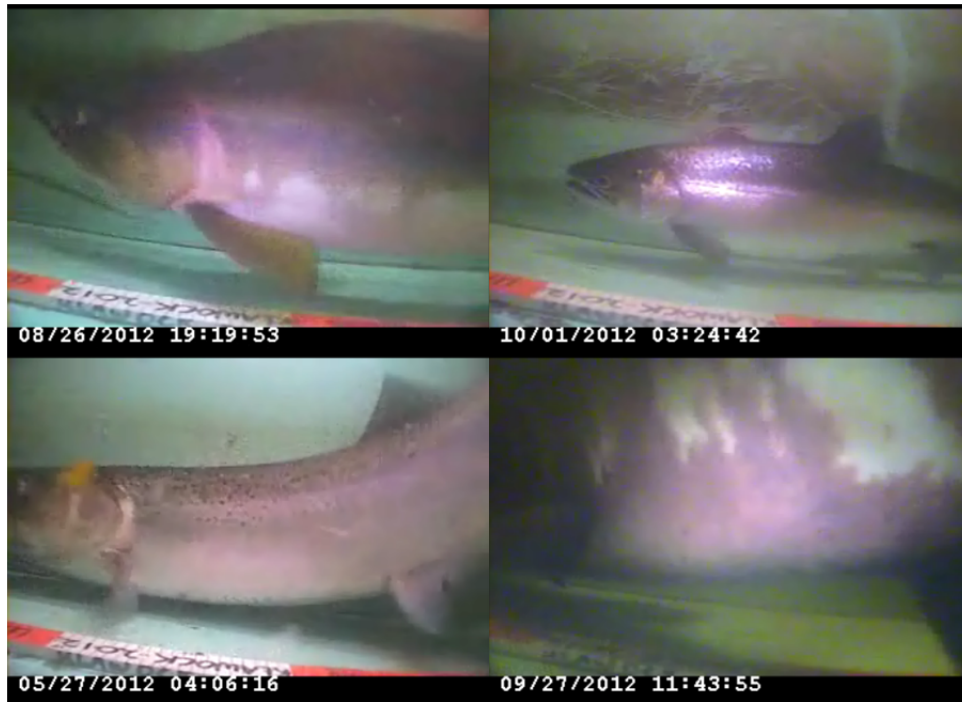
In order to document fish passage, a video system was installed inside the new culvert, and a full year of footage was analyzed (excluding the winter period) after breach of the causeway. Continual video footage showcased migration through the causeway by adult coho salmon, pink salmon, chum salmon, and steelhead trout (Figure 10). No adult sockeye salmon were positively

Figure 10. Video documentation of adult pink salmon, coho salmon, steelhead, and chum salmon.

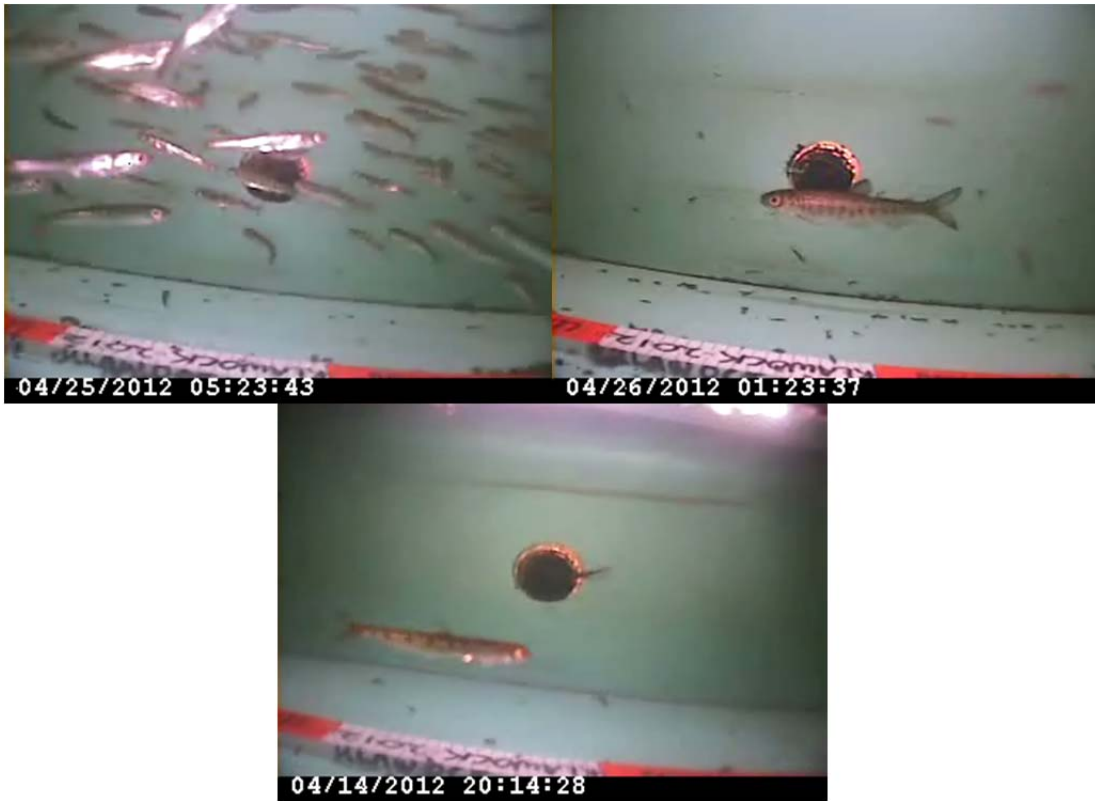
Figure 11. Video documentation of juvenile pink salmon, coho salmon, and chum salmon.

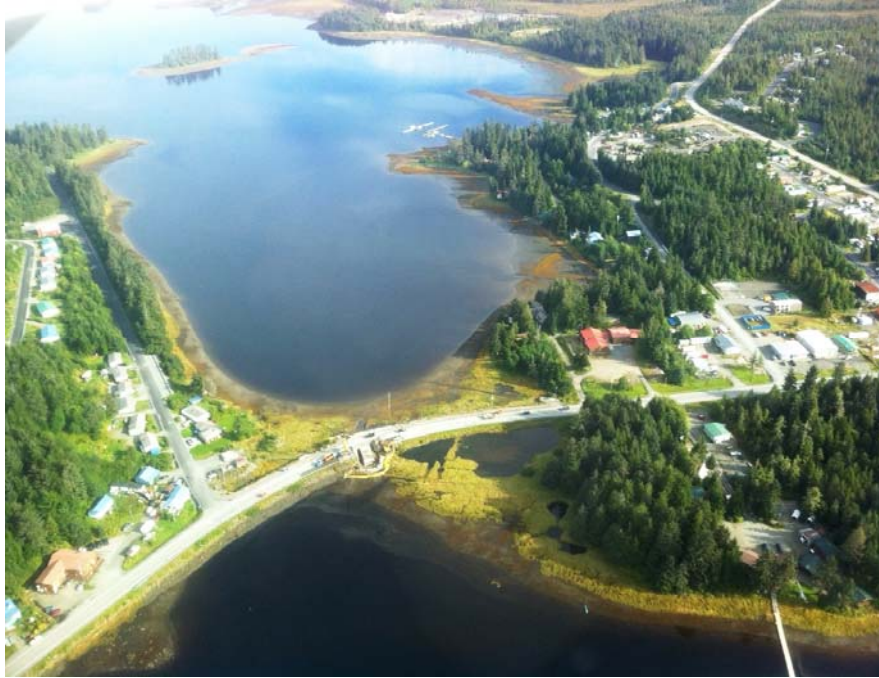
Figure 13: Aerial photograph of Klawock lagoon and causeway during early construction. Photo: The Nature Conservancy, 2010

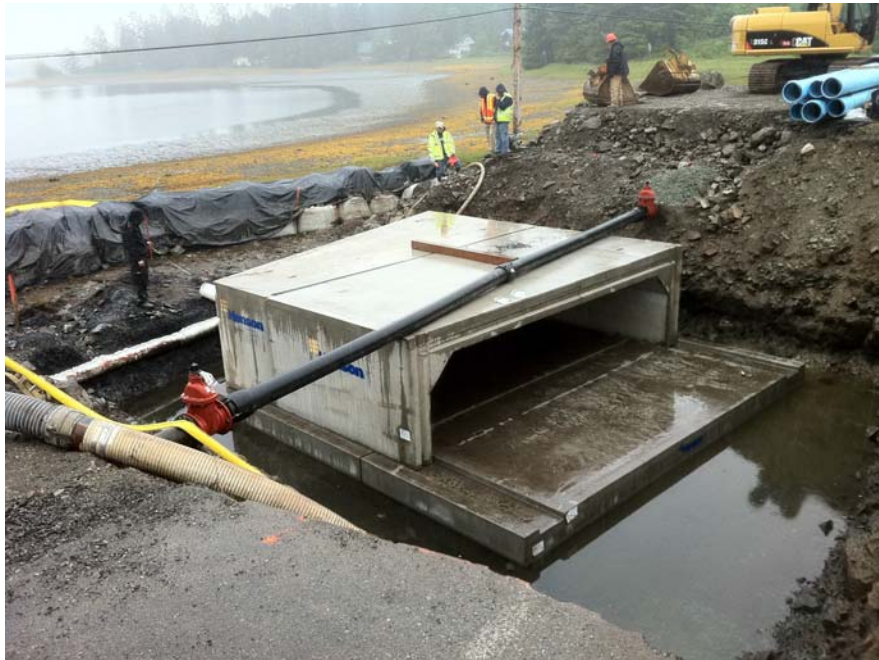
Figure 14: The culvert and utility lines. Photo: The Nature Conservancy, 2011.

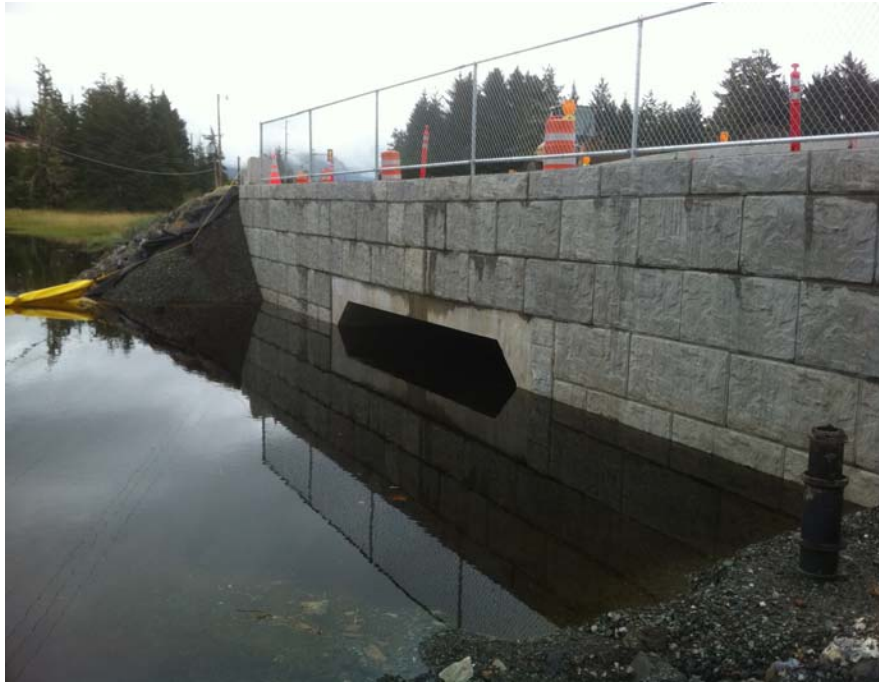
Figure 15: Klawock River (bay) side of the culvert, late summer 2011. Photo: The Nature Conservancy, 2011.
