Accelerated Recruitment Large Wood Workshops

October 17 and 23, 2013

Case Study: Big Salmon Creek

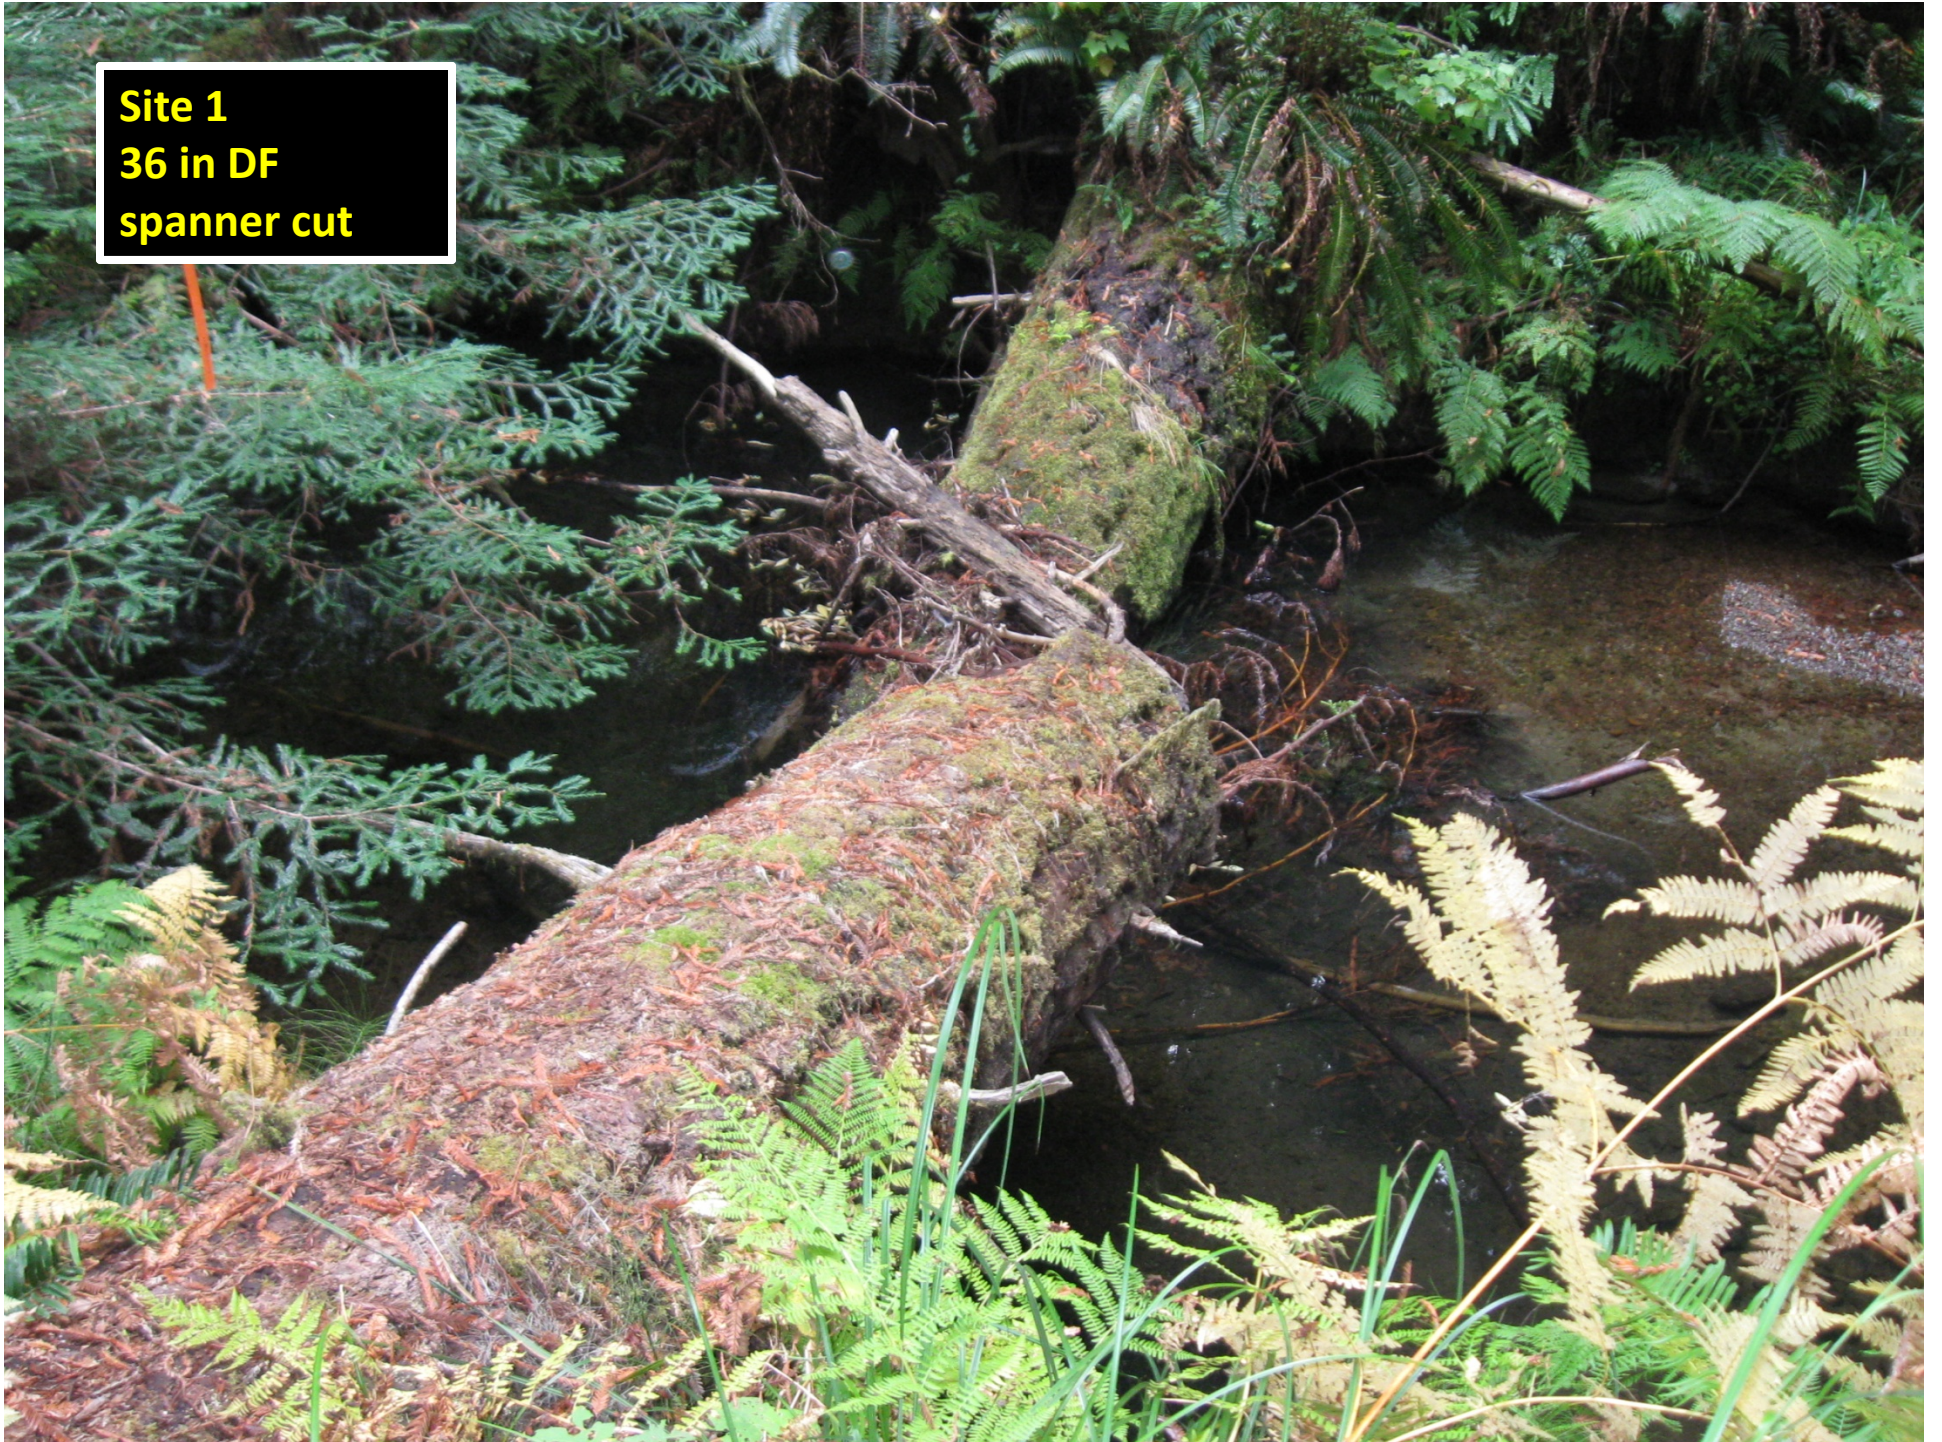
Site 1
36 in DF
spanner cut

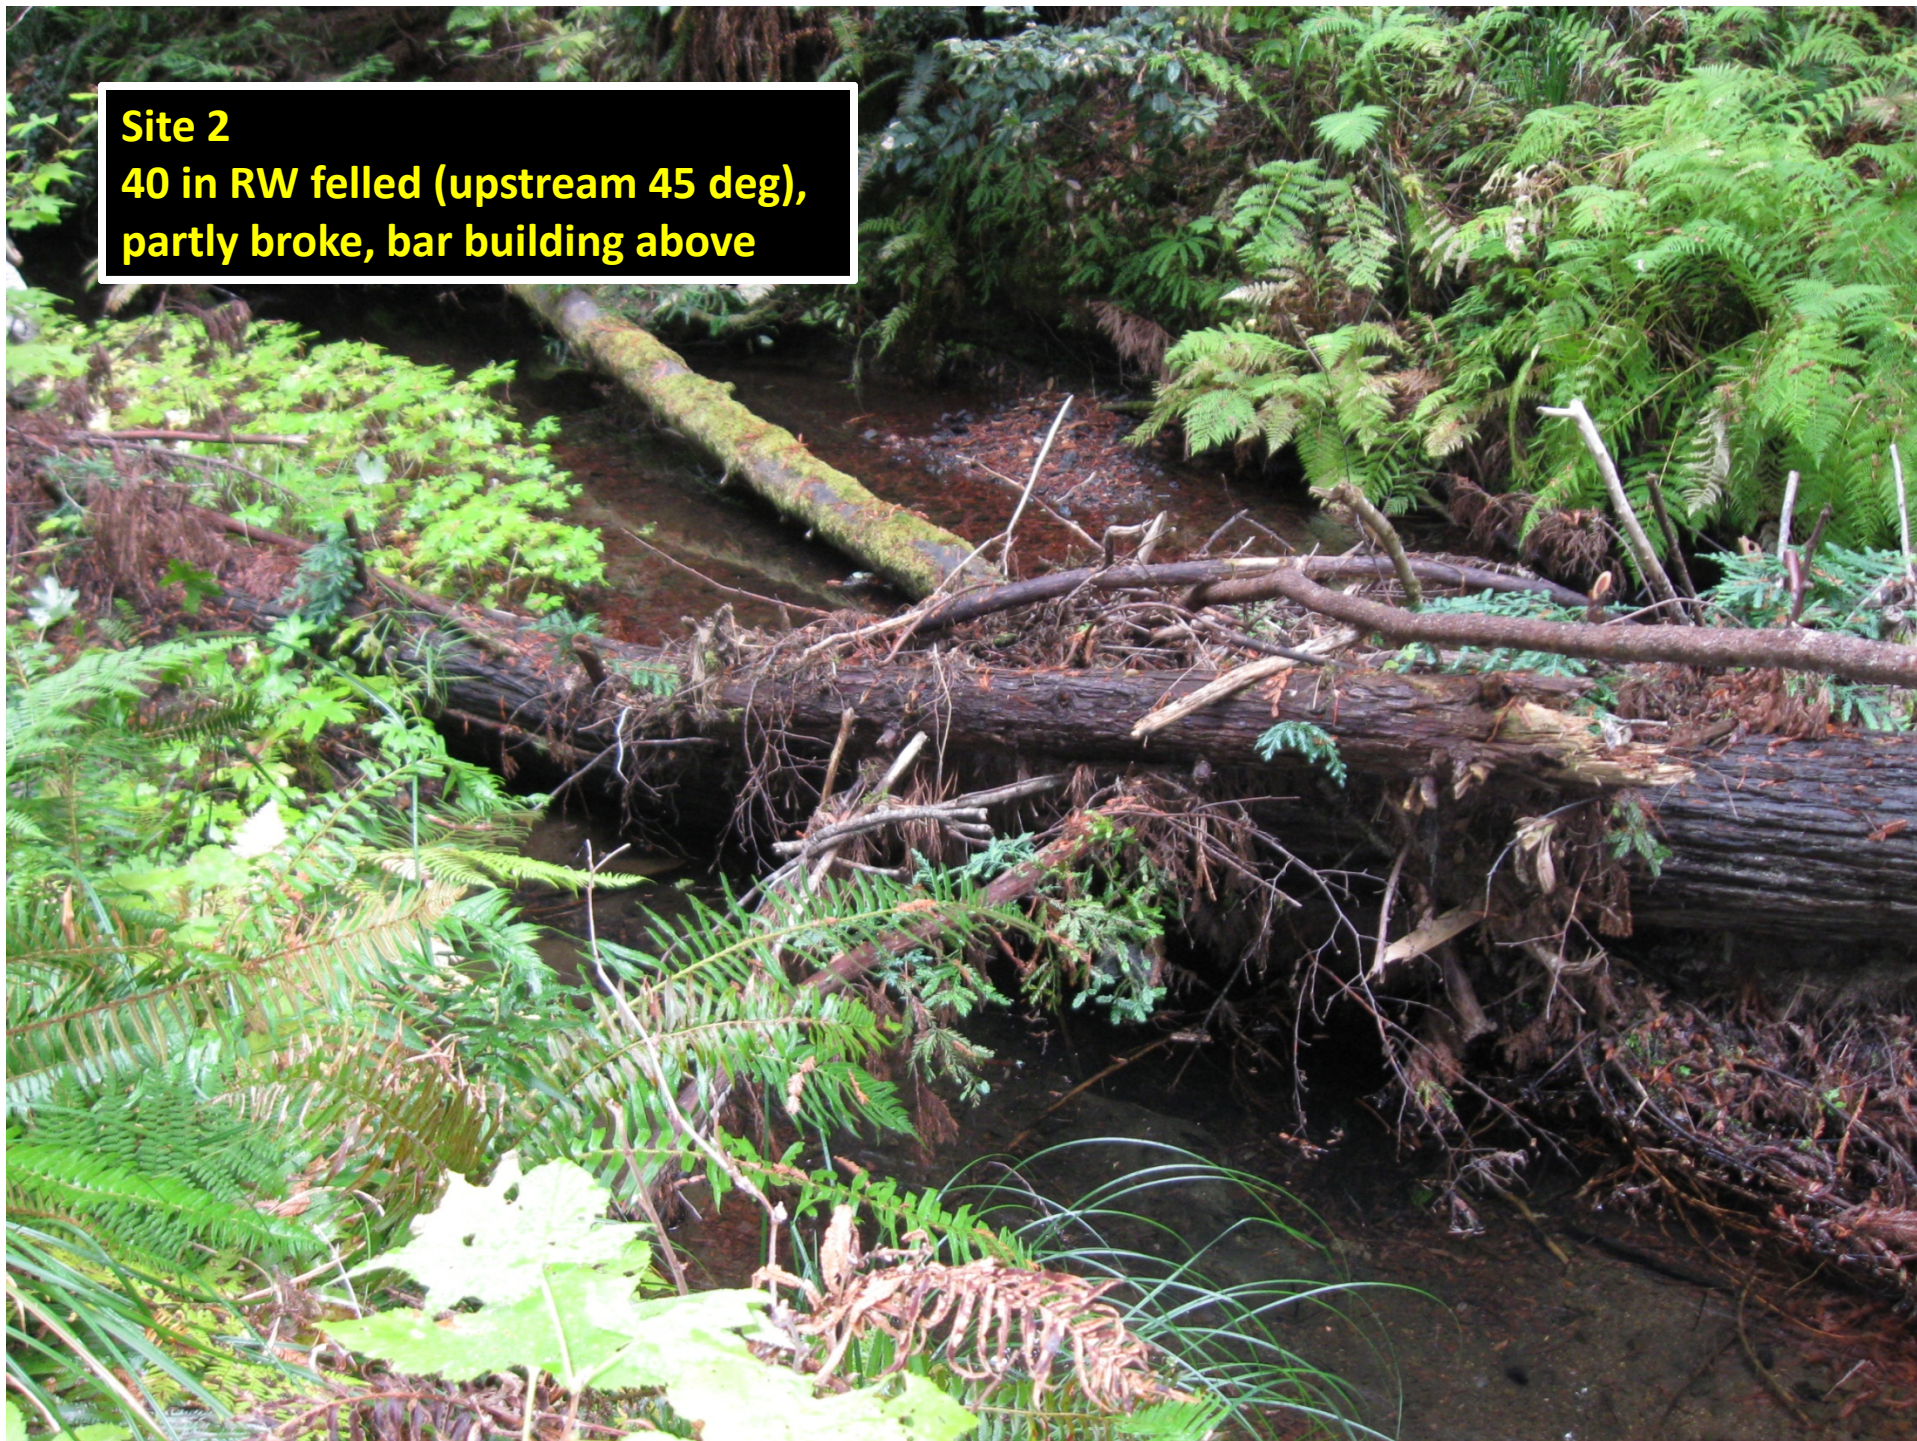
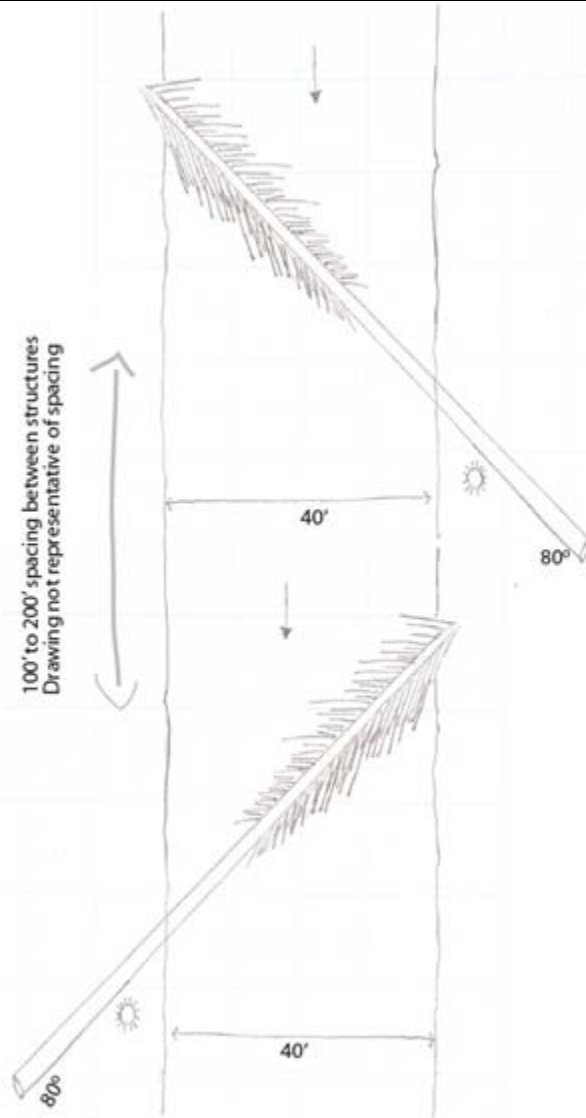
Site 2
40 in RW felled (upstream 45 deg),
partly broke, bar building above

**Upstream 45
degrees;
Log clusters,
1-2 trees,
No rootwads**

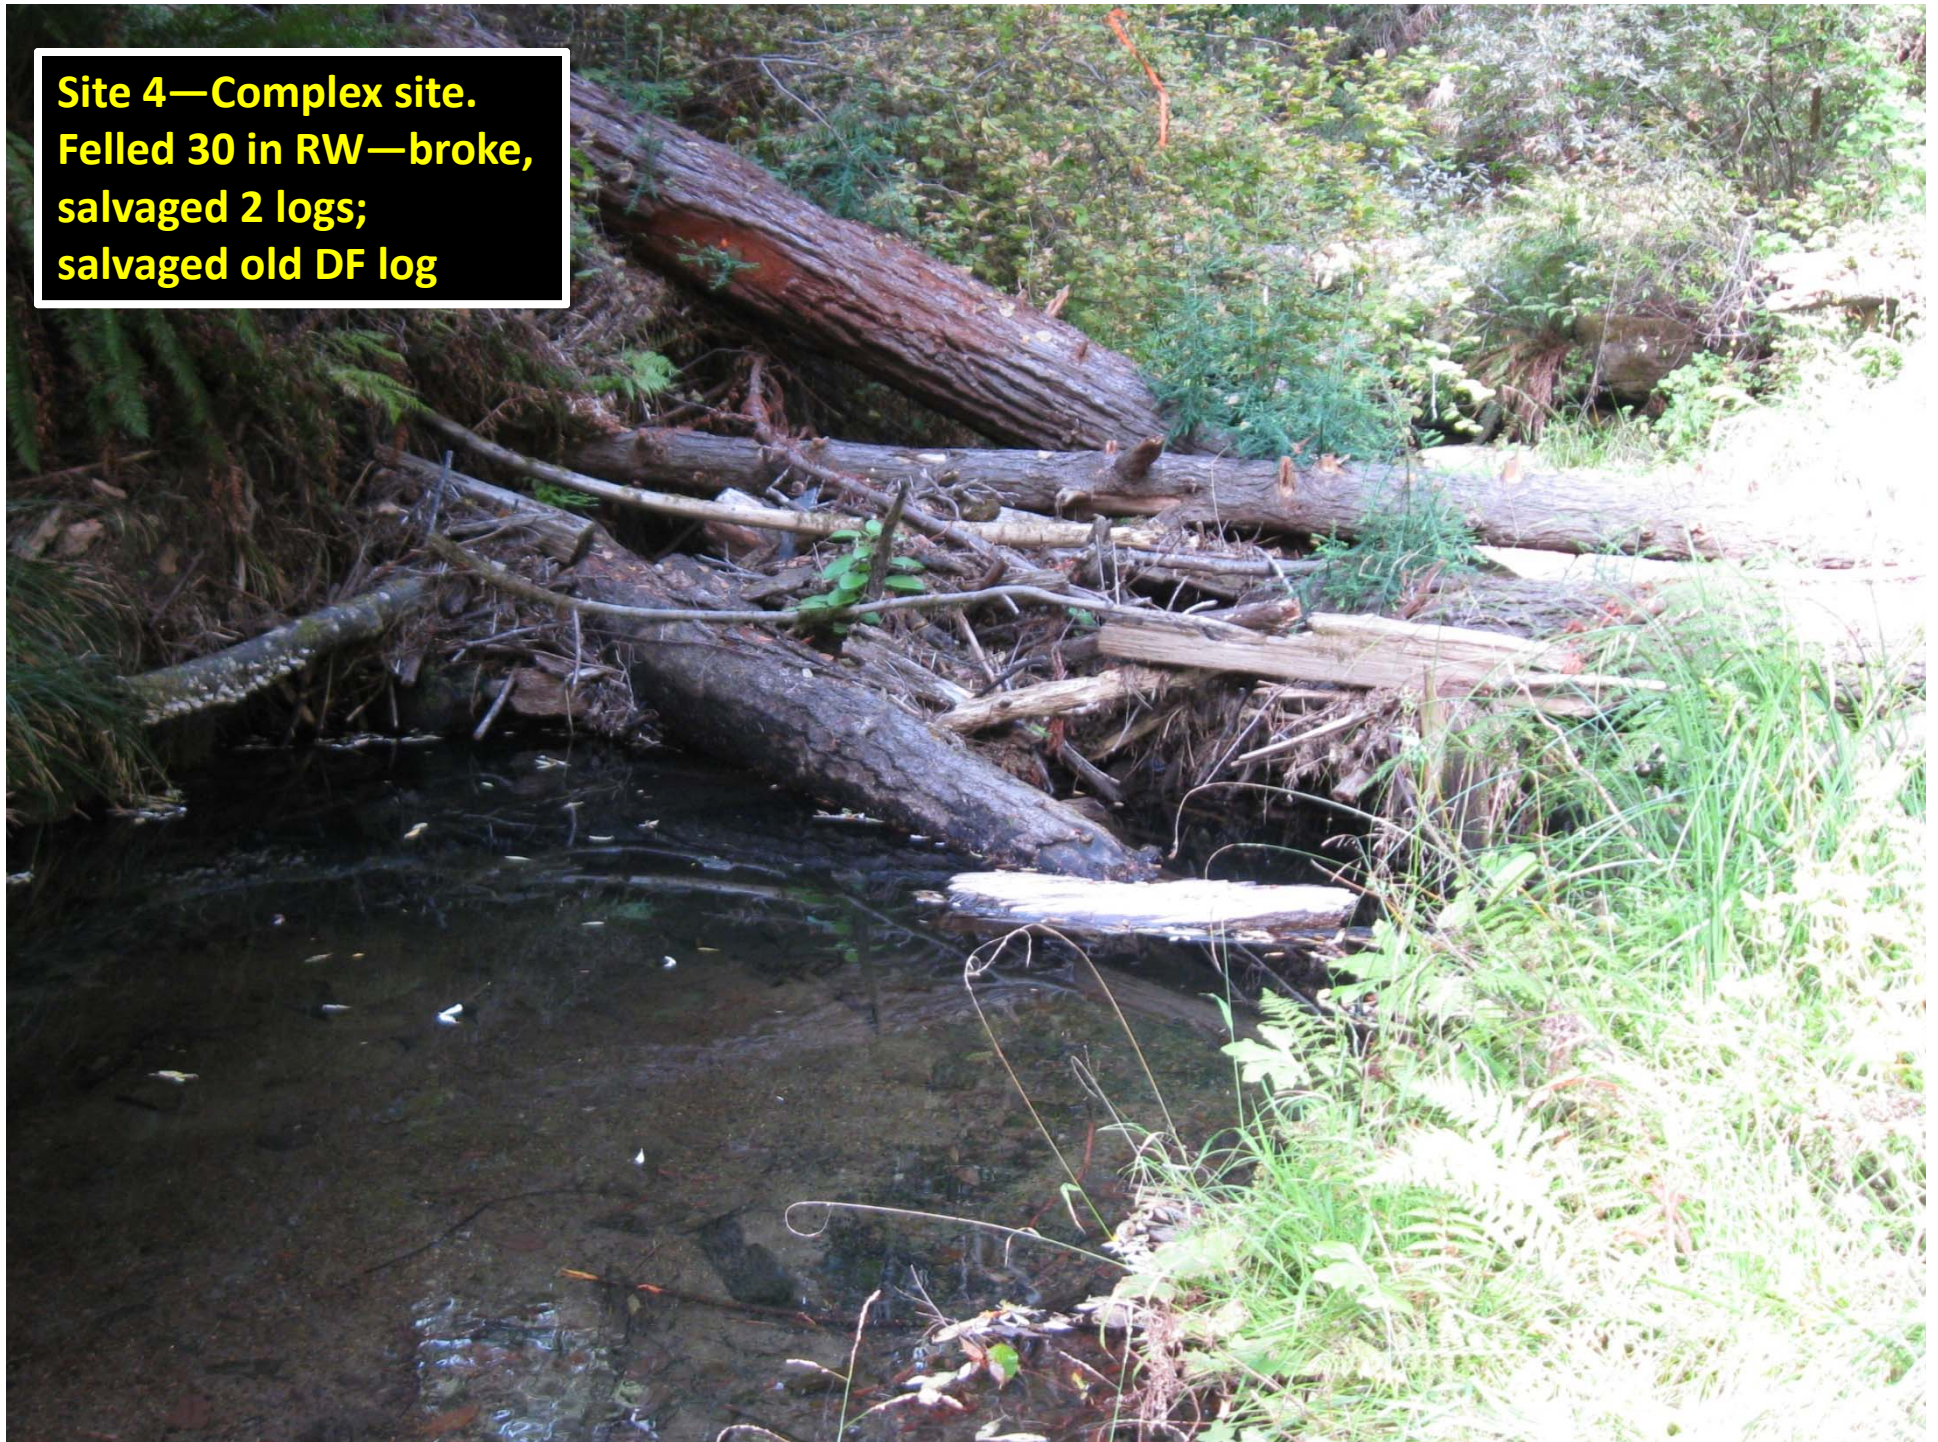
Site 3
36 in RW blowdown--
RTS installed; GF adjusted

**Site 4—Complex site.
Felled 30 in RW—broke,
salvaged 2 logs;
salvaged old DF log**

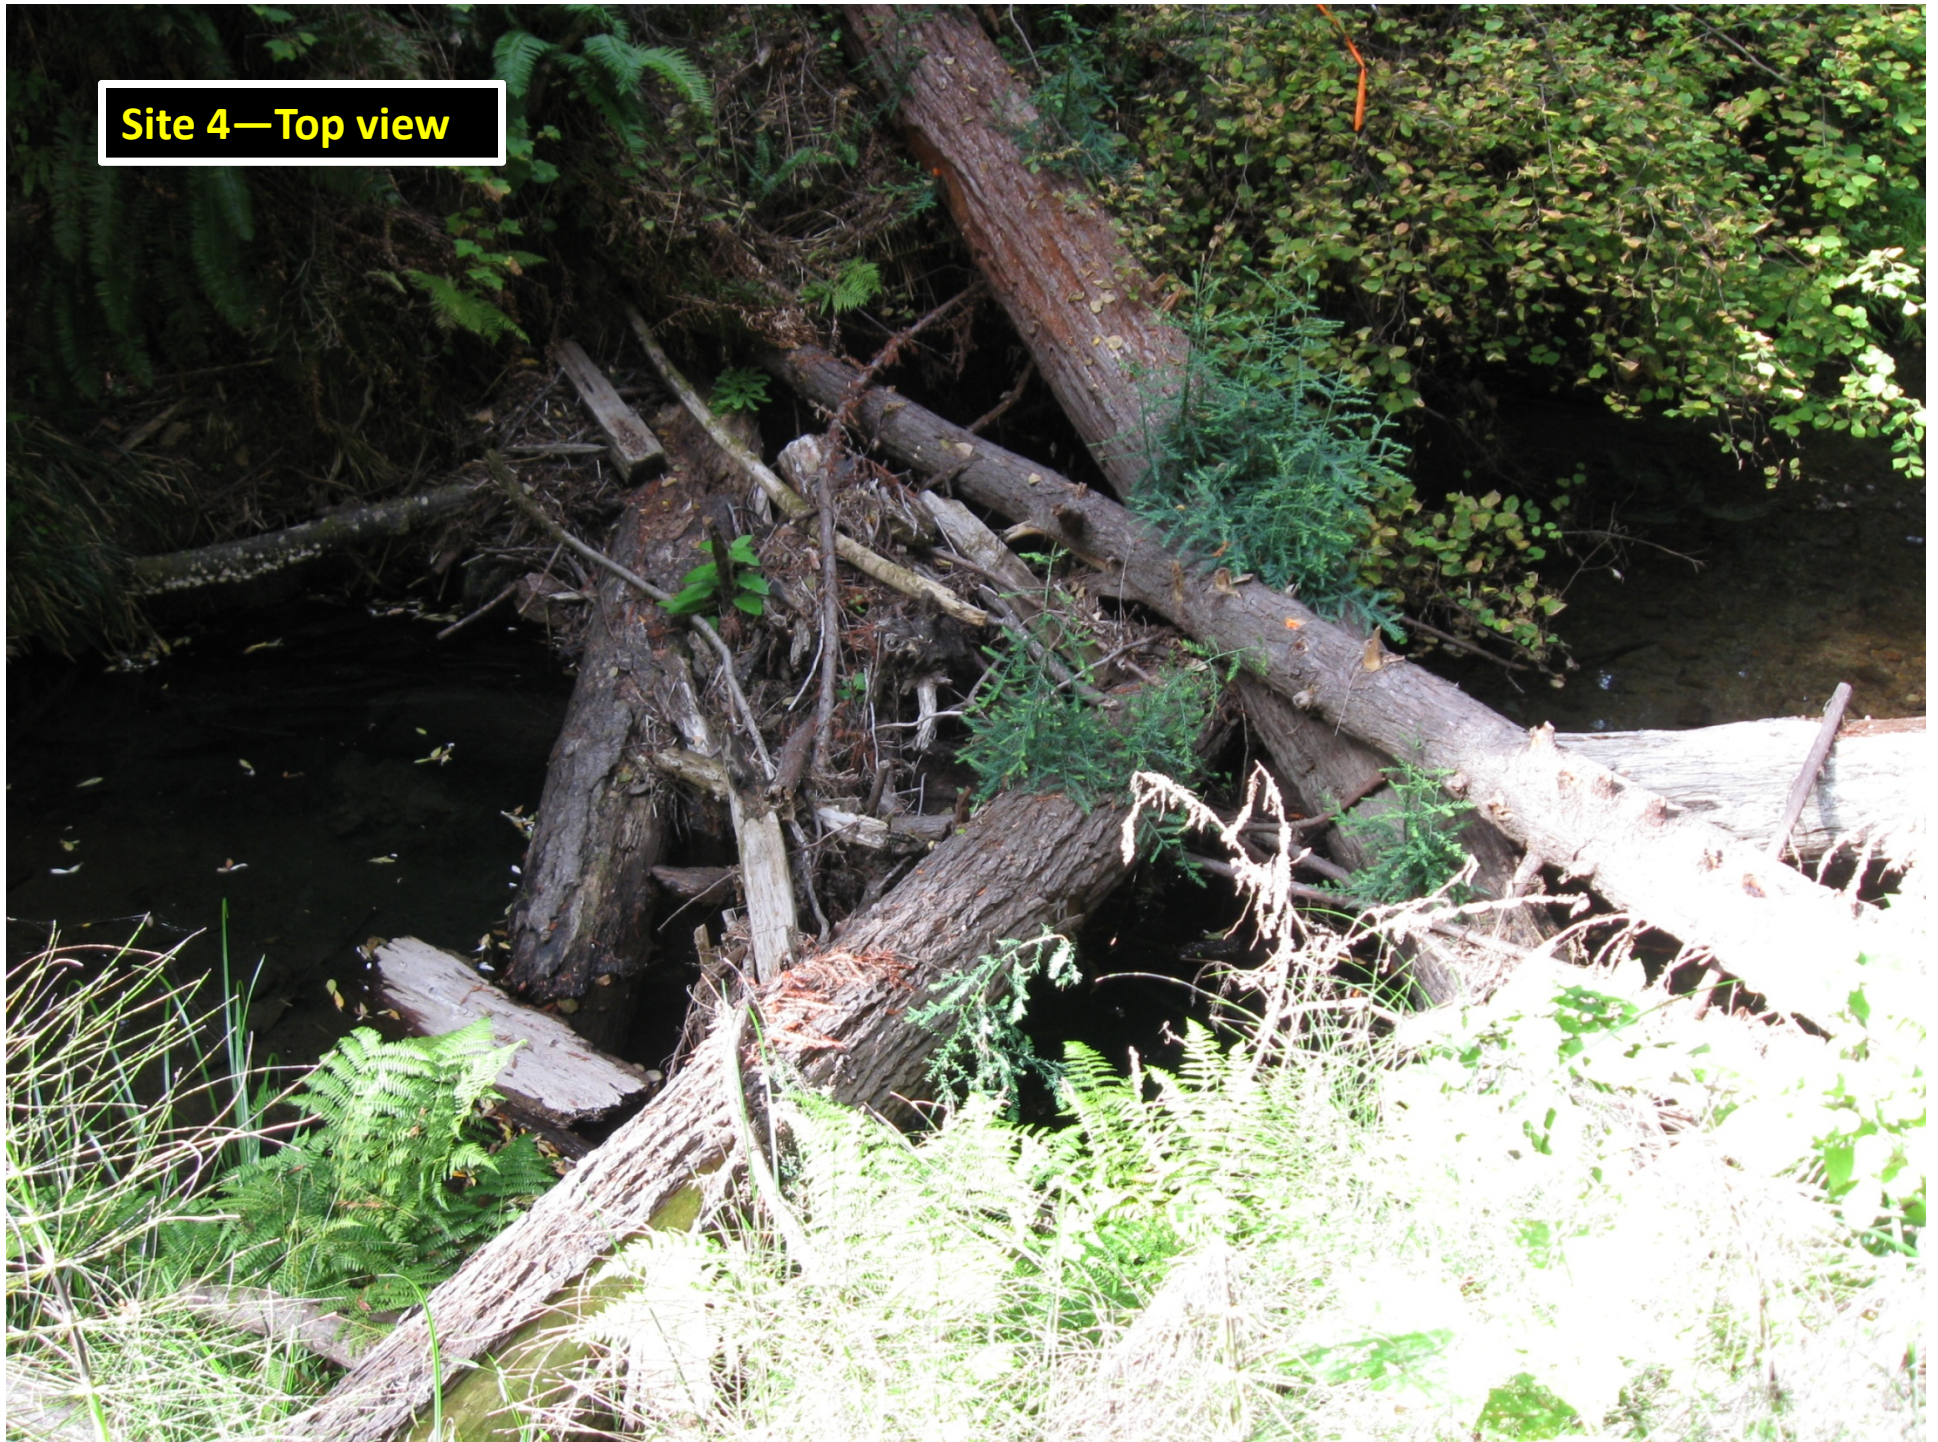
Site 4—Top view

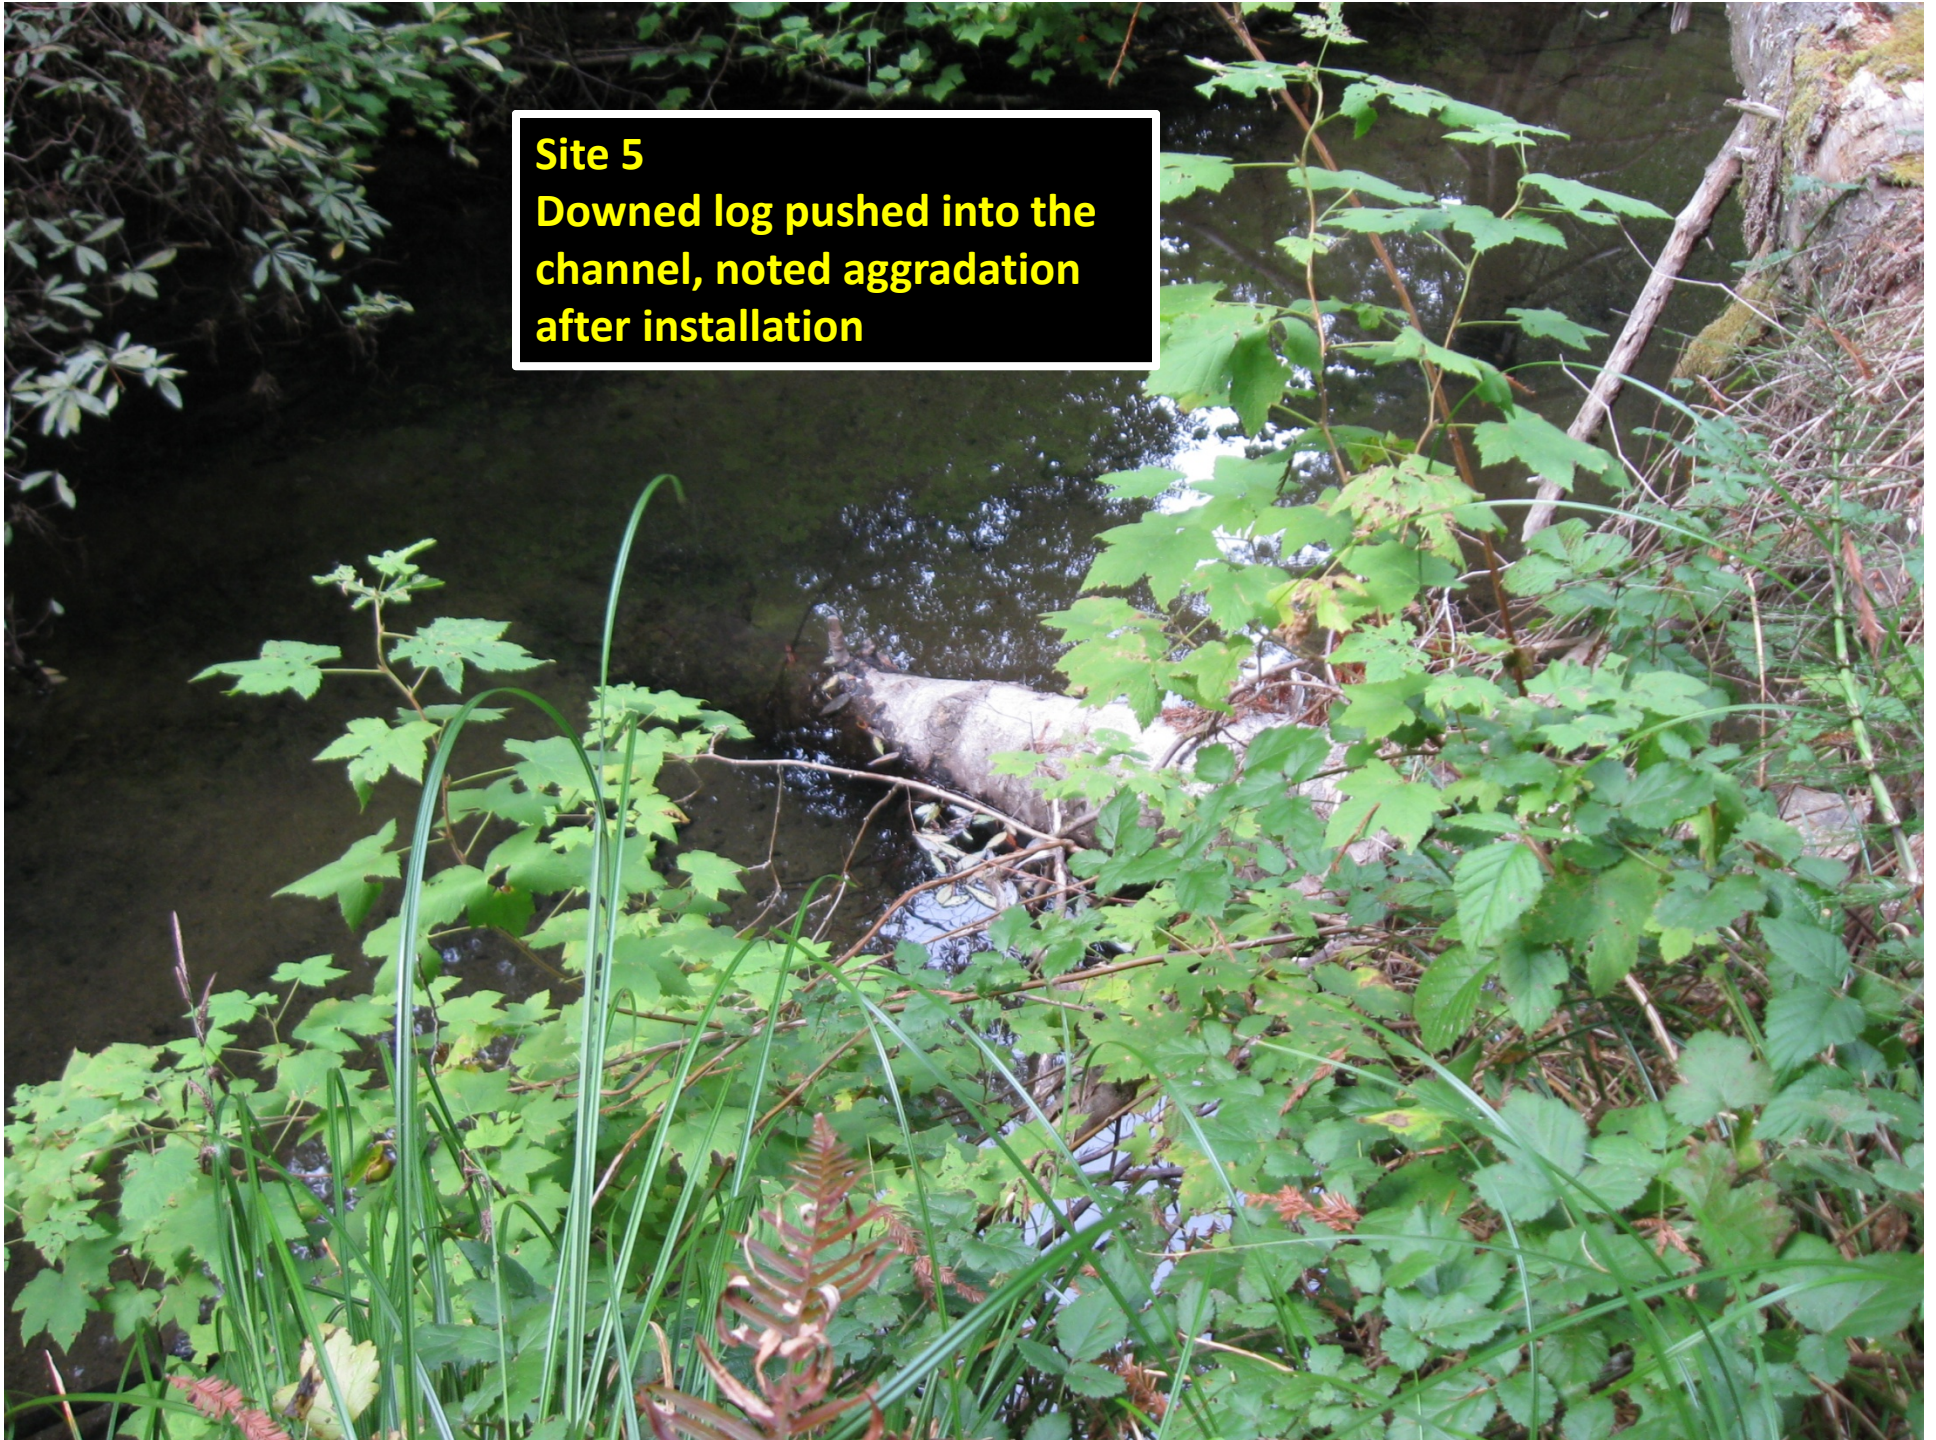
Site 5
Downed log pushed into the
channel, noted aggradation
after installation

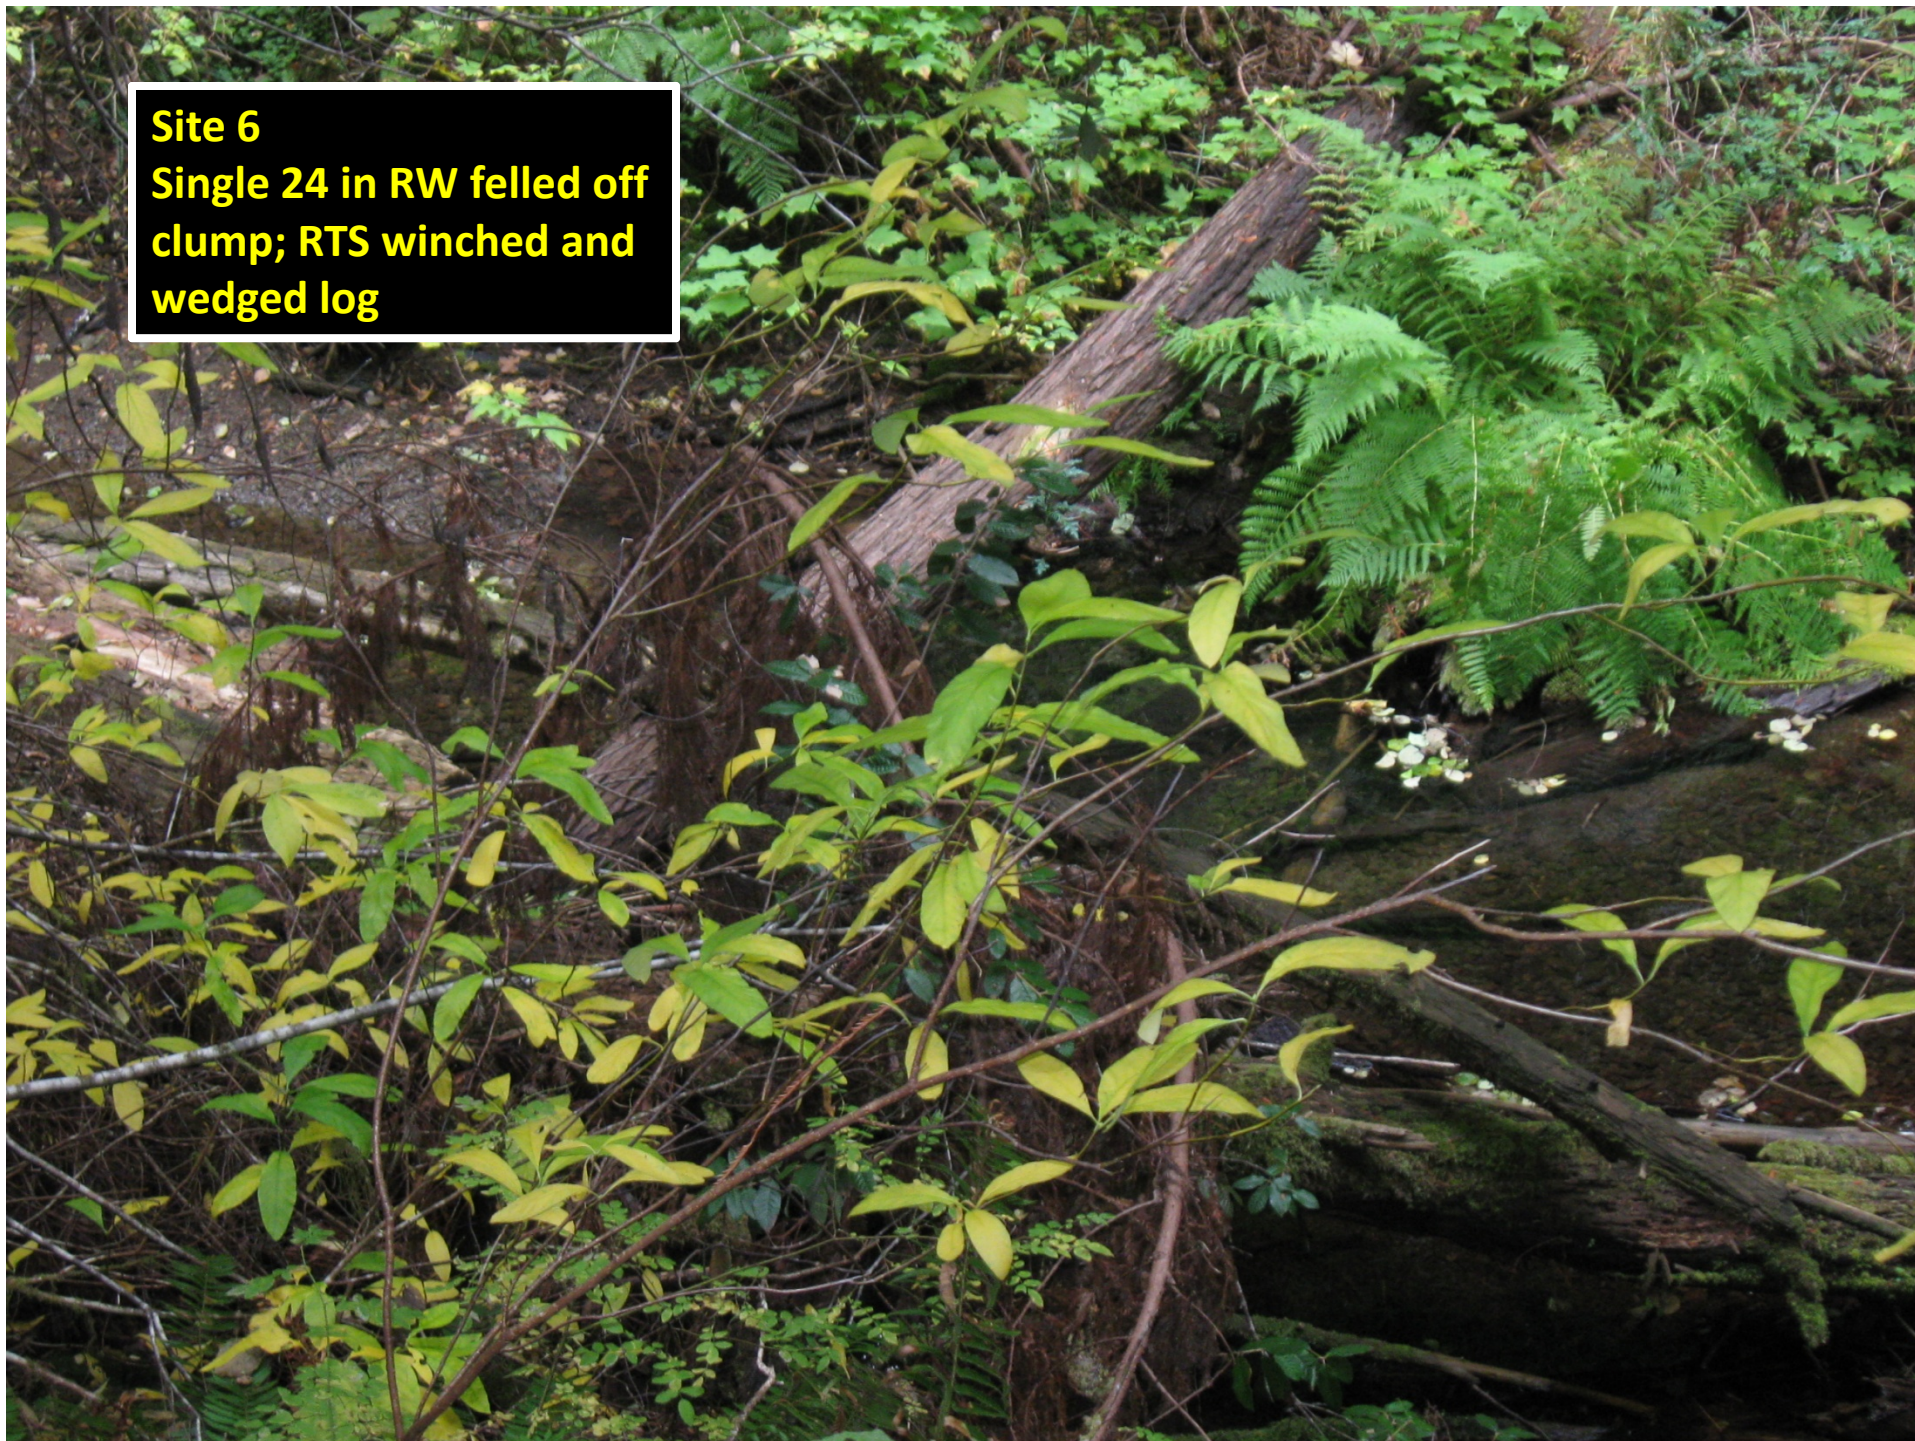
Site 6
Single 24 in RW felled off
clump; RTS winched and
wedged log

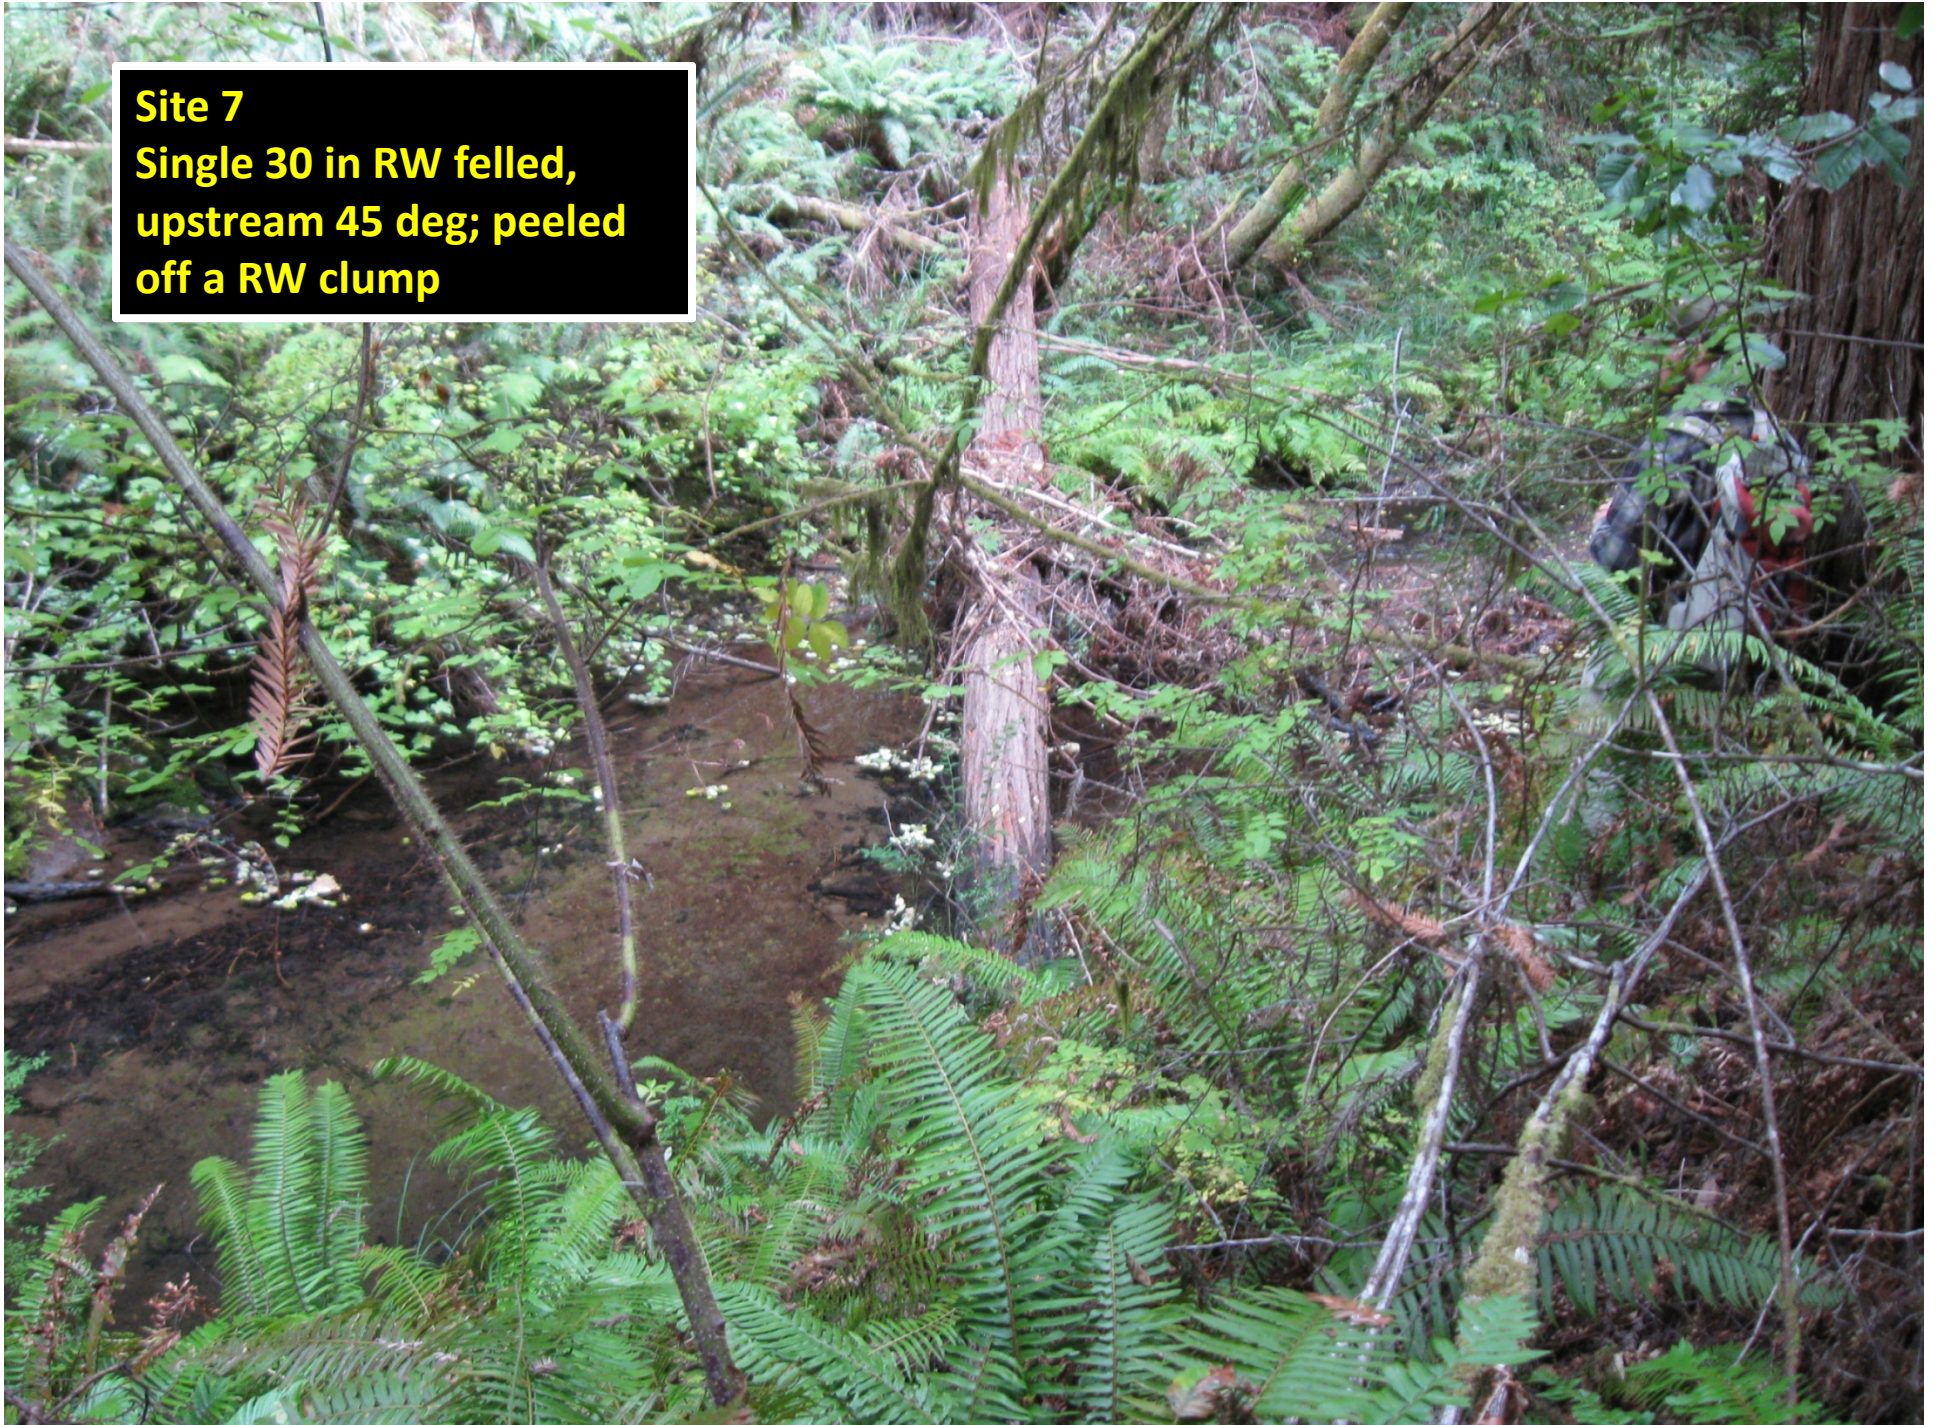
Site 7
Single 30 in RW felled,
upstream 45 deg; peeled
off a RW clump

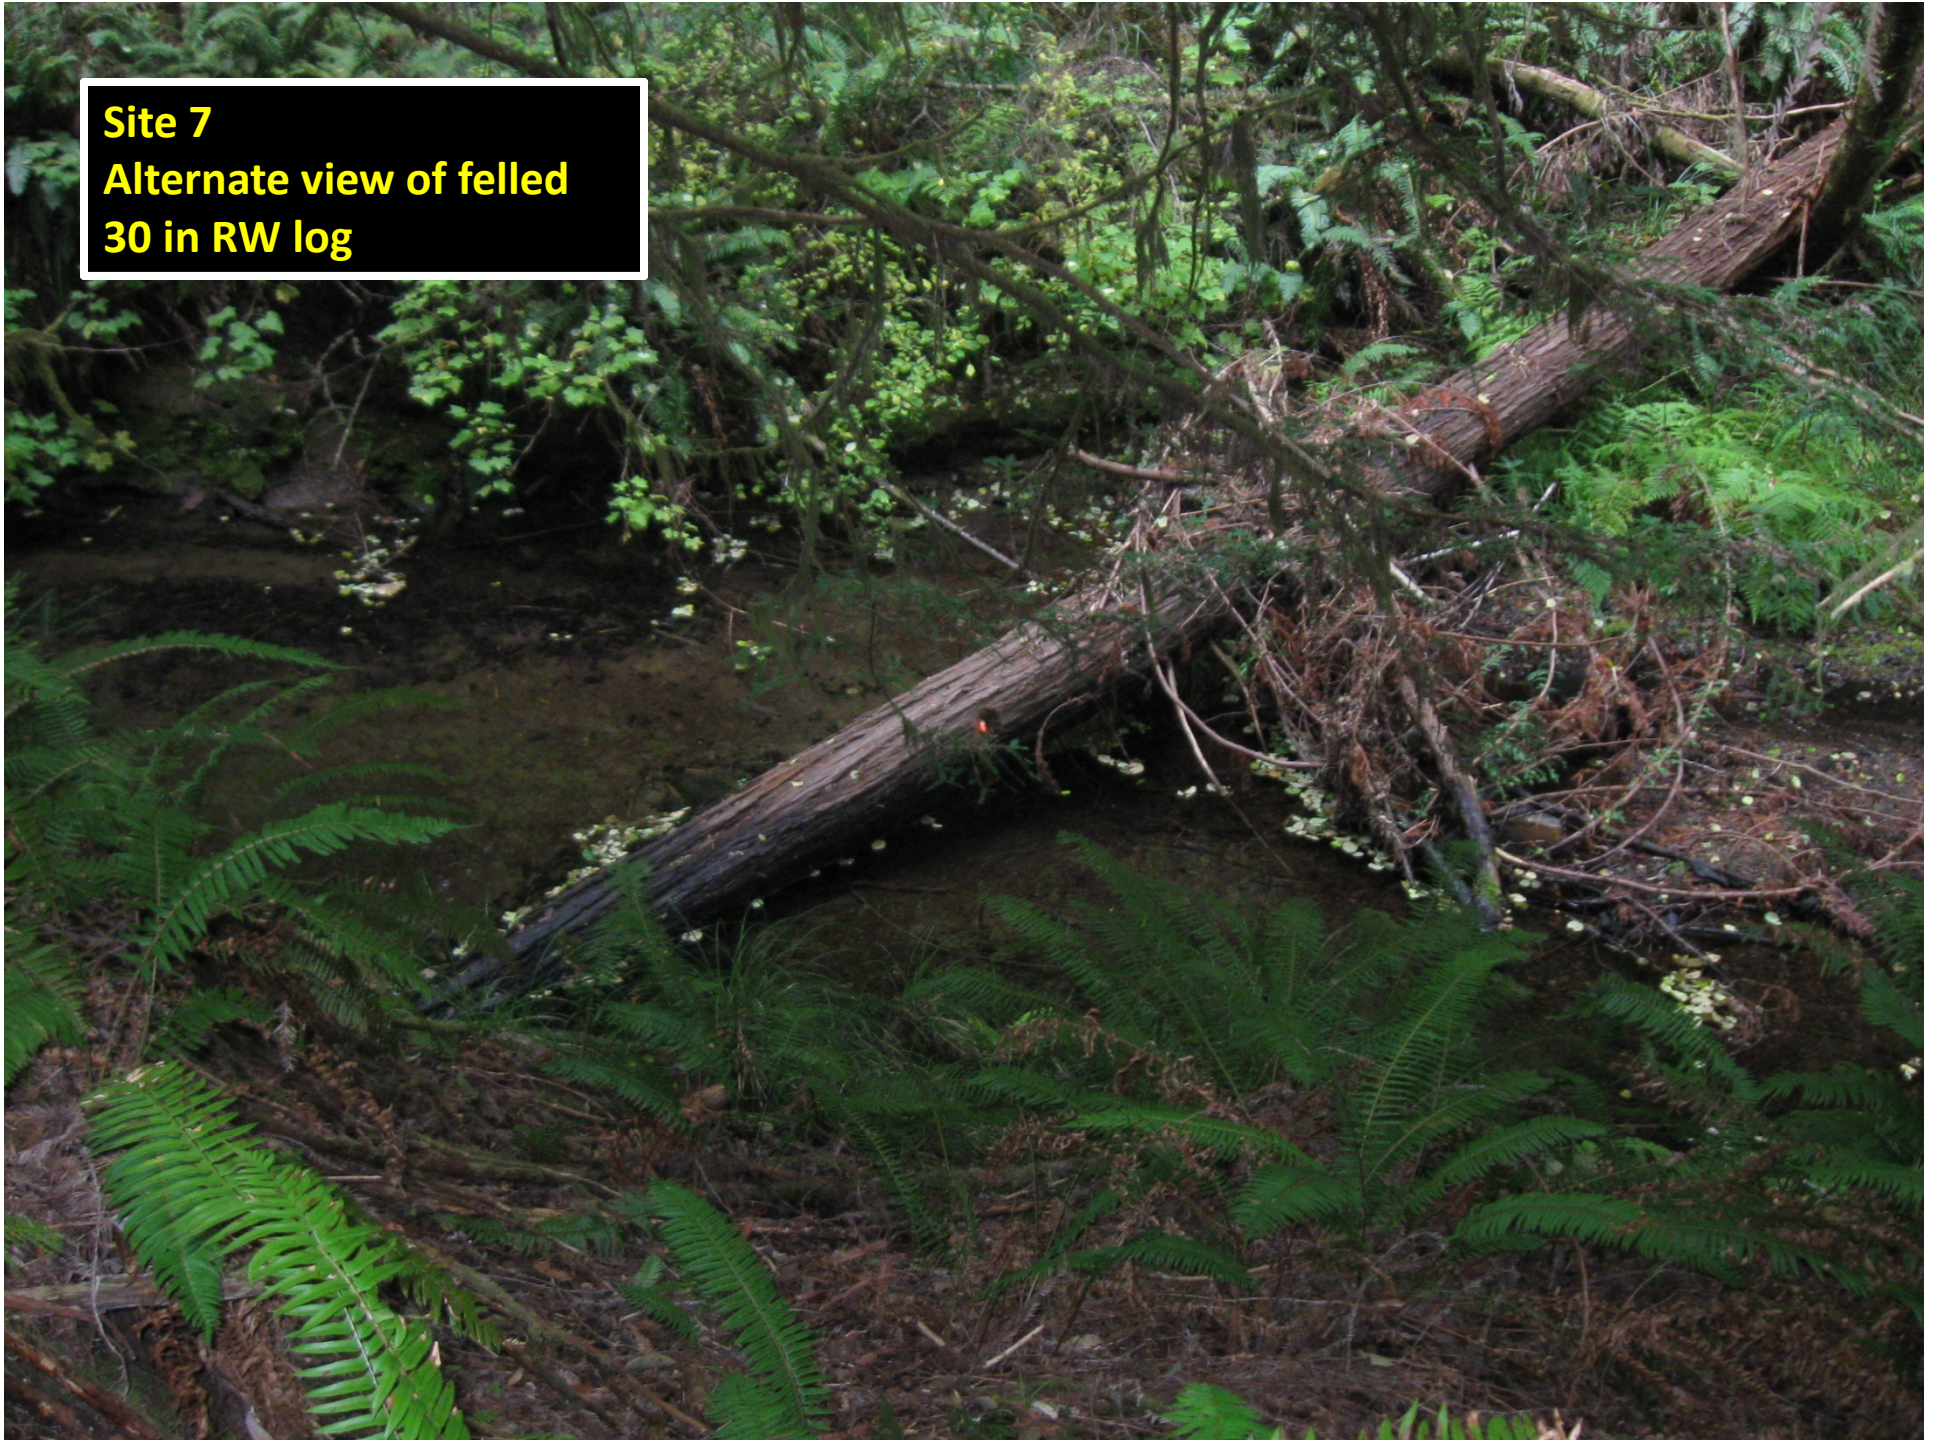
Site 7
Alternate view of felled
30 in RW log
