Accelerated Recruitment Large Wood Workshops

October 17 and 23, 2013

Case Study: Big Salmon Creek

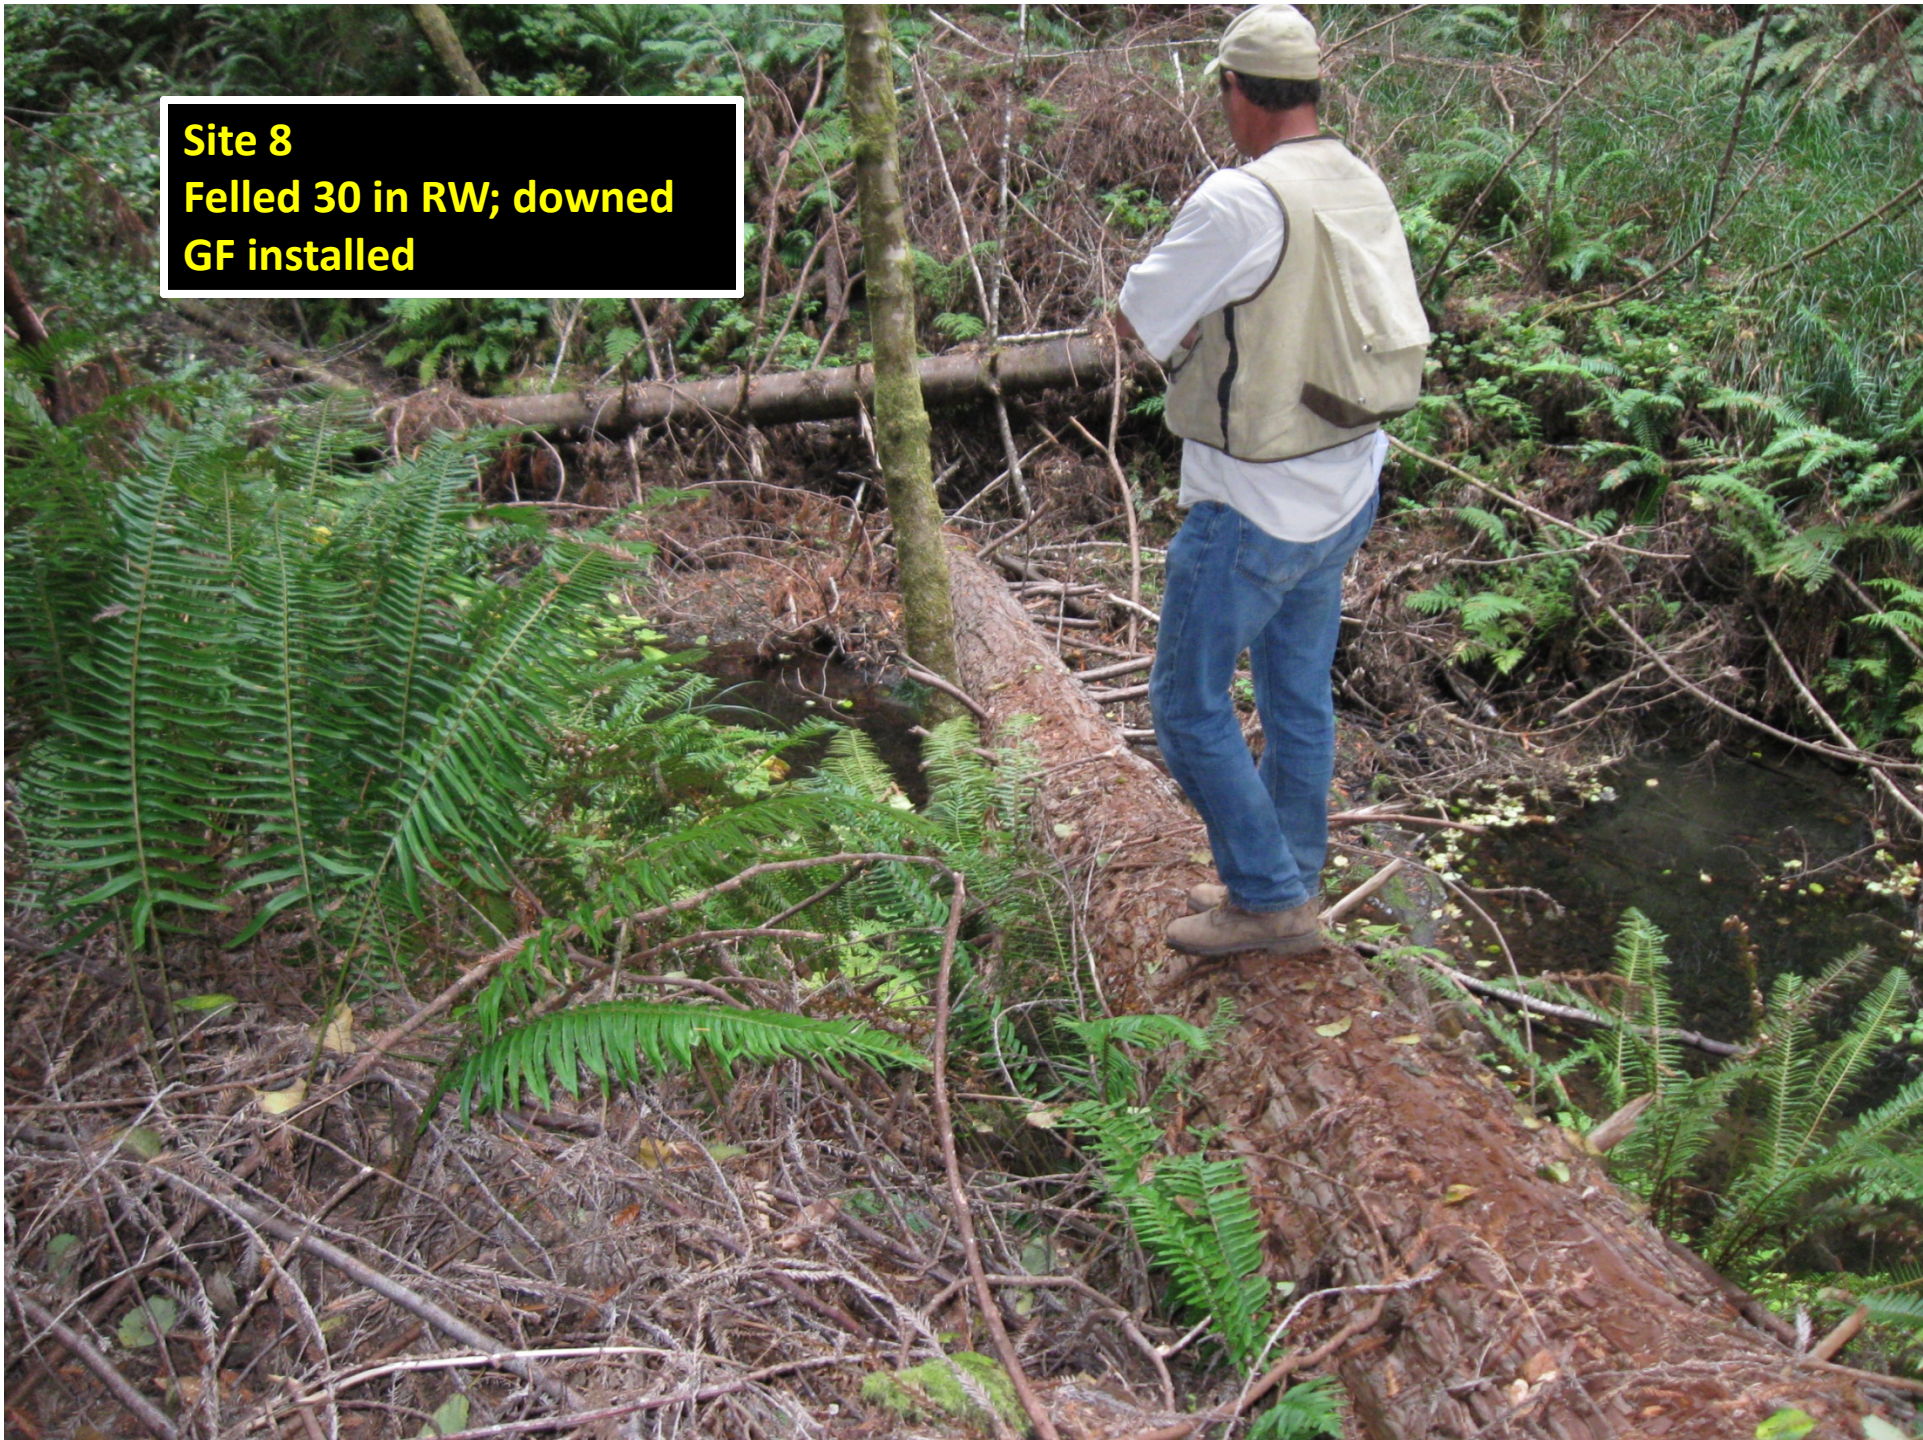
Site 8
Felled 30 in RW; downed
GF installed

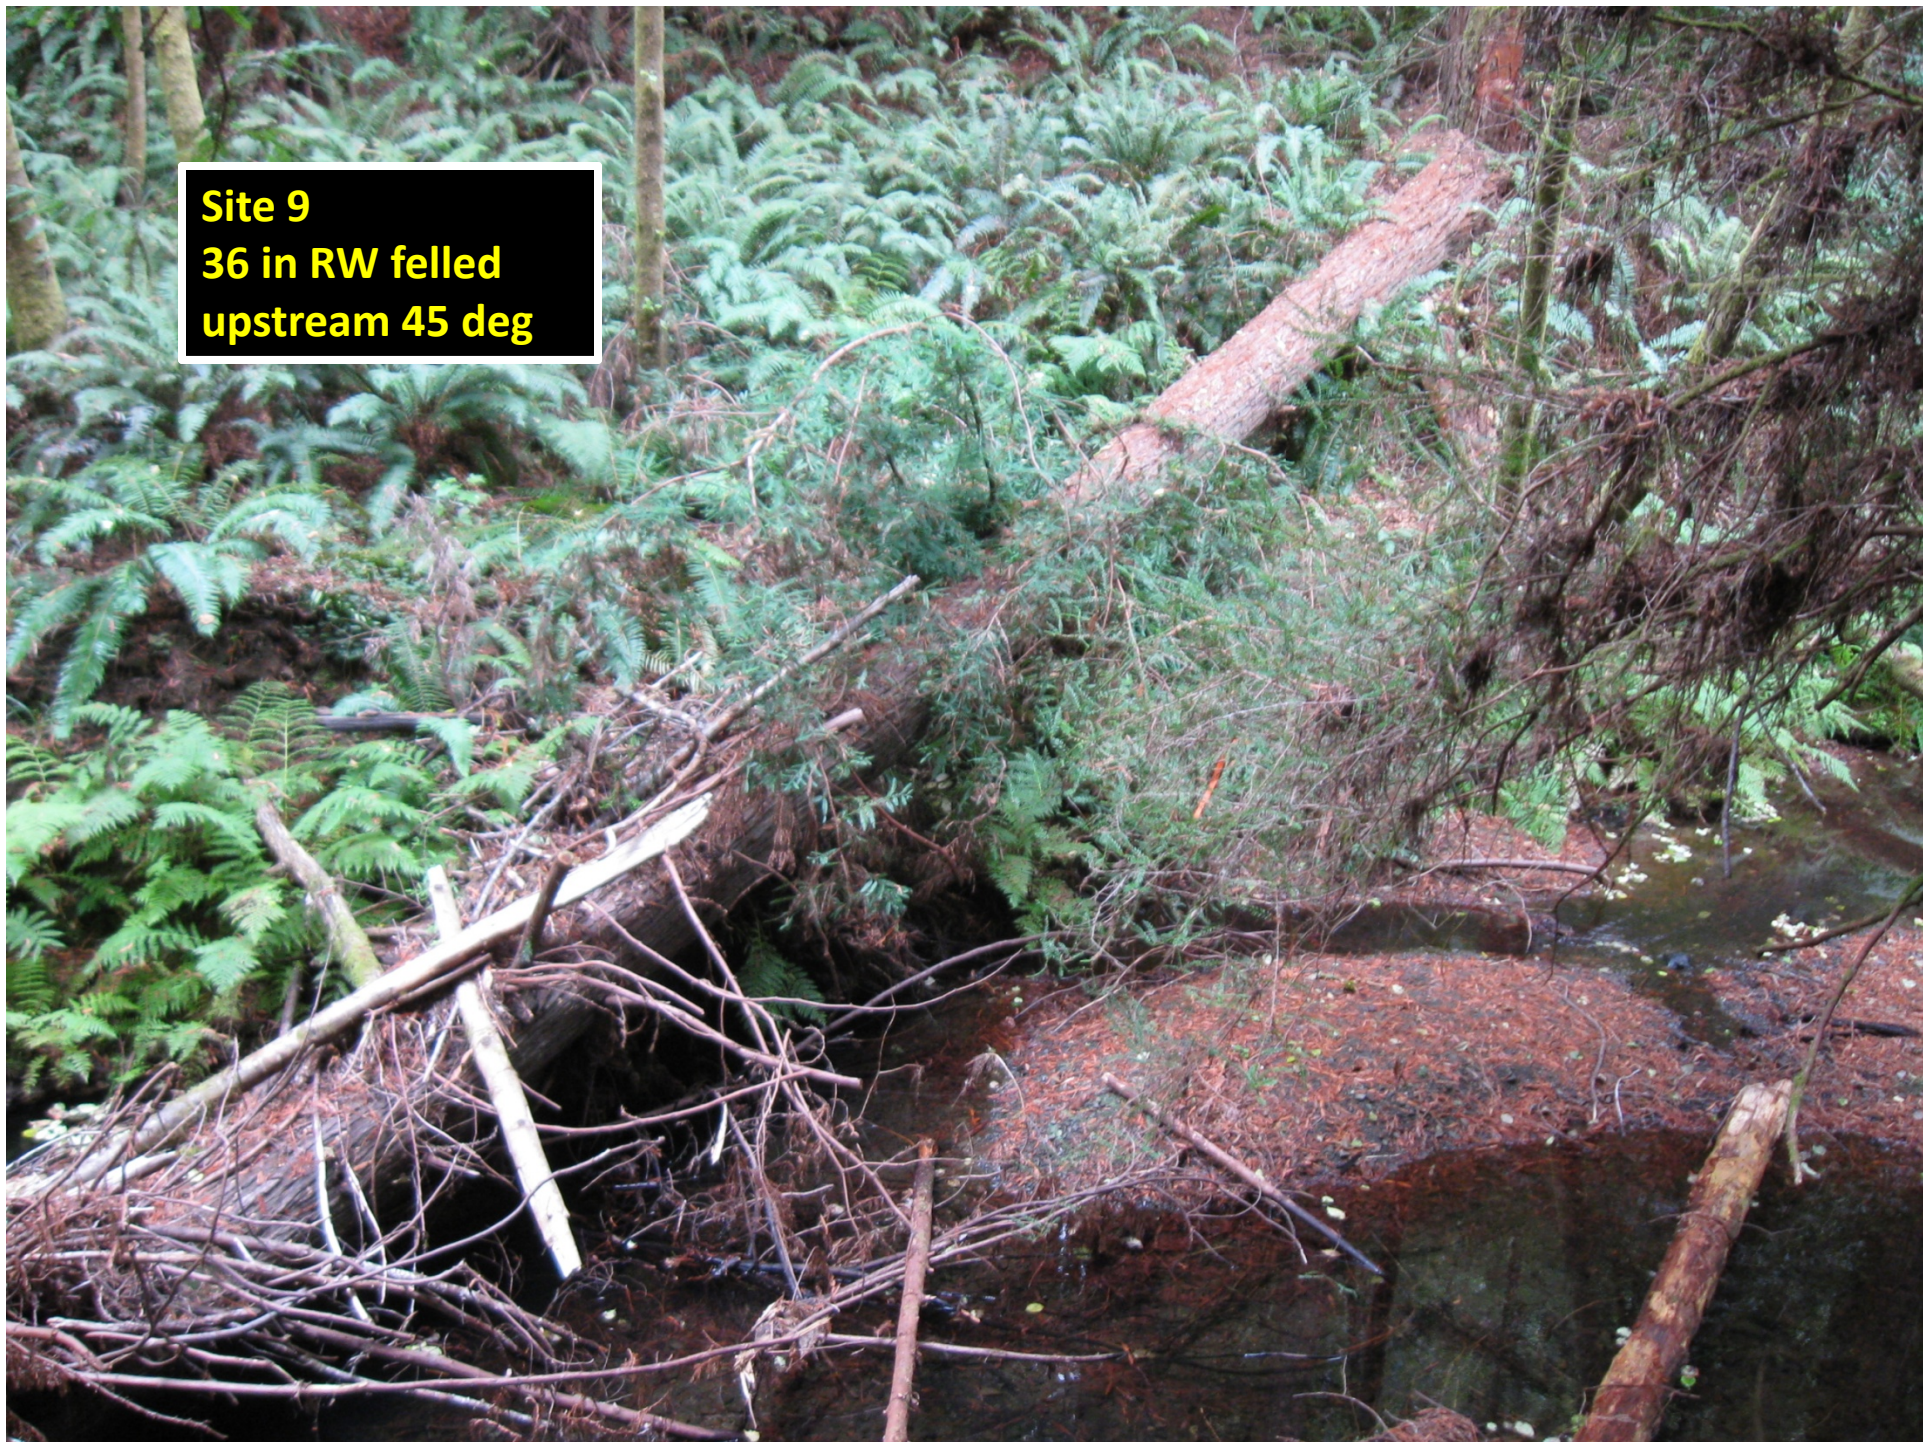
Site 9
36 in RW felled
upstream 45 deg

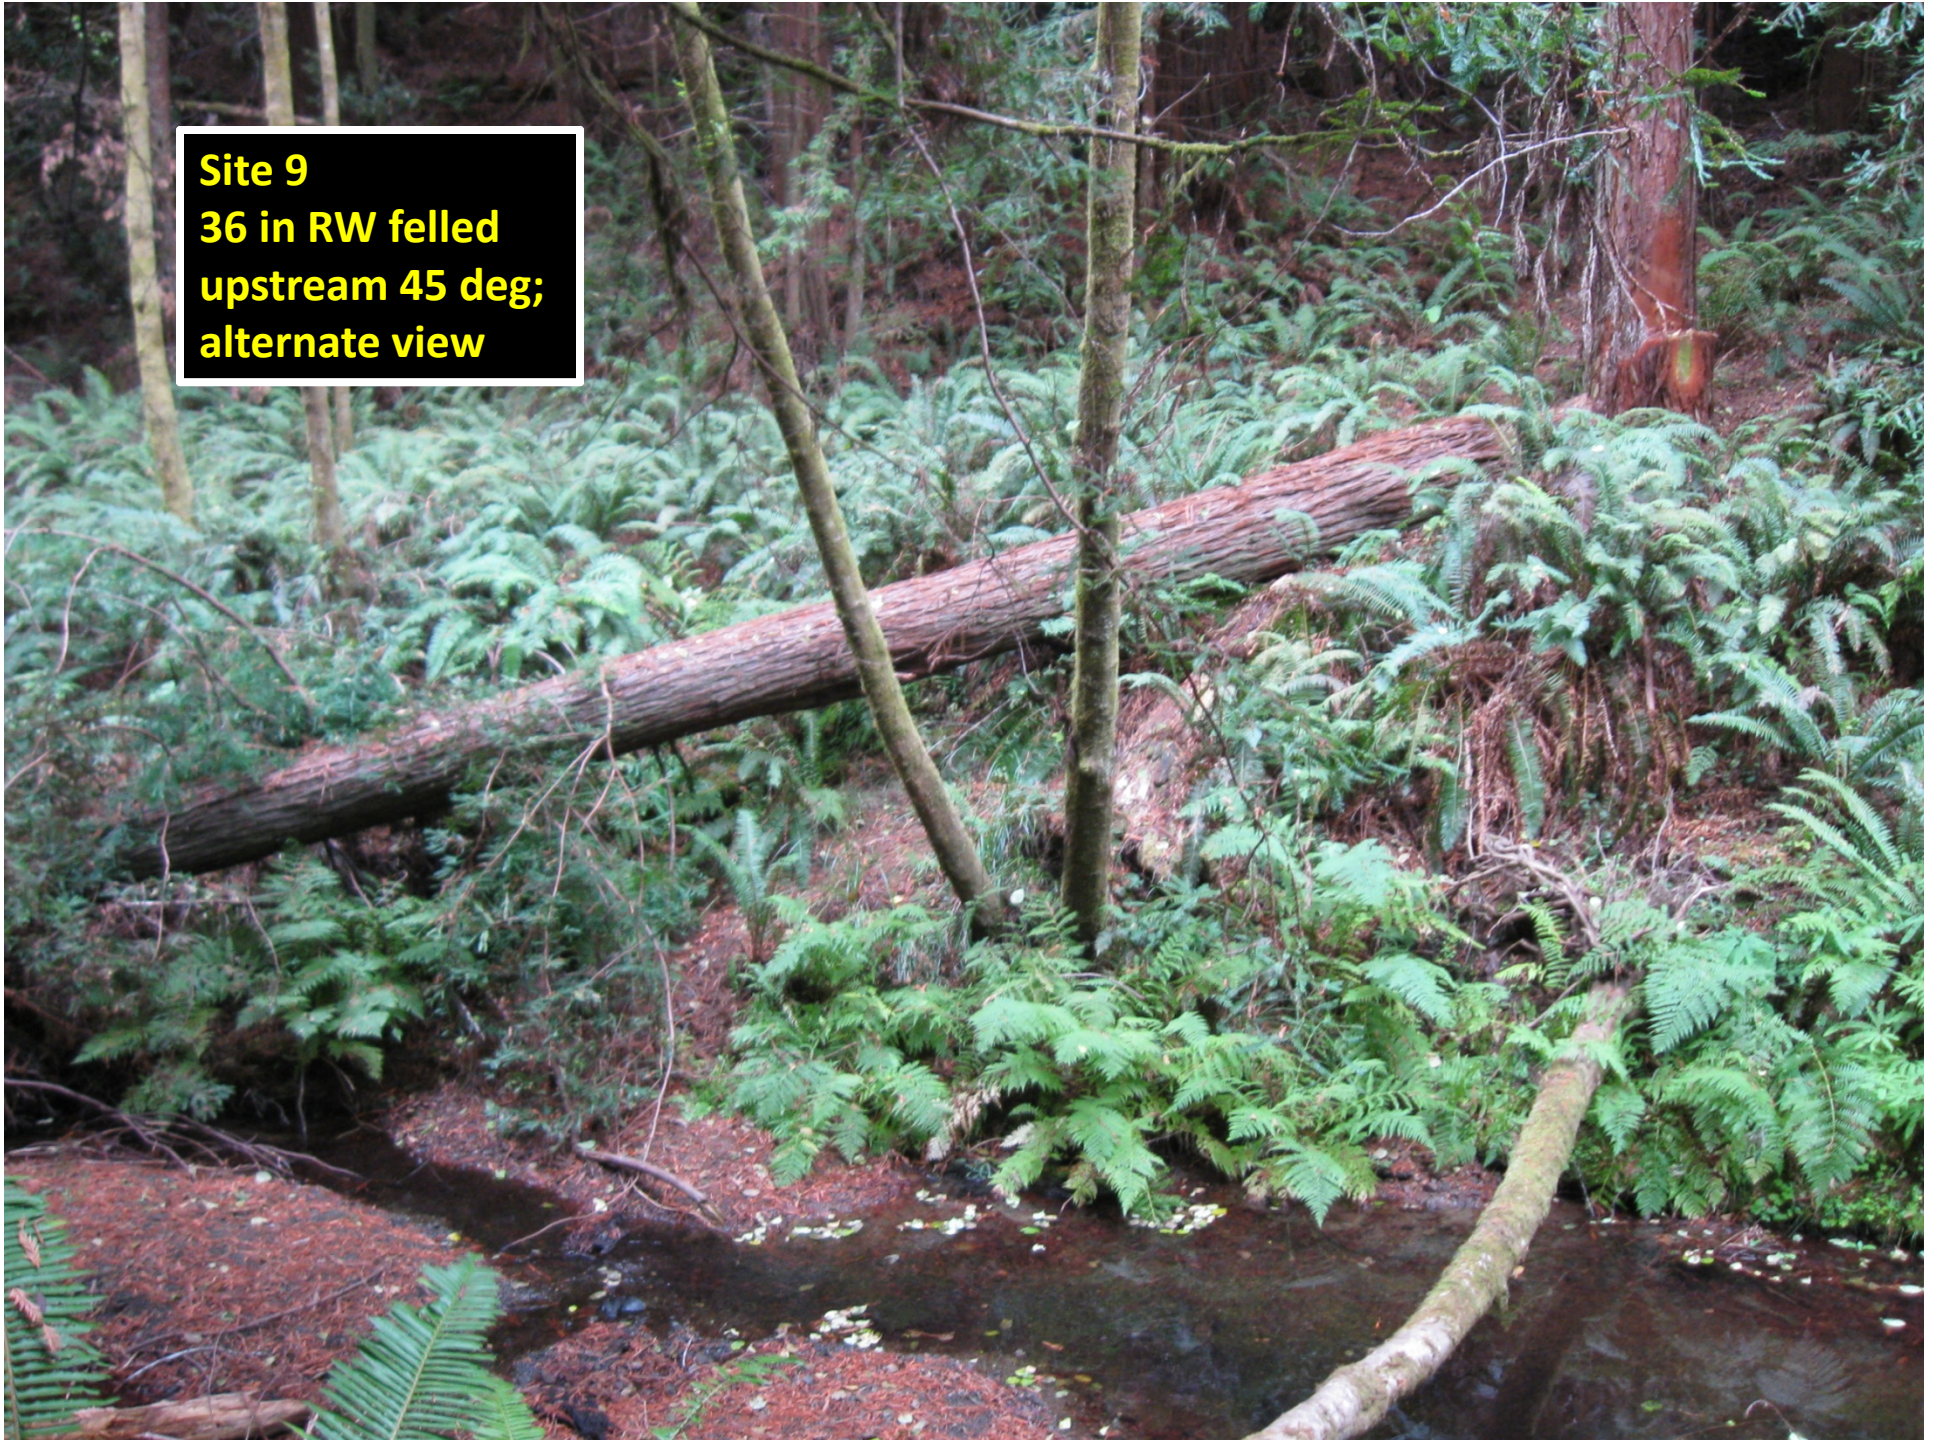
Site 9
36 in RW felled
upstream 45 deg;
alternate view

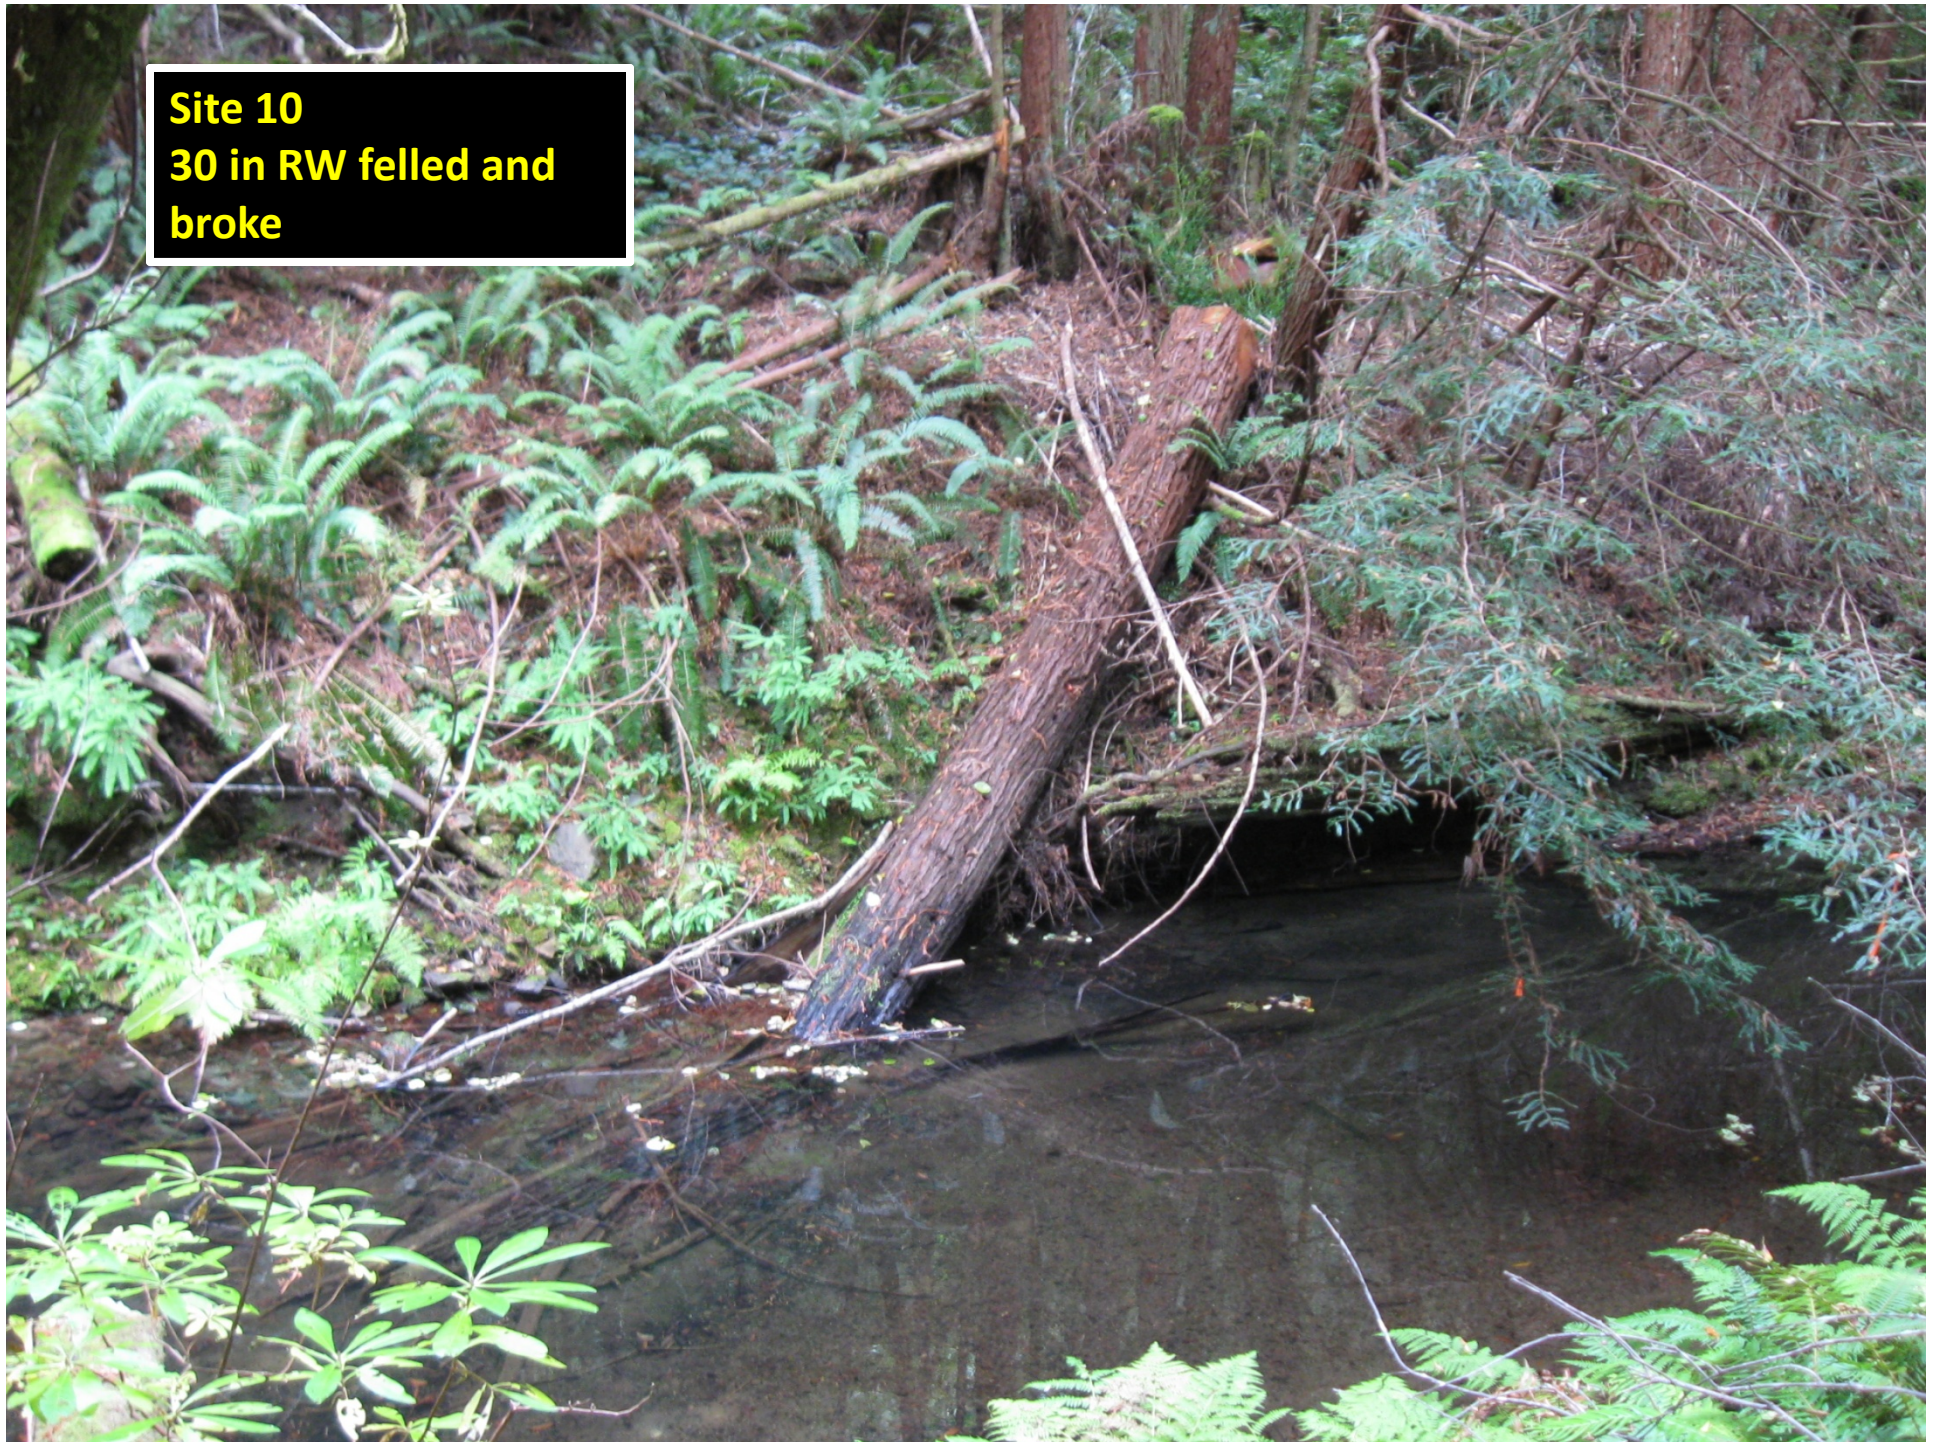
Site 10
30 in RW felled and
broke
