Cost and Effectiveness Analysis of Select New Jersey Living Shoreline Projects

The Nature Conservancy (TNC)

SIT-DL-20-9-CV5

June 30, 2020

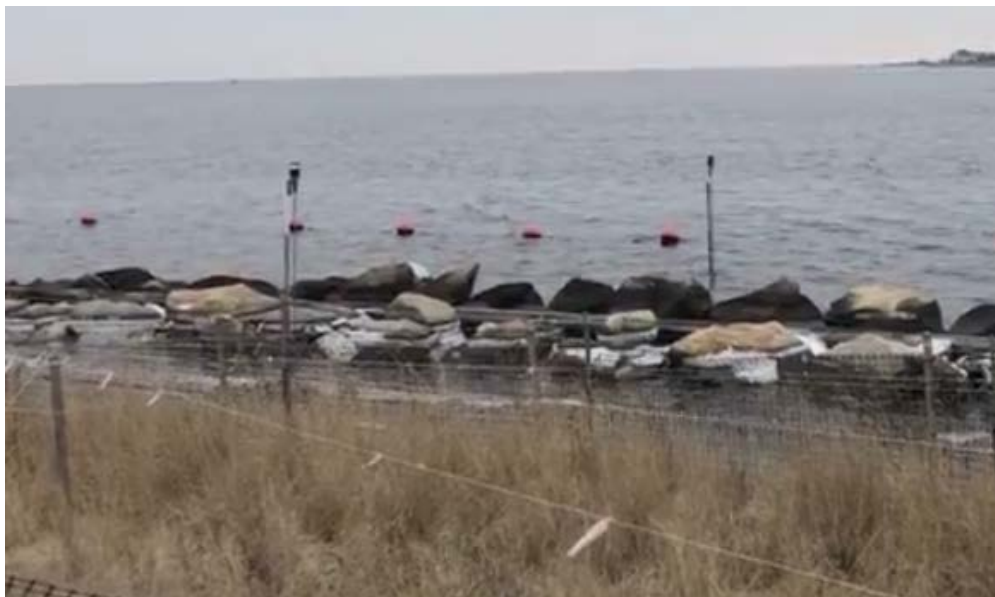
Figure 2: The effectiveness of a sill or breakwater can be evaluated by measuring the waves both in-front-of (offshore) and behind (inshore) the sill or breakwater to calculate effectiveness at attenuating waves under various conditions. Above shows two Wavelogger IIIs deployed at Berkeley Island, NJ, for such purpose in January 2019. The waveloggers are mounted to posts, which are pounded into the ground.

Three of the selected projects (Berkeley Island, Gandys Beach, and Gardner’s Basin) include offshore structures intended to reduce wave energy at the shoreline. At these sites, wave attenuation was selected as a second measure of effectiveness. Sills and breakwaters function by attenuating wave energy prior to it reaching some landward feature such as a beach or marsh edge. For each of the sites containing a sill or breakwater (Gardner’s Basin, Berkeley Island, Gandys Beach), waves were measured both offshore and inshore of the wave attenuation structure. Ocean Sensor Systems Wavelogger IIIs (waveloggers) were used to measure total water level at a sampling frequency high enough to extract the wave climate in post-processing. A typical wave sampling transect is shown in Figure 2. As illustrated in the figure, it was common for there to be no water at the inshore wavelogger during periods of low tide. During these periods, inshore waves could not be measured, and wave attenuation statistics could not be calculated. The actual duration of each data collection period was based on the expected dominant contributor to wave energy at each site. Table 5 summarizes the deployment and retrieval dates for wave data collection at each of the sites throughout the study period.

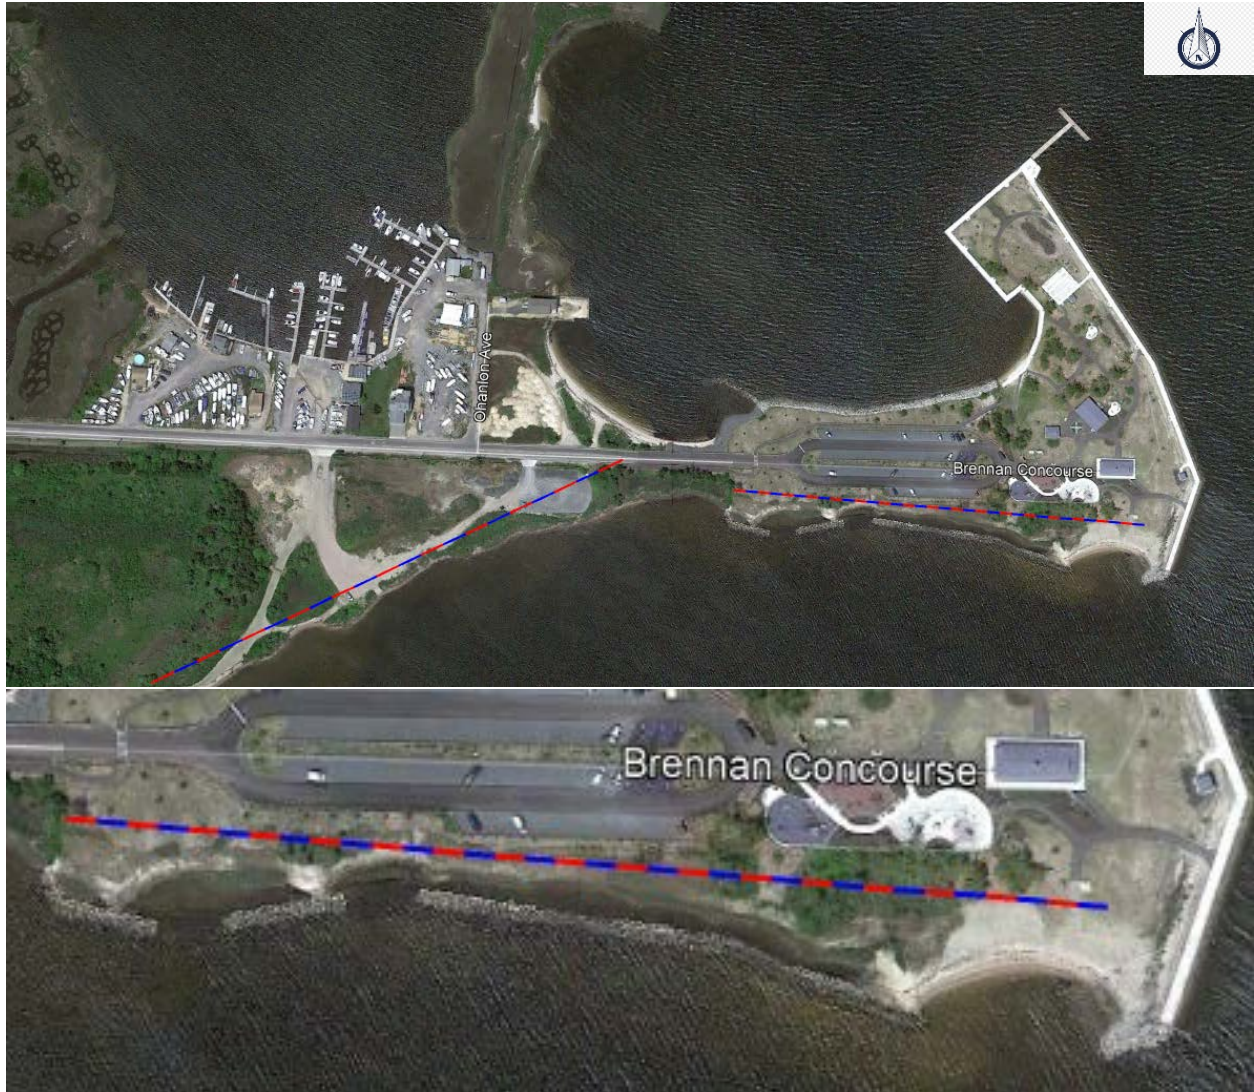
Figure 4: Google Earth Image (May 2019) showing Berkeley Island County Park, Berkeley Township, NJ, at two scales. The red and blue lines on the left in the top image are the baseline for the control area of the shoreline stability analysis. The red and blue line, landward of the breakwater/sill structures, is the baseline for the project area used in the shoreline stability analysis.

Transects perpendicular to the pre-defined baseline (shown in Figure 4) used in the Berkeley Island shoreline stability analysis were spaced at 25-foot intervals. The shoreline feature selected for analysis at this location was the wet/dry line, where available, and, otherwise, the vegetated edge. The vegetated edge is particularly relevant/useful in areas of marsh erosion and scarp formation. The shoreline identified as the control area is located to the east of the project area. Figure 5 and Figure 6 show the pre- and post-installation shoreline positions at each transect relative to the project and control baselines. Figure 5 illustrates that before installation of the living shoreline project, changes throughout the area were relatively homogenous with the exception of the eastern tip of the area; in this location, there is a hardened edge where no change is observed. Figure 6 shows that there is an initial adjustment of the shoreline to the project in the project area (May 2018 to June 2019), after which the shoreline stabilizes. This commonly occurs during/immediately after the construction of nearshore structures, as the sediment adjusts to the presence of the structures. In the case of segmented breakwaters, it is typical for the shoreline to accrete behind the structure and retreat to a stable position behind the gaps, as shown in Figure 4.

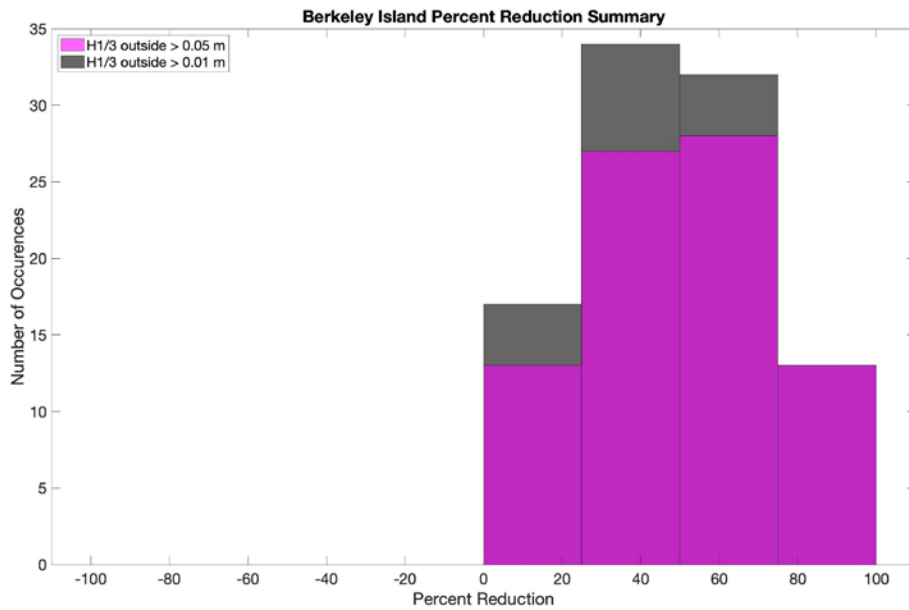
Figure 8: Histogram describing the distribution of percent reduction values at Berkeley Island during all deployments for offshore significant wave heights greater than 1 cm (gray) and greater than 5 cm (purple).

significant wave heights greater than 5 cm) is additionally shown. The average percent reduction for just these larger wave events was 52.1%.

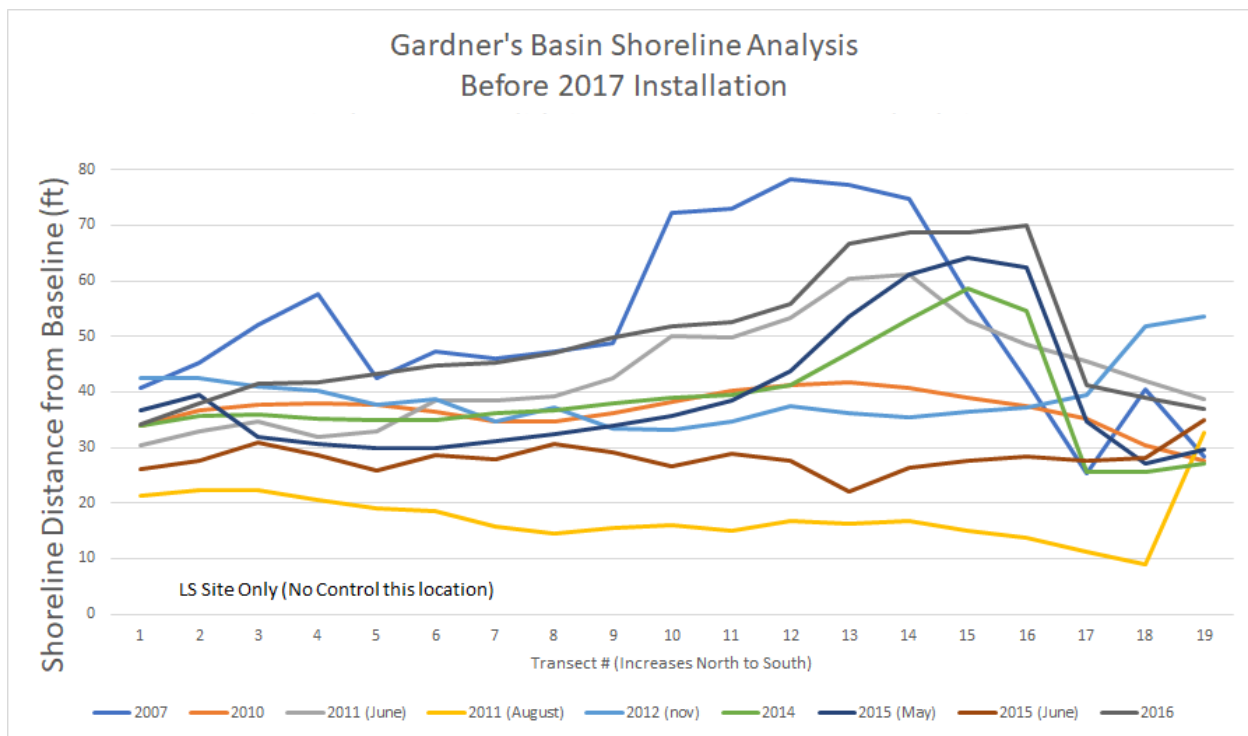
Figure 11: Pre-installation shoreline stability analysis for Gardner's Basin living shoreline. Analysis is based on historical imagery provided in Google Earth.

A summary of the measured shoreline changes is presented in Table 13. At Gardner's Basin, it was found that the average rate of shoreline change in the project area was -0.7 ft/year (erosion) prior to installation and -0.9 ft/year (erosion) after installation with a pre-installation range of -2.6 (erosion) to -2.3 ft/year (erosion) pre-installation and a post-installation range of -3.3 (erosion) to 0.8 ft/year (accretion). The standard deviation, which measures the uniformity of the shoreline fluctuations, did not change, remaining constant at 1.3 ft/year.

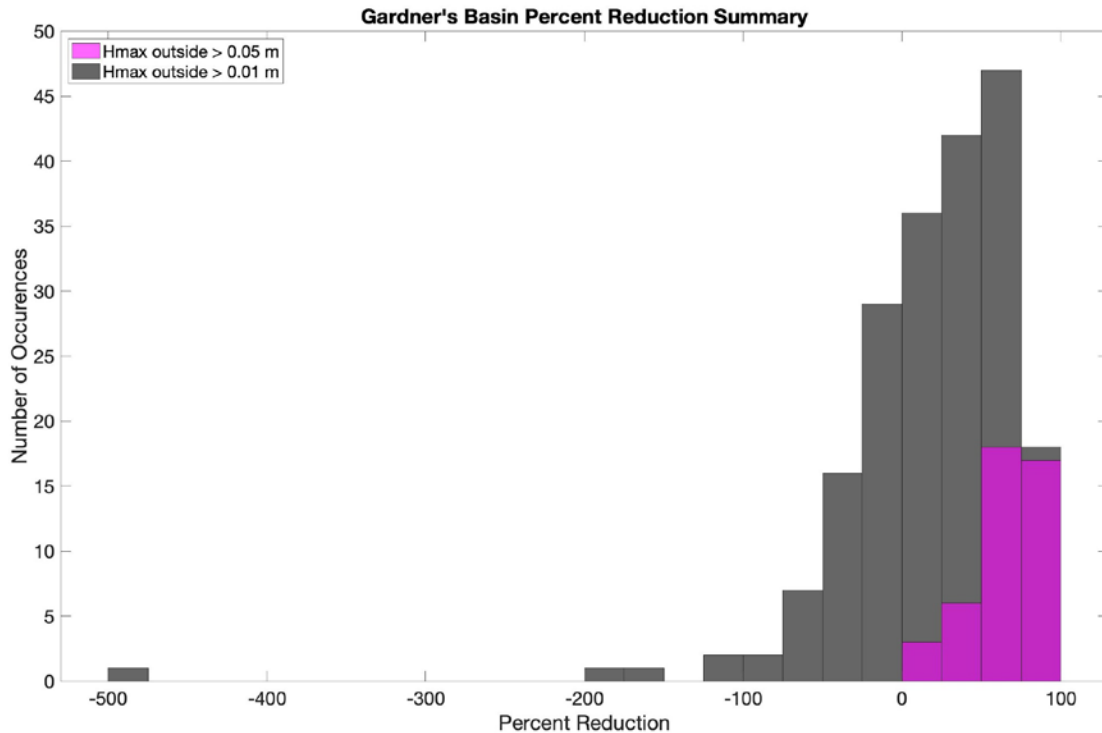
Figure 14: Histogram describing the distribution of percent reduction values at Gardner’s Basin during all deployments for offshore maximum wave heights greater than 1 cm (gray) and greater than 5 cm (purple).

sill. Kerr, et al. (2020), discusses a number of possible physical explanations; however, at Gardner’s Basin all of these instances occur when the offshore waves were smaller than 5 cm. This is close to the measurement and noise threshold of the instrument. If only the waves larger than 5 cm are considered (purple in Figure 14), the negative percent reduction values are eliminated, the average percent reduction increases to 65.9%, and the vast majority exceed 50%. All leading to the conclusion that the sill is effectively attenuating waves.

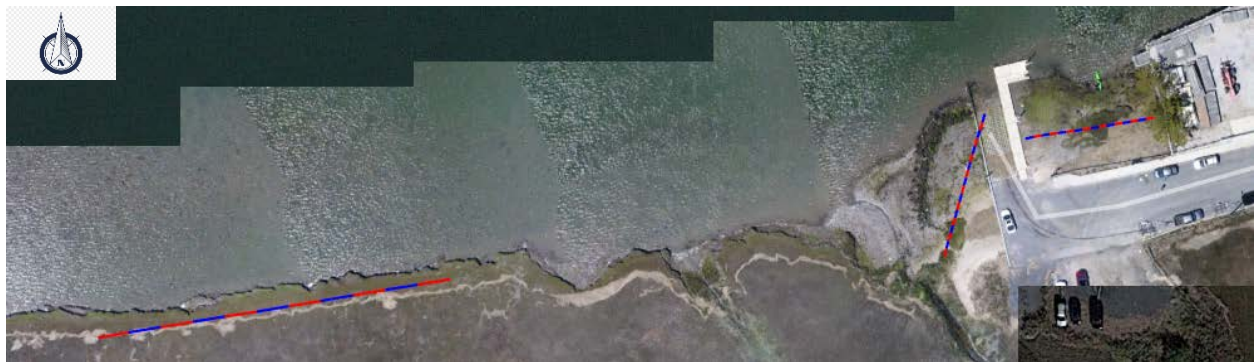
Figure 16: Orthomosaic created from UAV imagery collected on May 7, 2020, showing Strathmere, Upper Township, NJ. The red and blue lines to the left of the image is the baseline for the control area of the shoreline stability analysis. The two red and blue lines, landward of the sill and landward of the vegetated shoreline, to the right of the image are the baselines for the project area used in the shoreline stability analysis.

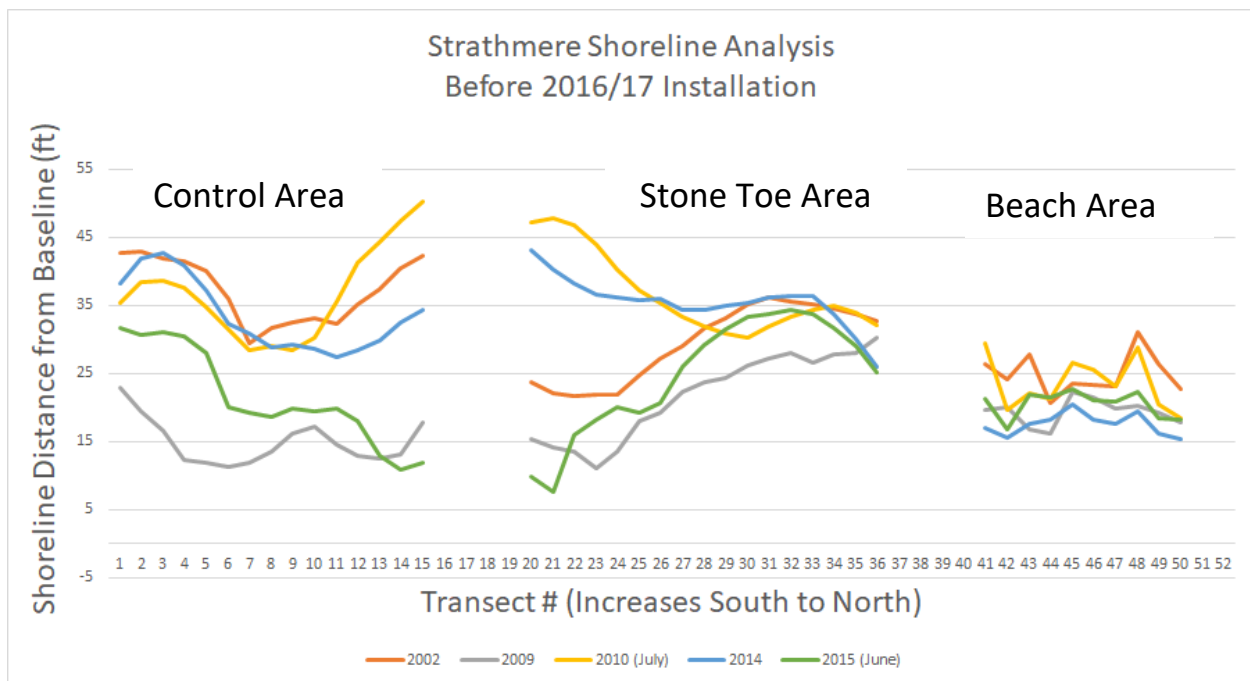
Figure 17: Pre-installation shoreline stability analysis for Strathmere living shoreline. Analysis is based on historical imagery provided in Google Earth.

Figure 17 and Figure 18 show the pre- and post-installation shoreline positions at each transect relative to the project baselines. The pre-construction shorelines in the control and stone toe areas display a significant amount of variability. While this may be real, there is also a possibility that at least some of the variability is related to the challenges associated with interpreting some of the older historical images from Google Earth. The data in Figure 17 shows that both the northern edge of the control area and the southern end of the stone-toe area eroded significantly before the living shoreline was installed. The UAV imagery collected at low tide indicates that since the installation of the project, both the beach and control areas appear to be relatively stable. Unfortunately, no traceable features (vegetated shoreline or wet/dry line) could be identified in the drone images in the “Stone Toe ” section, therefore no data is presented for this area.

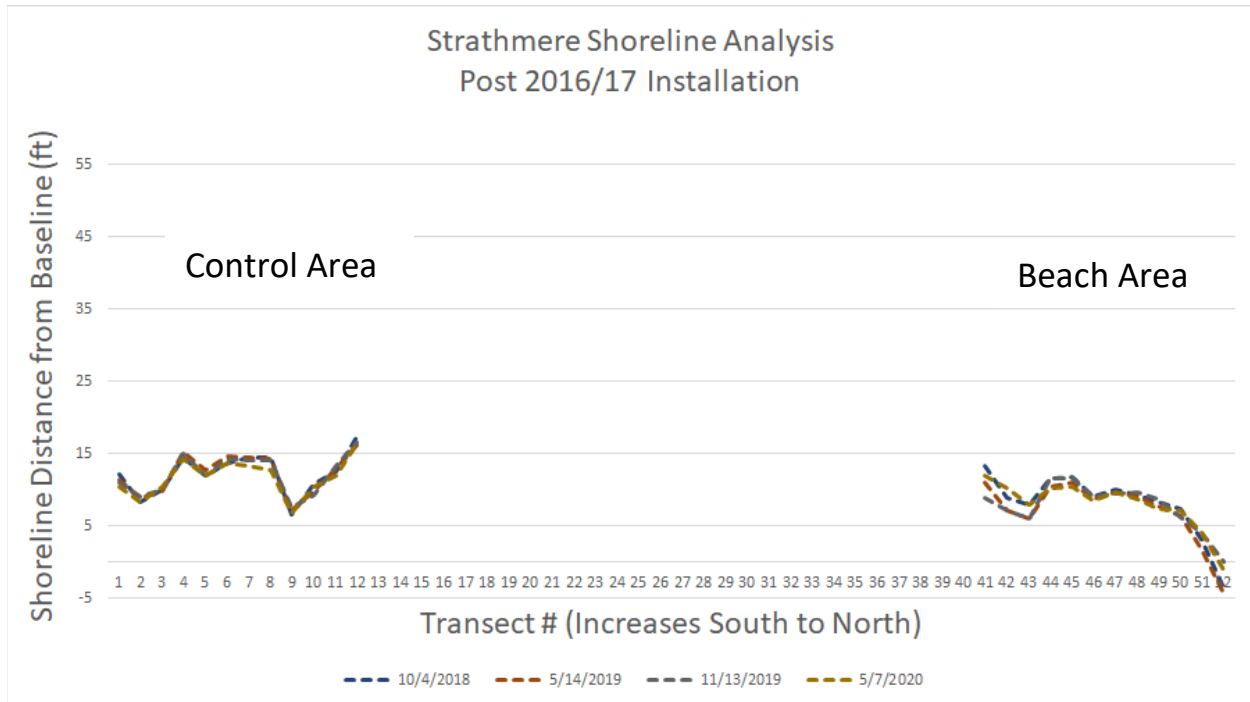
Figure 18: Post-installation shoreline stability analysis for Strathmere living shoreline. Analysis is based on imagery collected by the UAV as part of this study.

longshore variability, overall, the shoreline change rates are in the +/- 1ft/yr range at both the control and project sites both prior to and after installation.

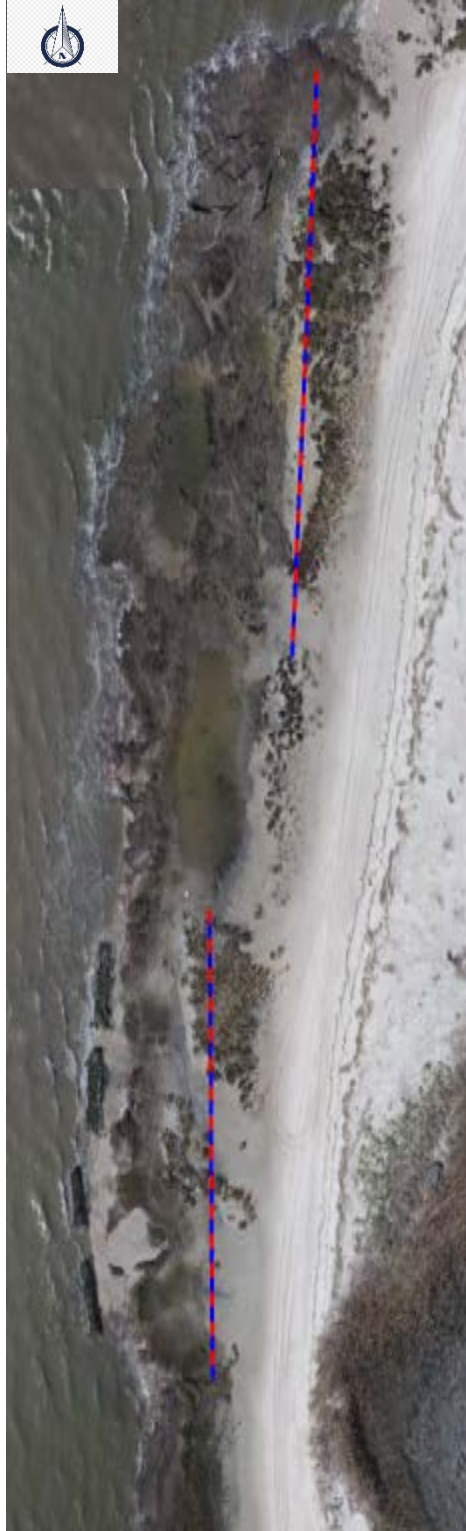
Figure 20: Orthomosaic created from UAV imagery collected on April 6, 2020, showing the Gandys Beach, Downe Township, NJ. The red and blue lines to the North (top) are the baseline for the control area of the shoreline stability analysis. The red and blue line, landward of the Oyster Castle structures at the bottom of the image is the baseline for the project area used in the shoreline stability analysis.

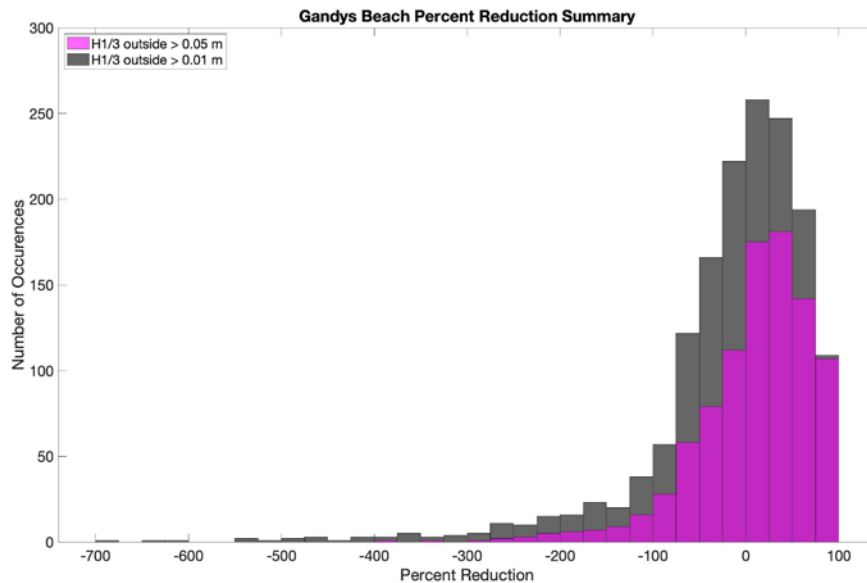
Figure 24: Histogram describing the distribution of percent reduction values at Gandys Beach during all deployments for offshore maximum wave heights greater than 1 cm (gray) and greater than 5 cm (purple).

The range in percent reduction at Gandys Beach is displayed in the histograms shown in Figure 24. The full distribution depicted in gray shows a wide range including many negative values. The modified distribution shown in purple, only includes the larger waves (offshore waves greater than 5 cm) and indicates that for these waves proportionally more dissipation occurs. The average reduction over all deployments at the site was -15.8% and the average reduction when the outside wave heights exceed 5 cm was 5.2%.

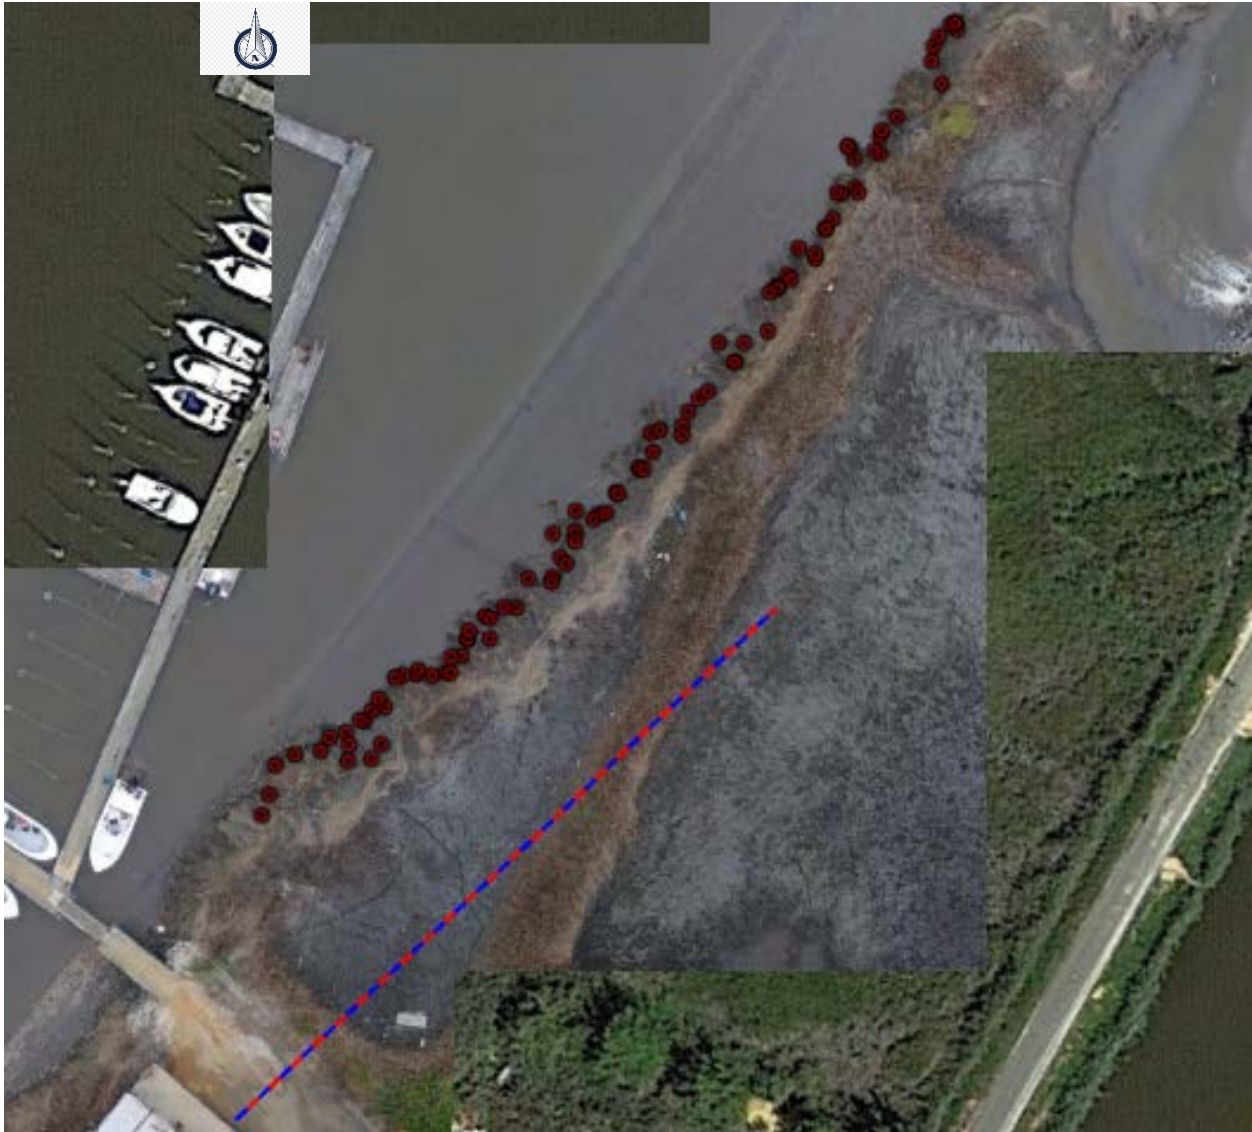
Figure 26: Orthomosaic created from UAV imagery collected on April 7, 2020, showing Matts Landing, Heislerville, NJ. The red and blue line is the baseline for both the control and project area of the shoreline stability analysis. The living shoreline project is along the southern edge of this strip of shoreline, and the control is immediately to the North.

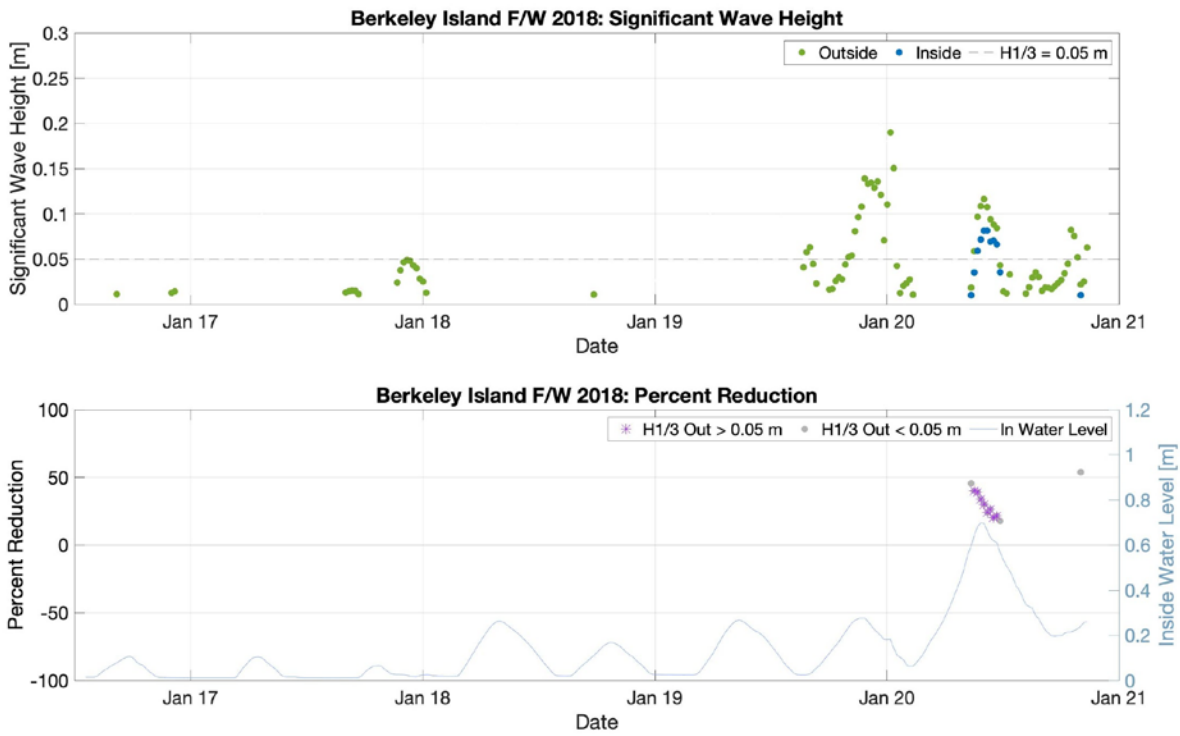
Figure 34: Significant wave height and percent reduction for Berkeley Island fall/winter 2018 deployment.
