State of the Las Cienegas National Conservation Area.
Part 3. Condition and Trend of Riparian Target Species,
Vegetation and Channel Geomorphology

Gita Bodner, The Nature Conservancy in Arizona, and
Karen Simms, Bureau of Land Management
January 2008

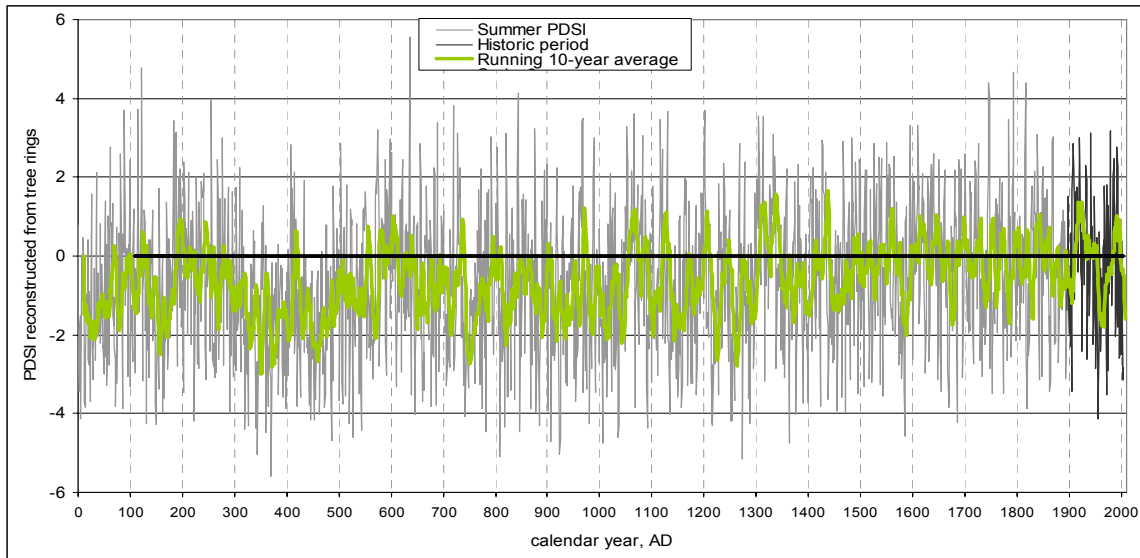
Figure 2. Long-term record of drought conditions. Summer Palmer Drought Severity Index reconstructed from tree rings, southern Arizona (gridpoint 105 data from Cook et al. 2004), with ten-year running averages. Note droughts from ~300 to 600 AD that are more extreme than any experienced in the historic period.

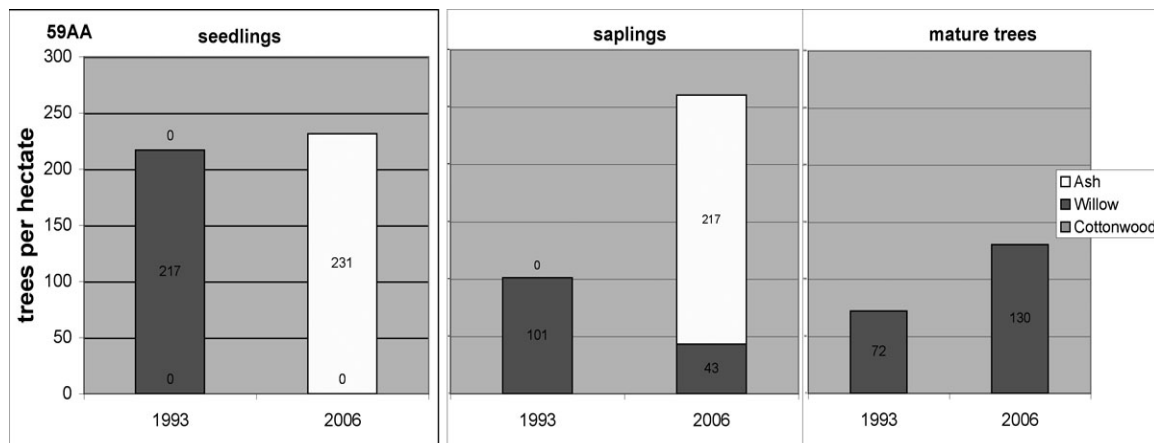
Figure 12. 59AA: This site is at the downstream end of LCNCA perennial flow and as such appears to be quite sensitive to drought effects. An abundance of dead willow trees in 2006 suggests that these trees grew up from seedling and sapling classes after 1993 and then died during drought years that led up to 2006. Tree recruitment remains good but has almost entirely shifted species composition.

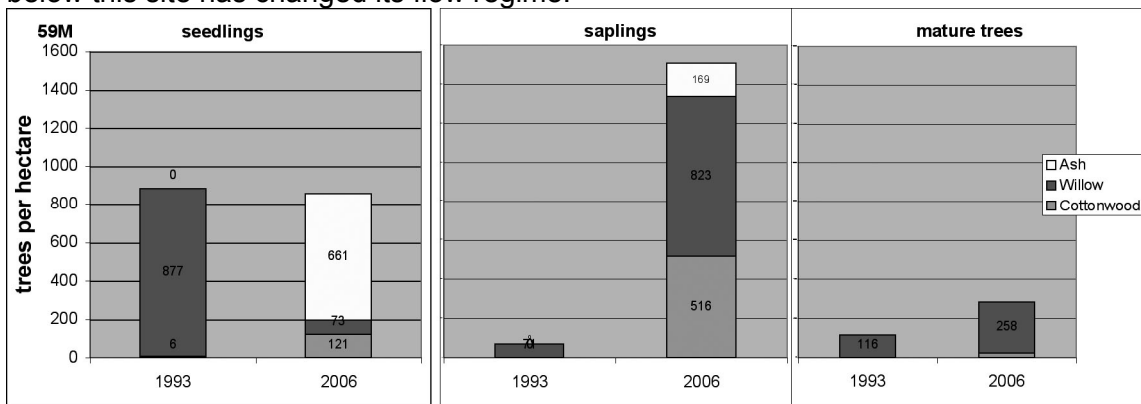
Figure 16. 59M: This is the only site surveyed in the perennial-flow area of the Headwaters reach. Sapling density in this reach now is extremely high, creating a “wooded swamp” character across the floodplain.

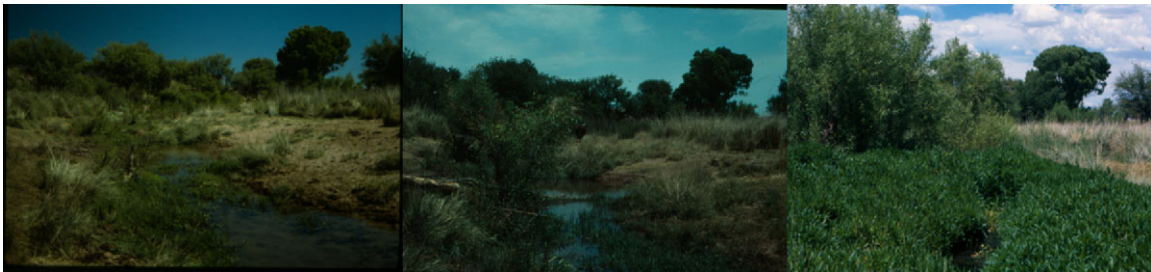
Figure 17. Headwaters reach, 1989, 1993 and 1997. Cattle were excluded from this segment of the creek in 1995.

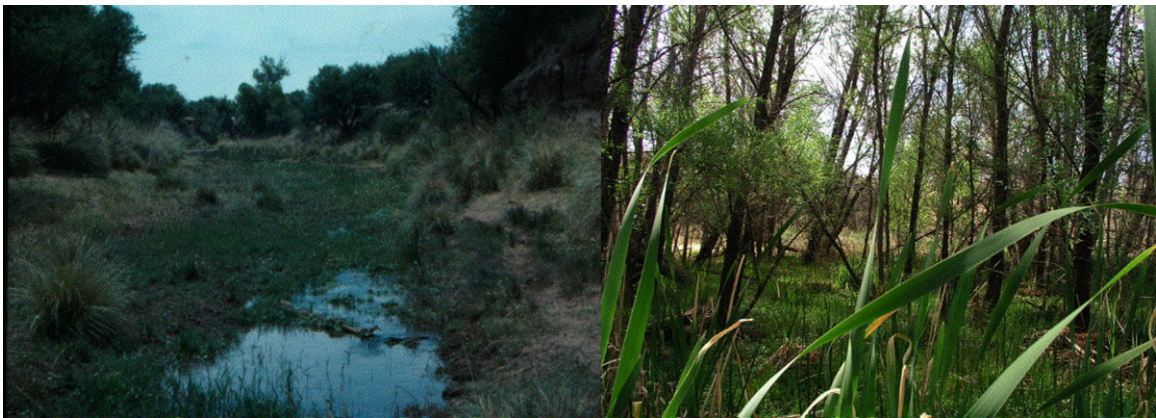
Figure 19. Headwaters reach, 1993 and 2006. This area has transformed into a wooded swamp and the original photopoint cannot be precisely located.

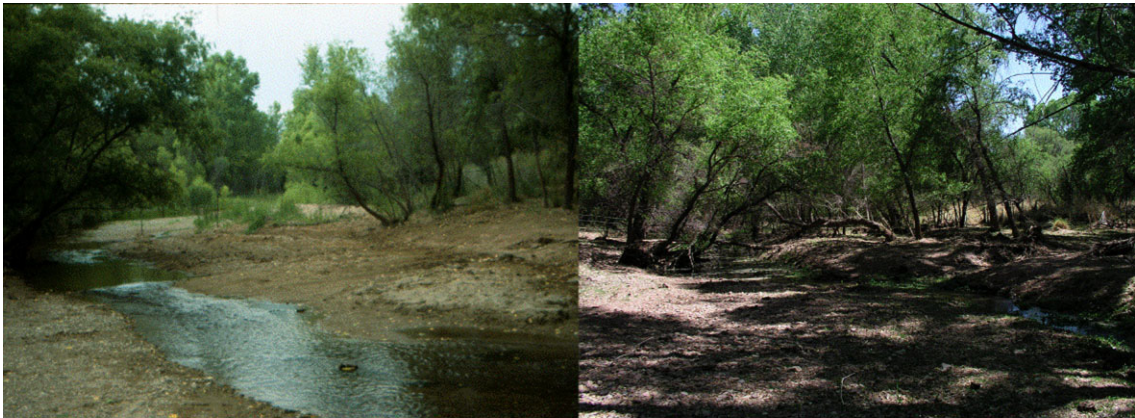
Figure 20. Fresno Gap (59F) 1993 and 2006. This spot was left as a cattle crossing lane when the reach was fenced.

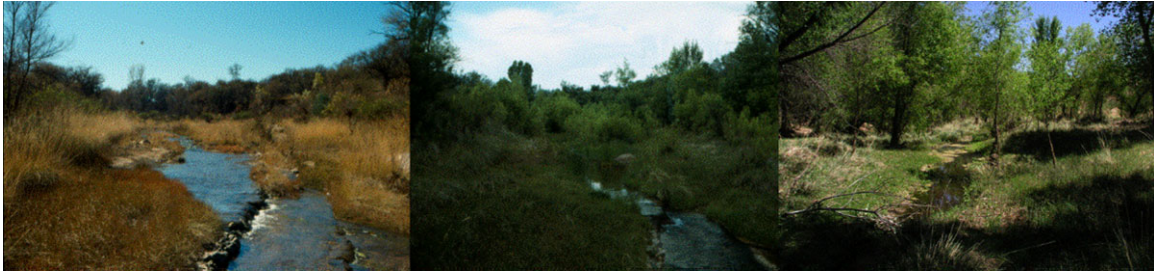
Figure 21. 59D, segment with bedrock ledges, 1989, 1993, and 2006. Earliest photo was taken in winter, others in summer.

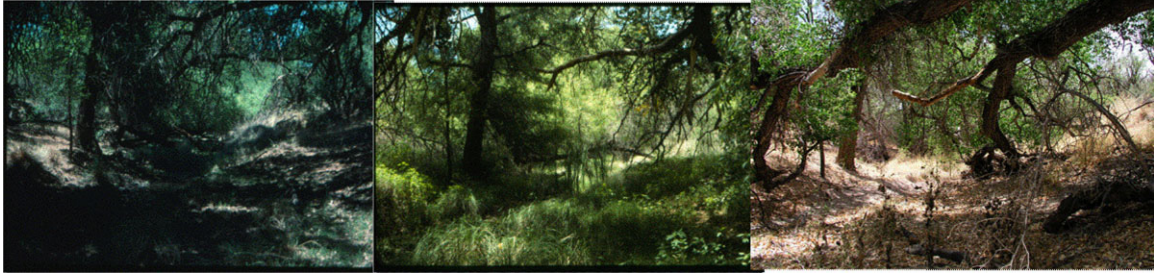
Figure 22. Agricultural fields reach, 1988, 1993, and 2006. Note little vegetation change apart from differences in season in which the images were taken and aging of the large cottonwood whose lower branches appear at the top of each photo. Trunk on the left-hand bank is a slow-growing ash tree.

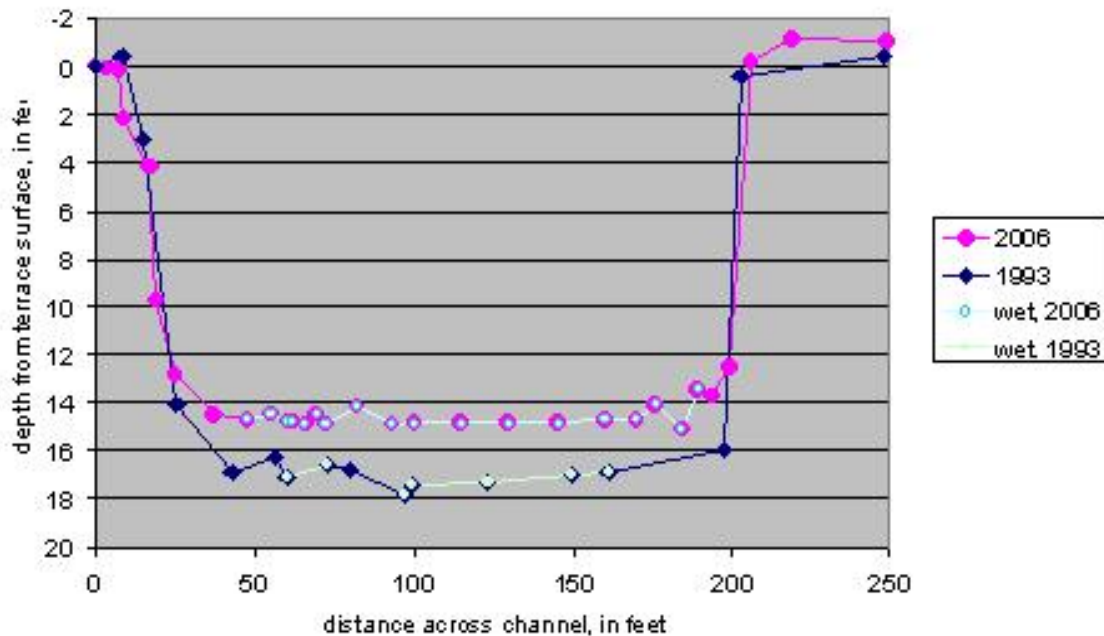
Figure 24. BLM Headwaters cross section (CC7). Note channel aggradation of approximately three feet, widening of wet zone and stable position and slope of cutbanks.

Aggradation in the headwaters flow area has combined with riparian vegetation growth to spread flow across the channel and expand marsh habitats. This accumulation of sediment and organic matter characterizes cienega systems (Hendrickson and Minckley 1984). If the channel stabilizes in this form, marsh expansion in the headwaters may

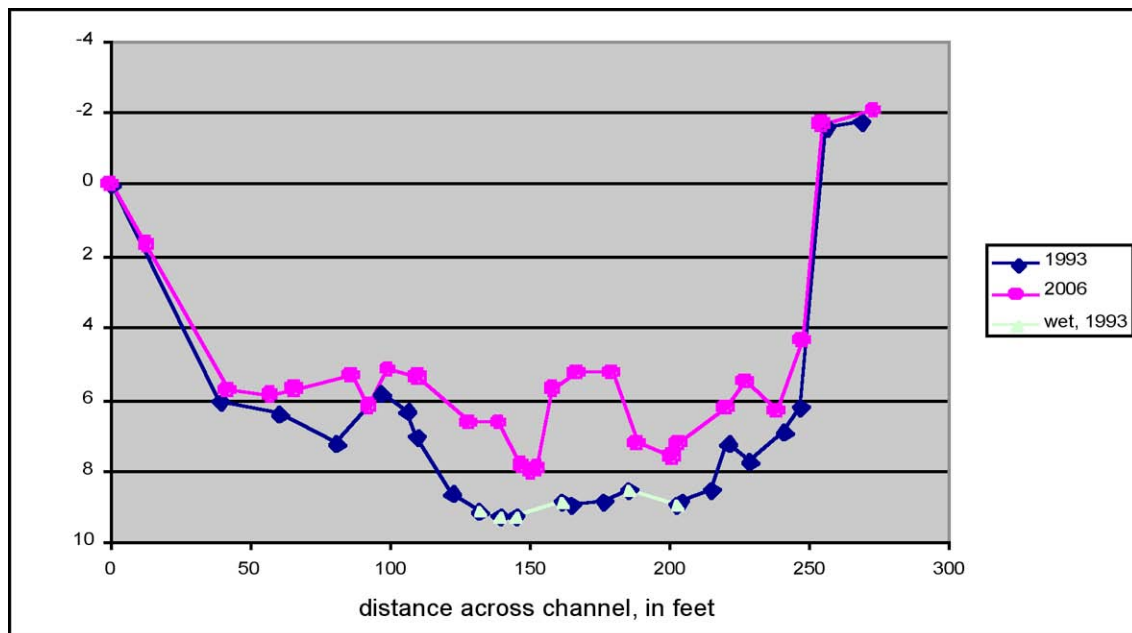
Figure 25. BLM cross section at Bahti's Bog (CC0). Note irregular channel aggradation from flood deposits, stable position and slope of cutbanks. Year-to-year alignment may

not be exact because western t-post was missing and (0) end point had to be reconstructed. There was no water in the channel when it was measured in 2006.
