Priority Restoration Sites Upper Gunnison Basin

Gunnison Climate Working Group

Wolf Creek Ranch (Private) - East Fork and Middle Fork Upper Gunnison Basin Restoration Structures and Monitoring

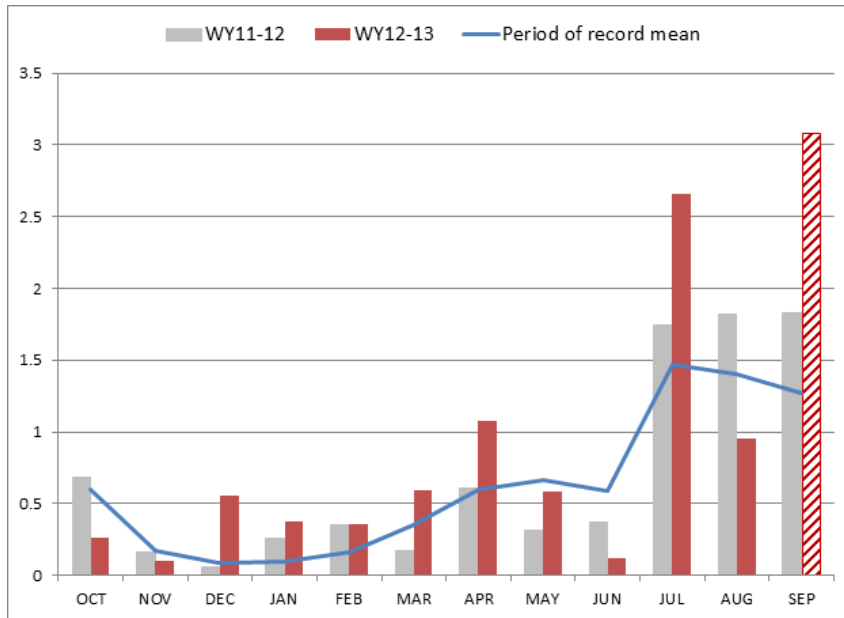
Monthly Precipitation (inches), 2012-2013

- Data are from Huntsman weather station
- In general, 2012 was considered a drier year than 2013
- Our control transects were established to detect changes associated with precipitation vs. restoration results

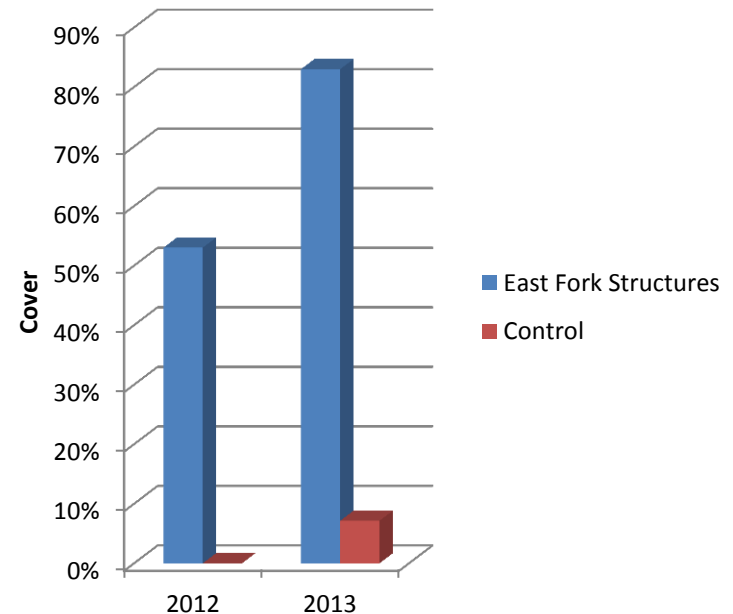
East Fork Wetland Species

- The canopy cover of wetland species significantly increased ($P \leq 0.05$) between 2012 and 2013 within the restored areas.
- The canopy cover slightly increased in the control (not restored).

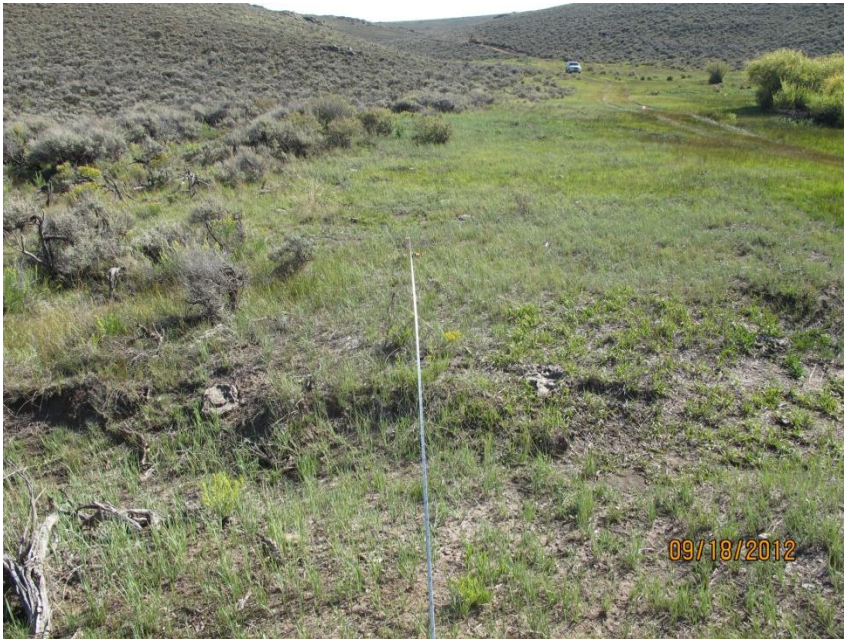
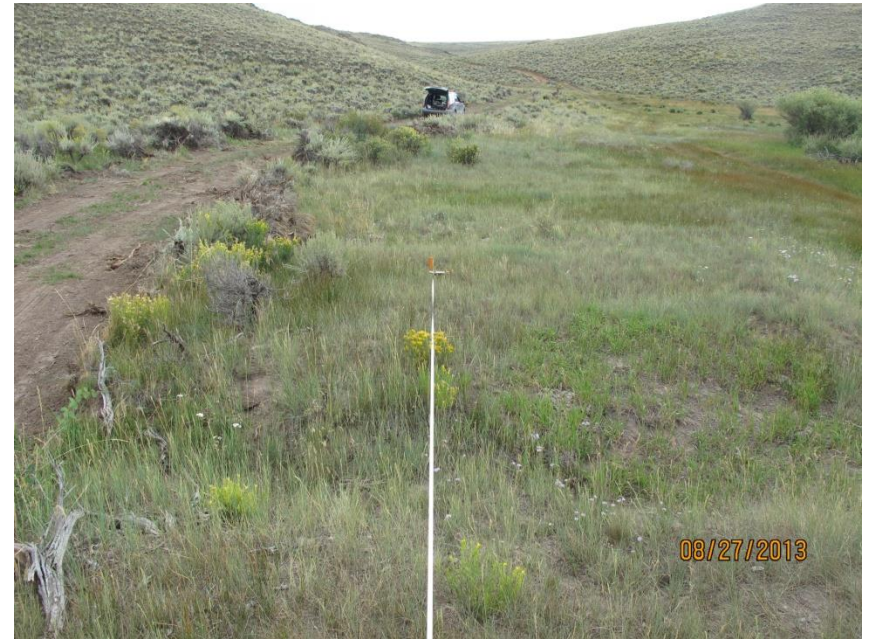
Control: no structures built

Note: the new two track visible in the 2013 photo is part of the overall restoration plan. The original two-track bisected a wet meadow and the new two-track is now on the edge of the wet meadow. Transect photo: C01_0m

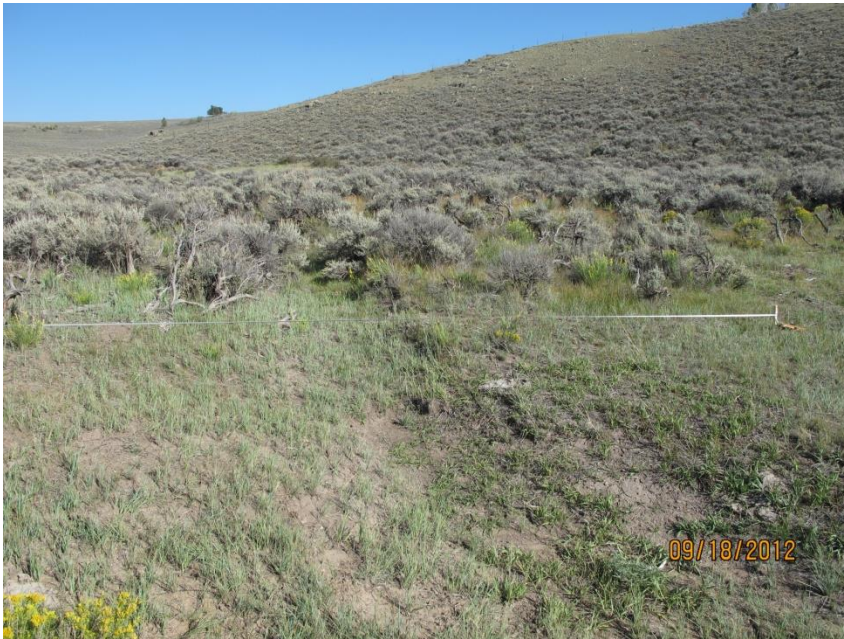
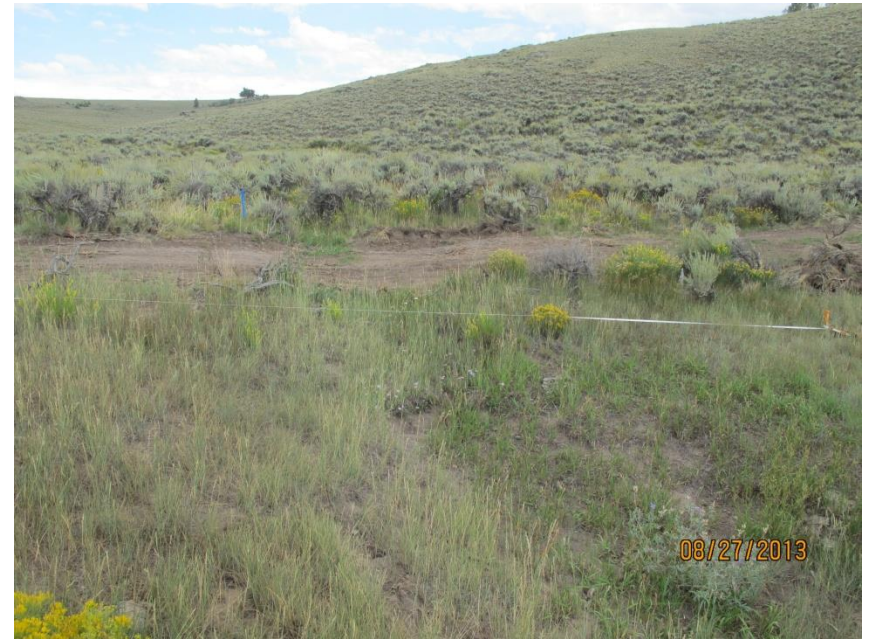
Control

We can see an increase in cover and height of western wheat grass in the 2013 repeat photo, due to increased precipitation.

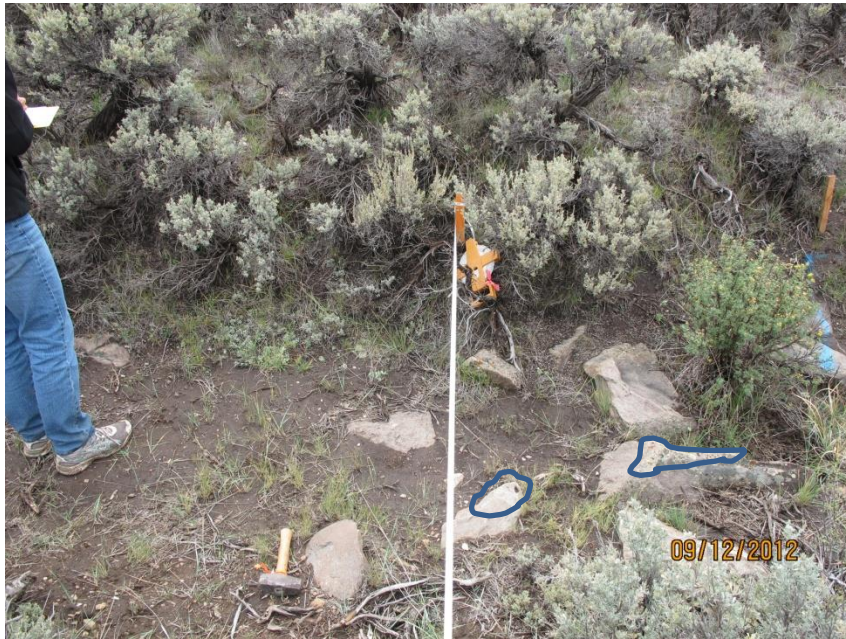
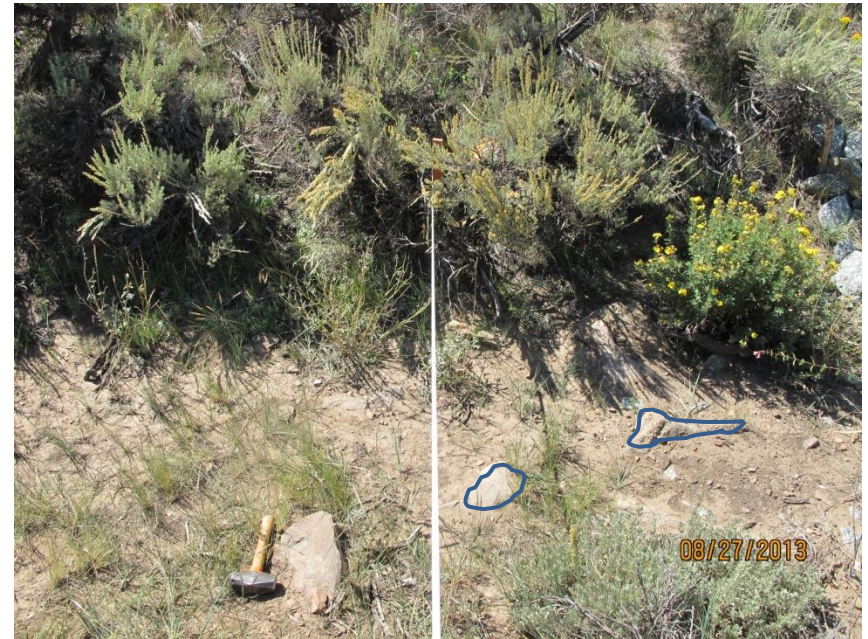
One Rock Dam on Ephemeral Stream, GWT29_0m

By 2013, sediments partially or completely covered many of the rocks. (Use the hammer to help locate the 2012 rocks and compare to the 2013 photo.)

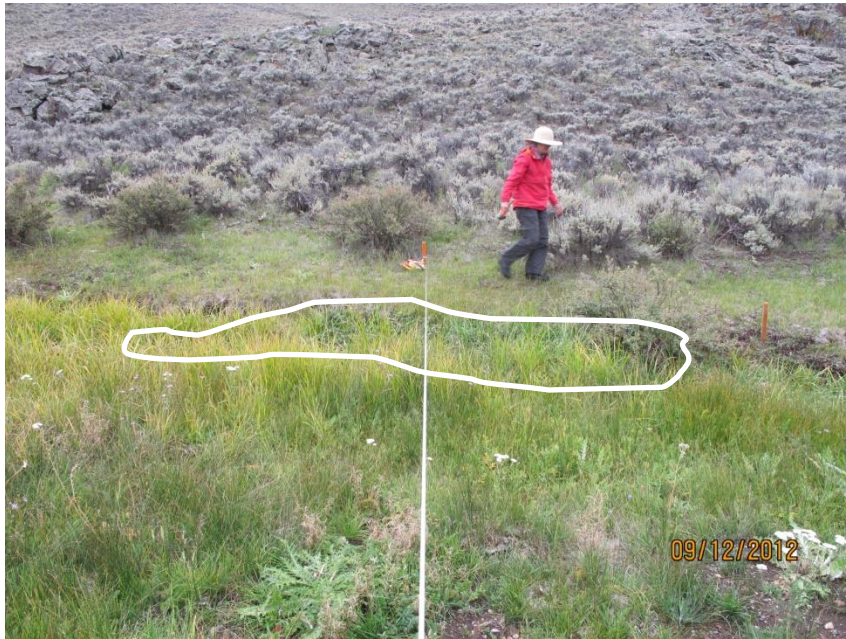
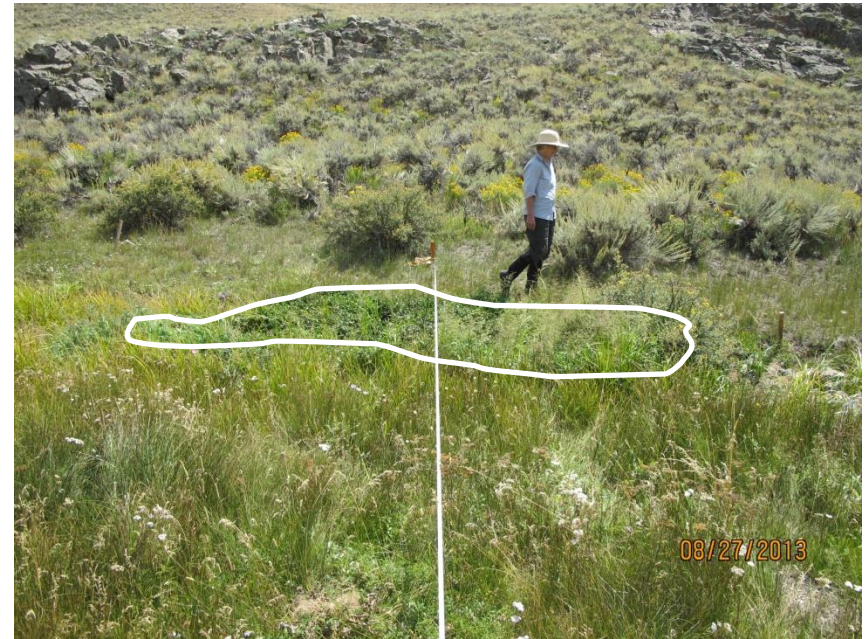
GWT38_0m

The white polygon was dominated by *Carex utriculata* in 2012 (left photo) and by *Veronica* in 2013 (right photo); *Veronica* only occurs in running water hence more water in 2013; **wetland obligates went from 35% in 2012 to 50% in 2013.**

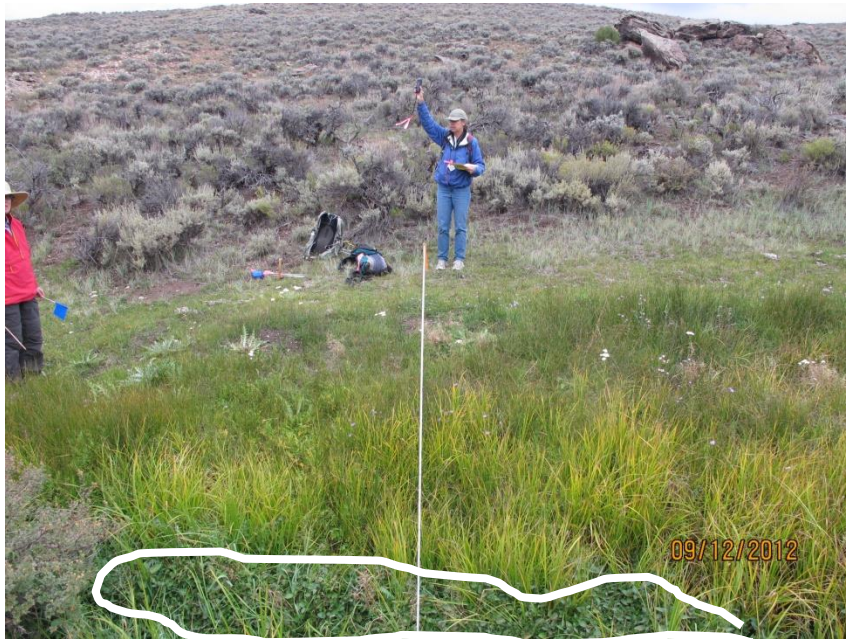
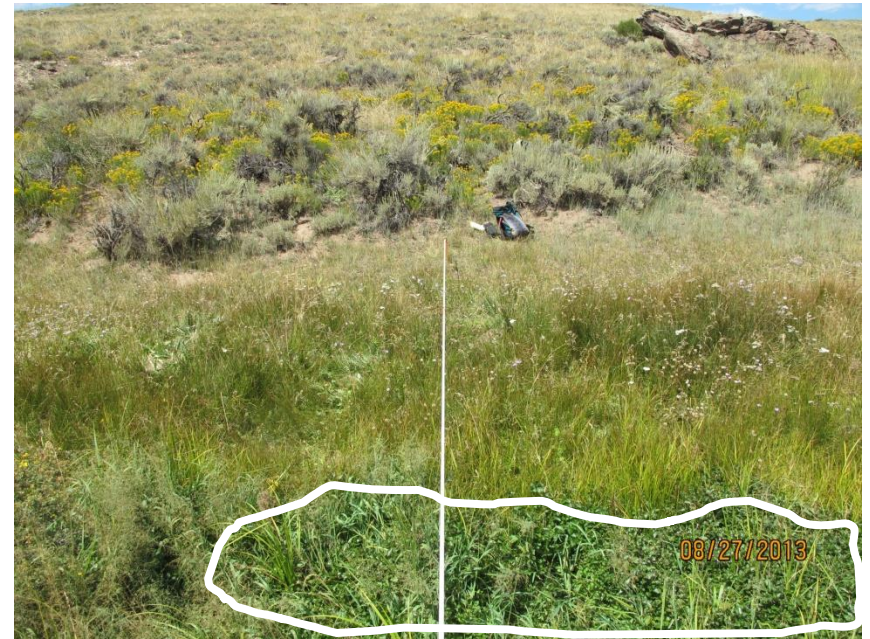
Rock Run Down GWT38_end

*The white polygon denotes the *Veronica wormskadii* area in 2012 (left) vs 2013 (right). At this site, **wetland obligates went from 35% in 2012 to 50% in 2013.***

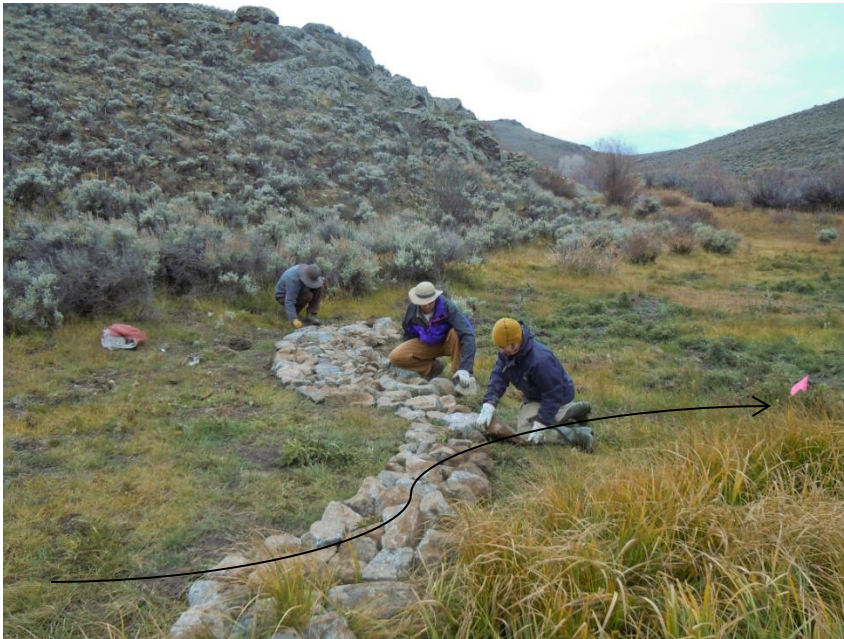
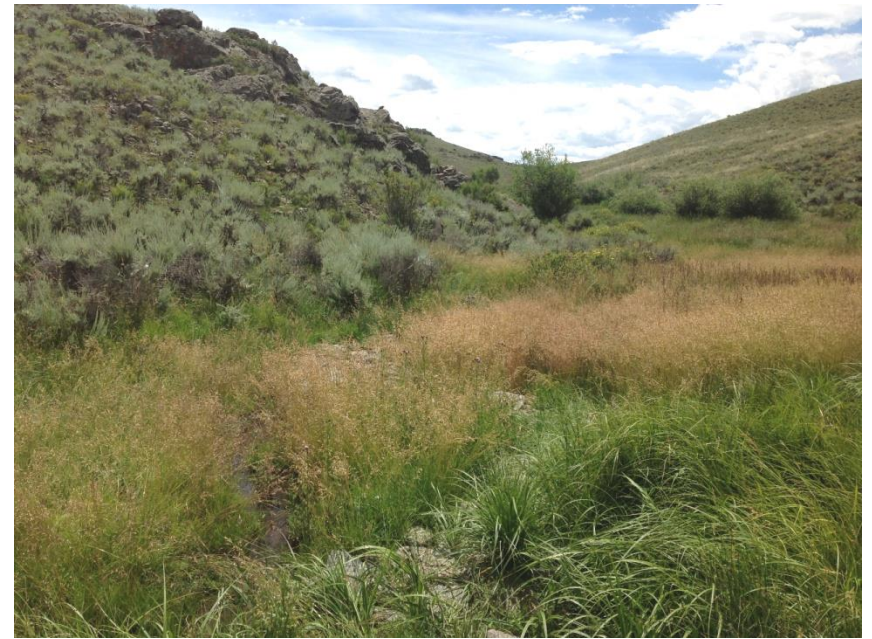
Media Luna 43

The media luna was positioned to spread the water across the meadow. By 2013 the water had significantly spread across the meadow into areas that had once been saturated prior to the stream downcutting.

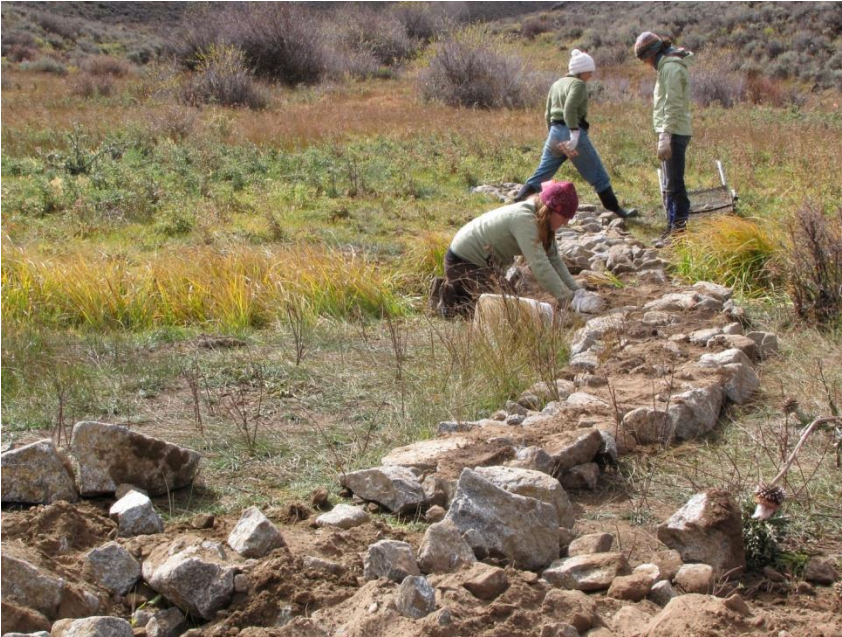
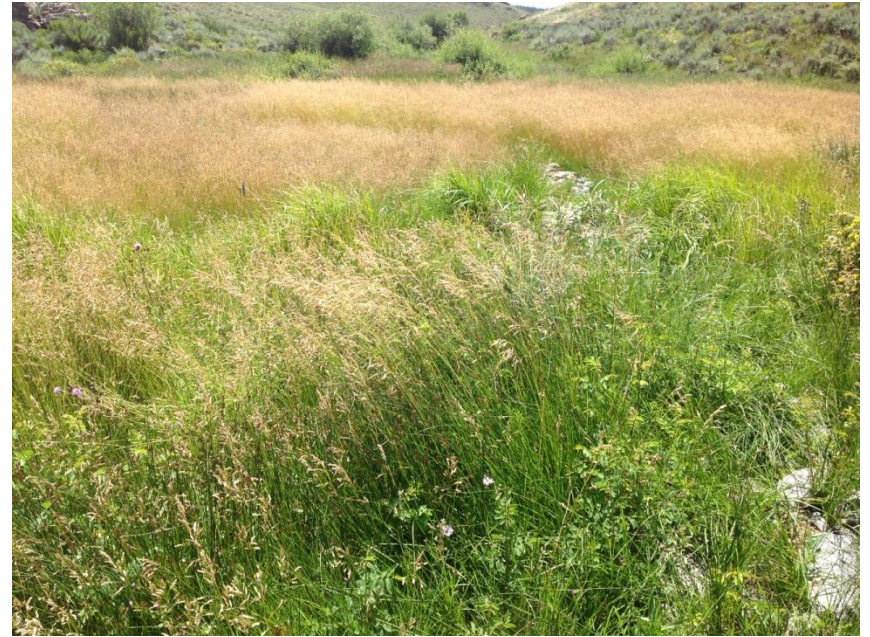
Media Luna, 45

We documented remarkable changes in the cover and height of the vegetation after one year of building the media luna. Species composition will most likely change within the next year or two.

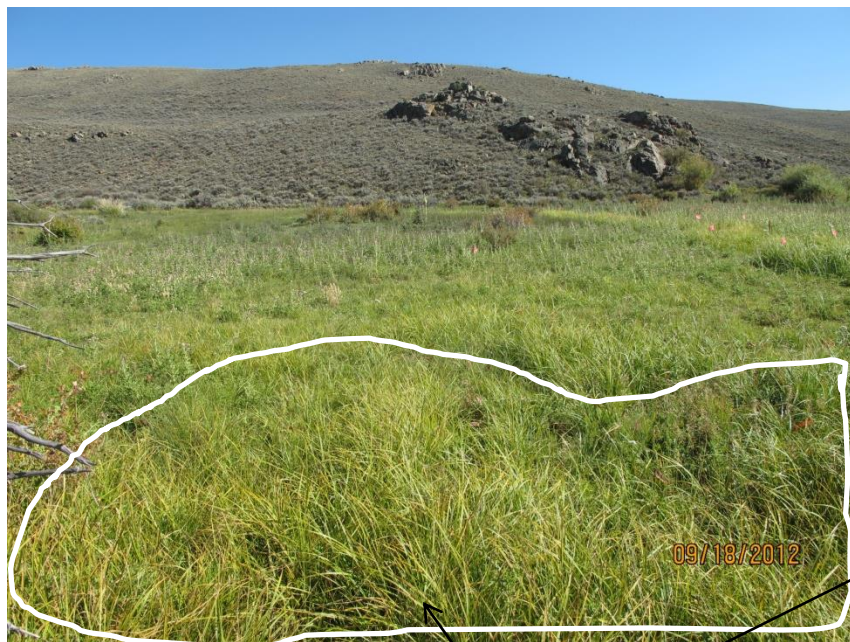
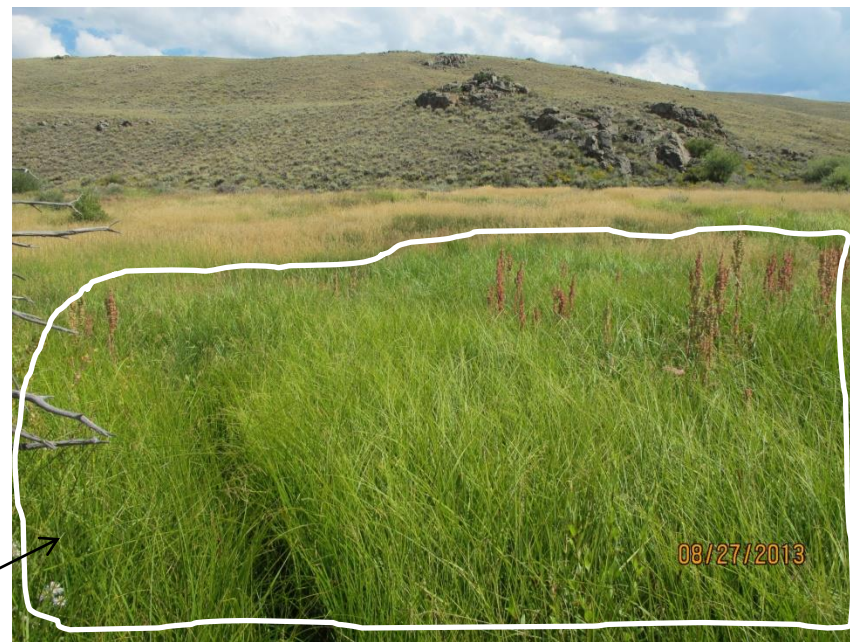
Downstream of two media lunas, GWT46PP_a

Carex utriculata, an obligate wetland species, expanded into new areas after the media luna was established.

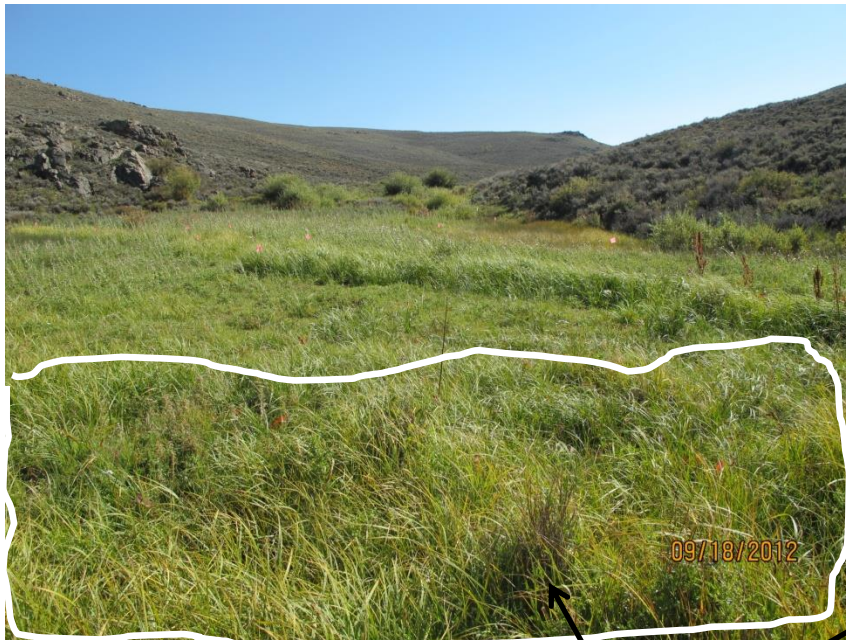
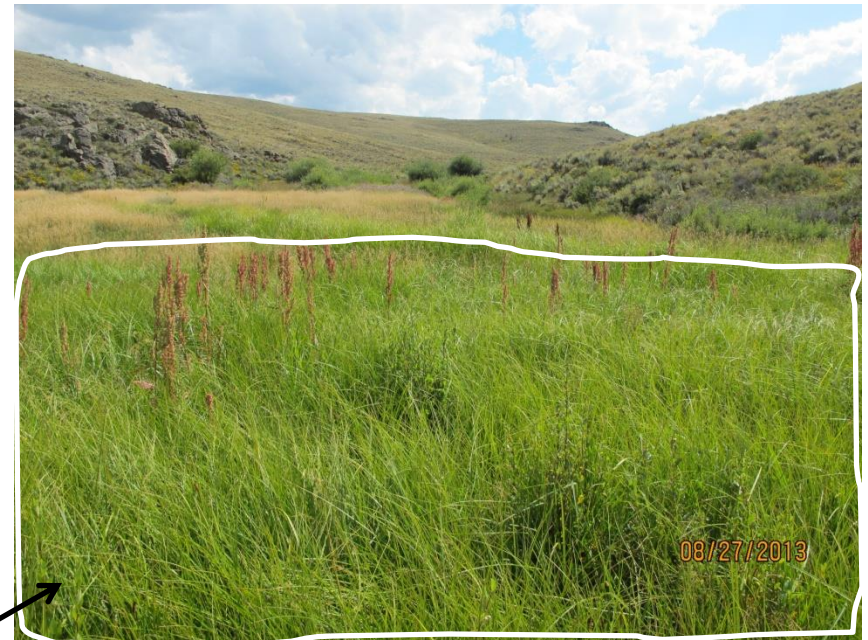
Downstream of two media lunas, GWT46PP_b

Carex utriculata, an obligate wetland species,
expanded in area after the media luna was
established.

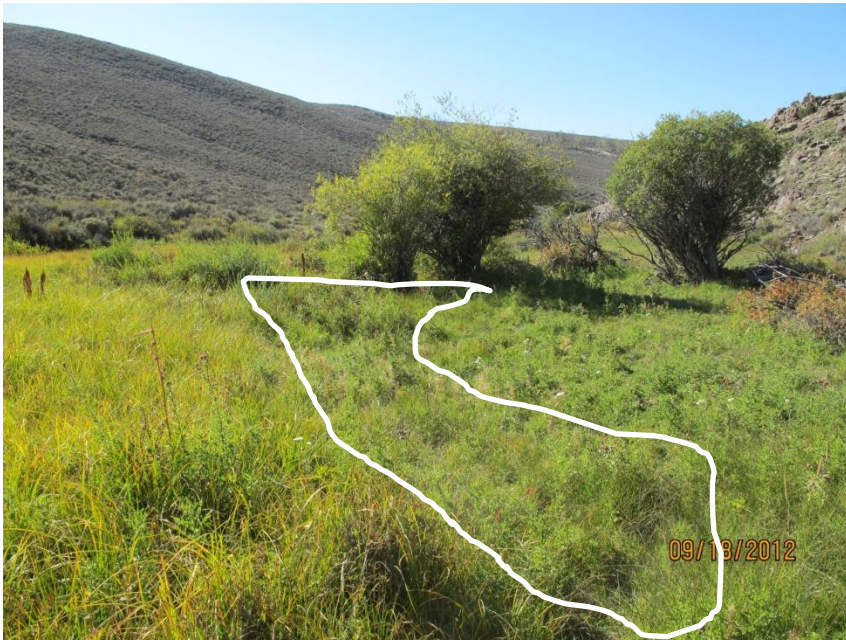
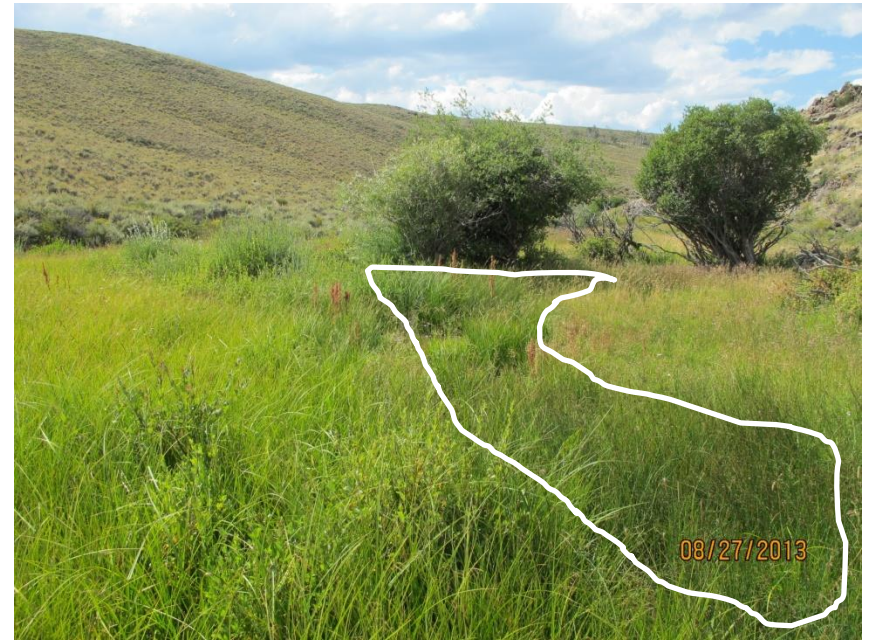
Downstream of two media lunas, GWT46PP_c

In 2012 (left photo) the white polygon was dominated by more xeric species and by 2013, one year after media lunas were established, the area was dominated by *Carex uticulata*, an obligate wetland plant

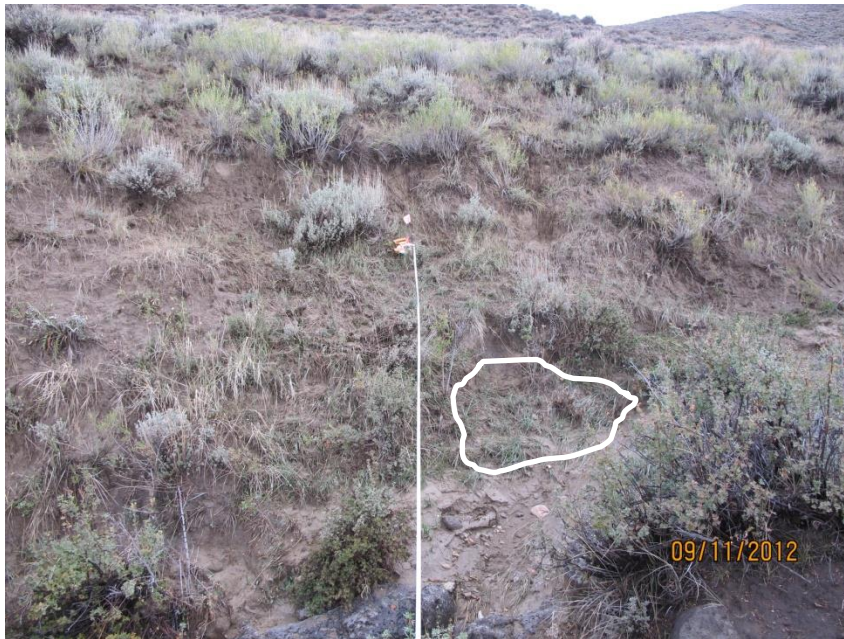
GTC02_0m

54% bare ground, liter or rock in 2012

The area within the white polygon is sparsely vegetated in 2012

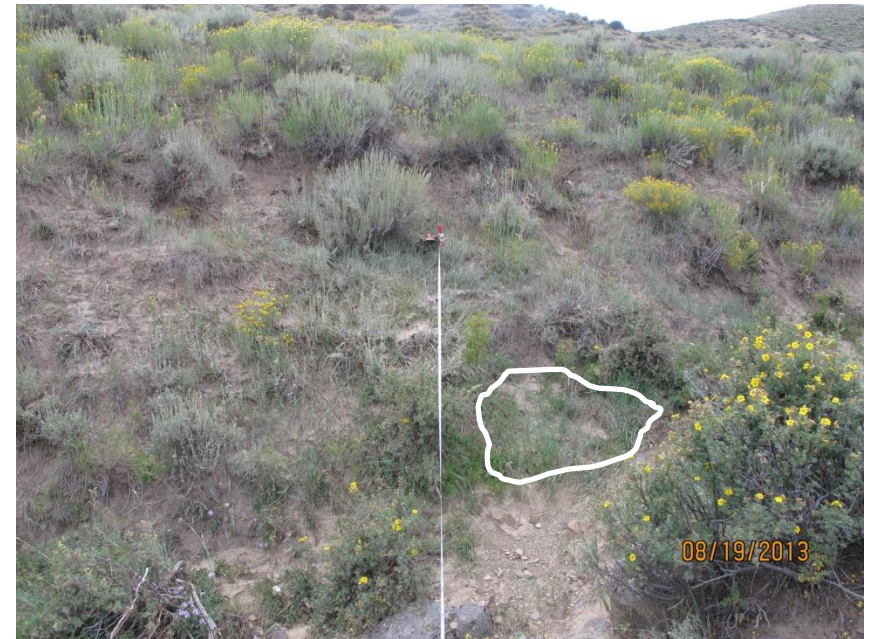
33% bare ground, liter or rock in 2013

The area within the white polygon has more cover in 2013, due to higher rainfall

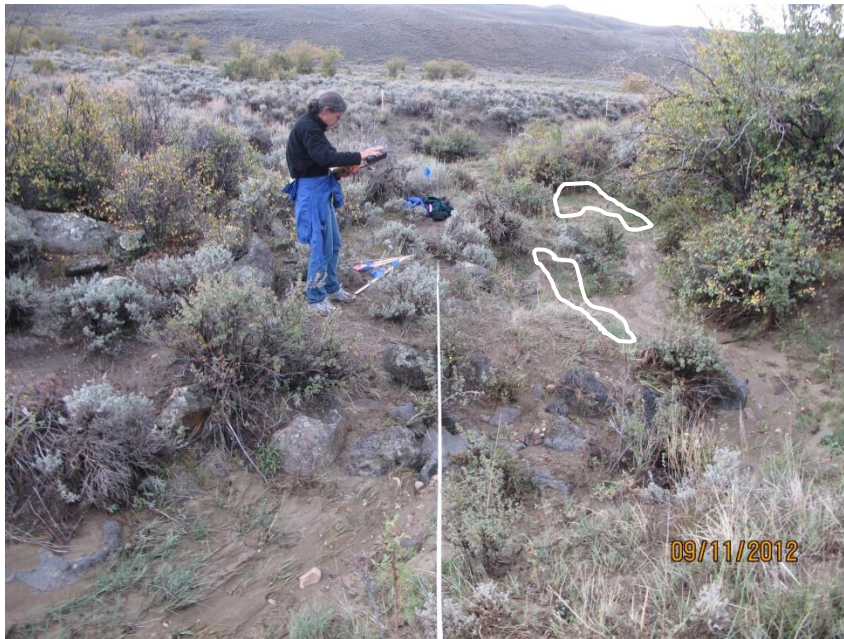
GTC02_end

54% bare ground, liter or rock in 2012

The area within the white polygon was sparsely vegetated in 2012

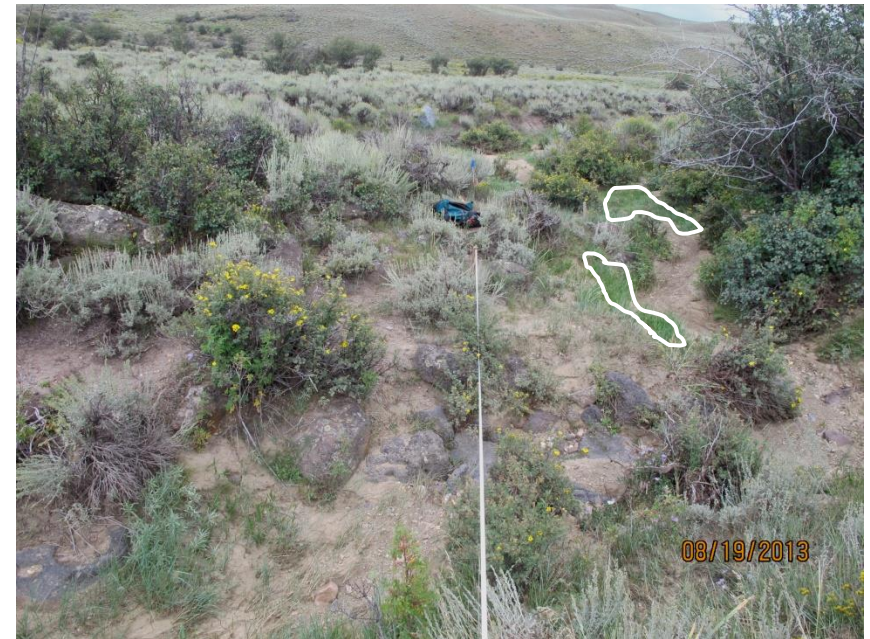
33% bare ground, liter or rock in 2013

The area within the white polygon is more densely vegetated in 2013, due to more rain

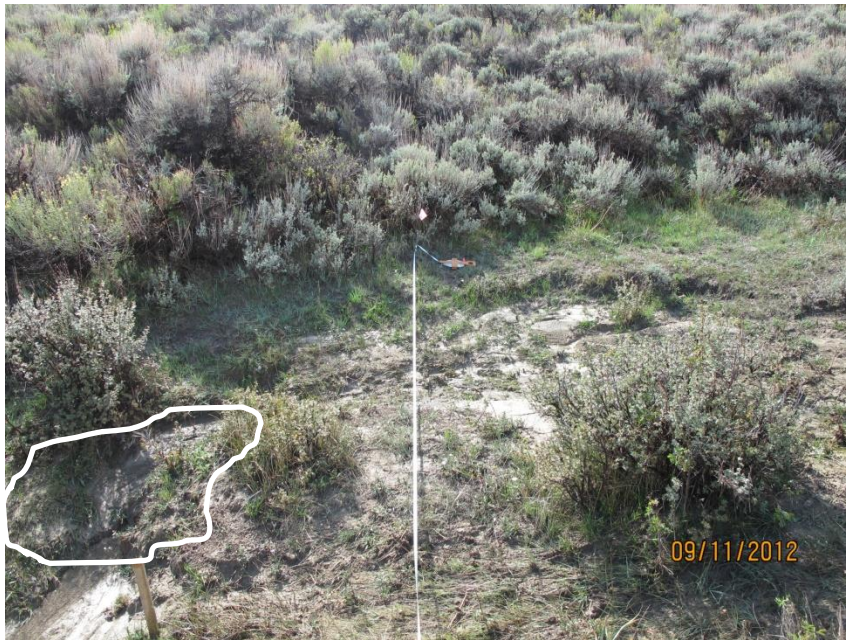
GRT07_0m

The white polygon denotes the area where the one rock dam will be built

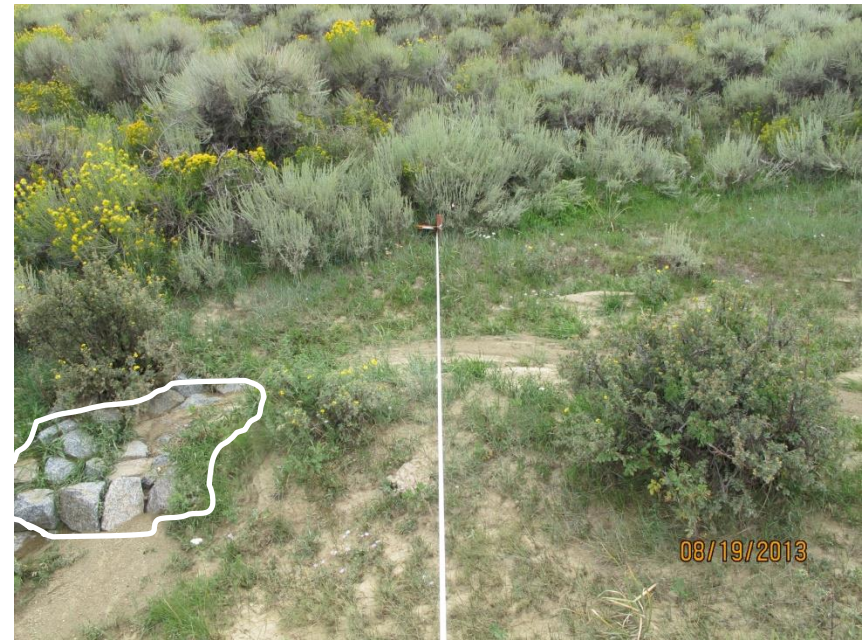
The white polygon represents the area where the one rock dam was built

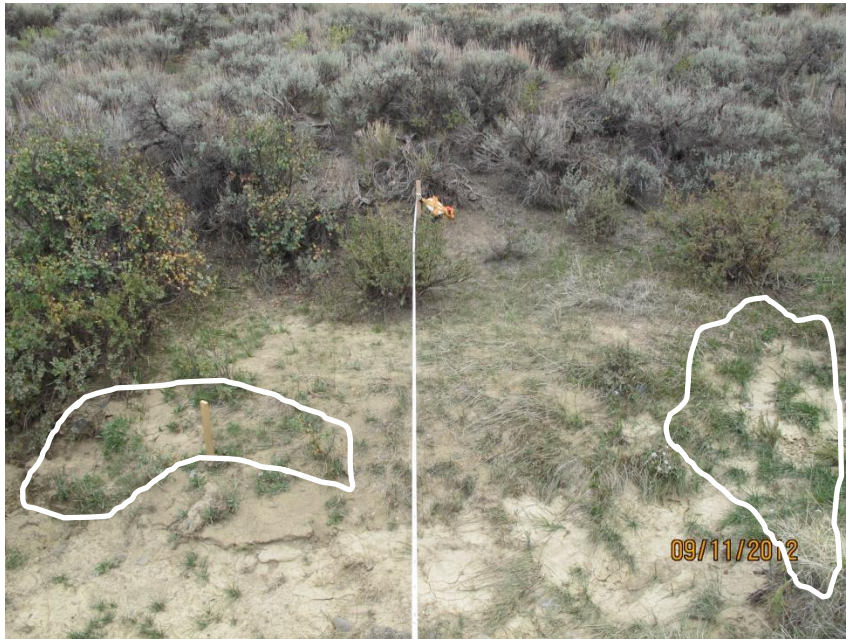
GRT28_0m

The are within the white polygon will be impacted by the one rock dam that was built shortly after this photo was taken

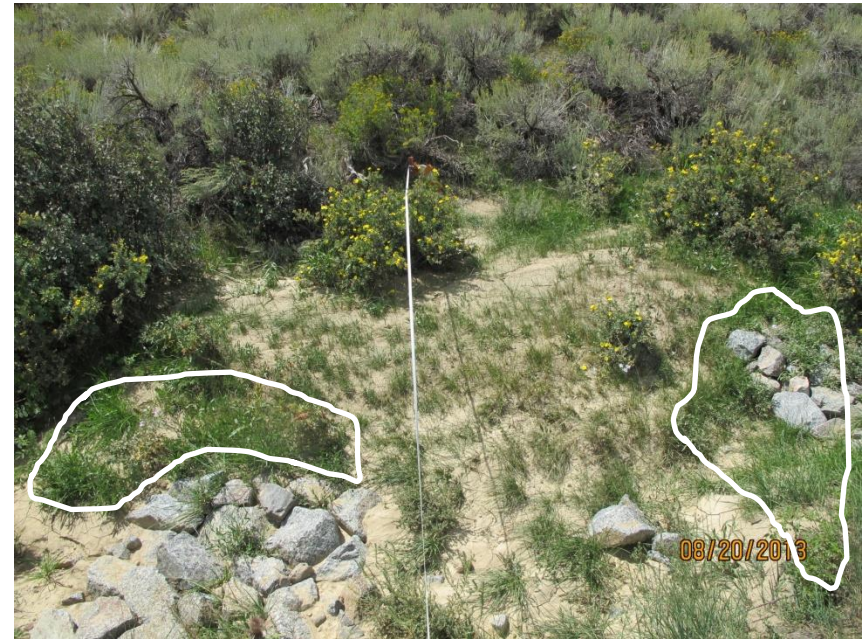
The area within the white polygon was impacted by the one rock dam

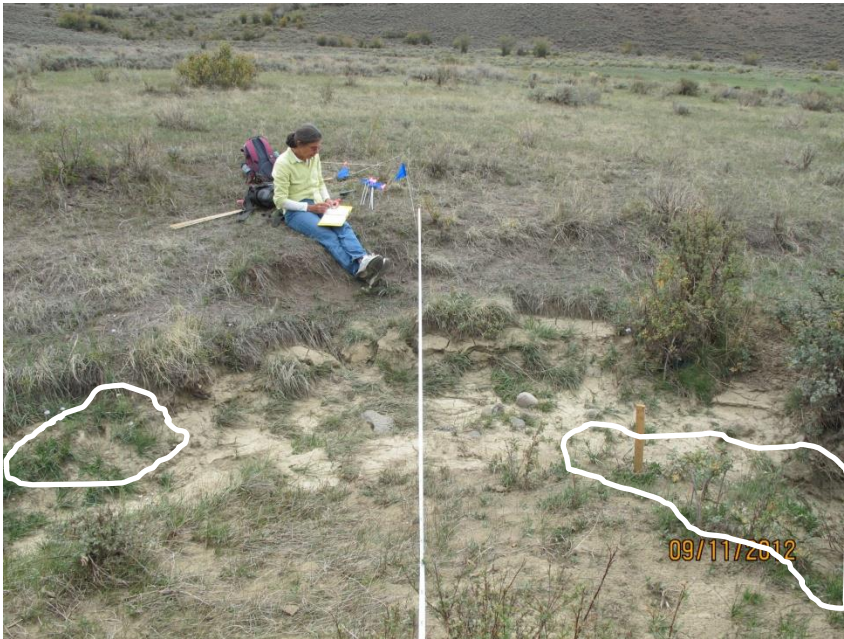
GRT28_end

White polygons denote the area that will be impacted by the one rock dam

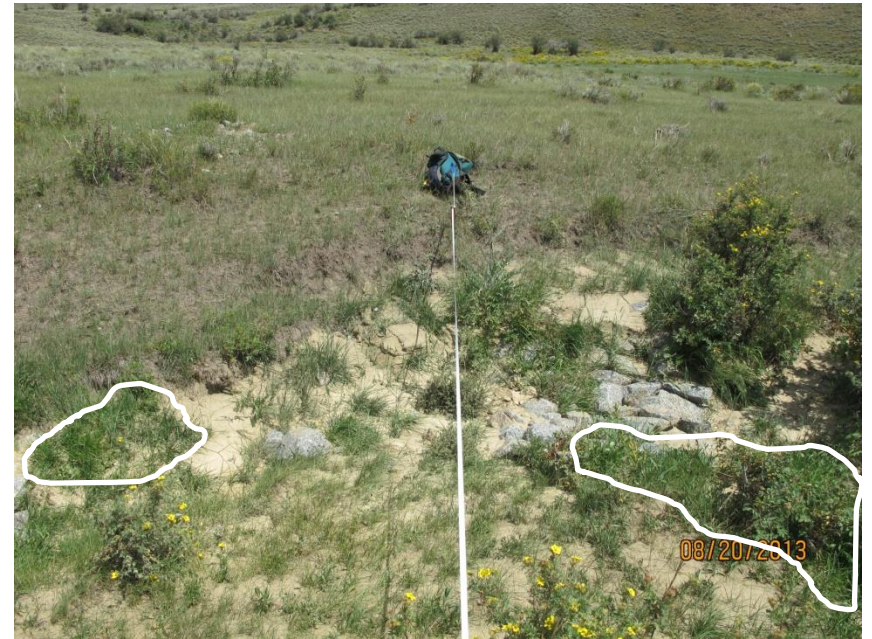
The white polygons denote the area impacted by the one rock dam one year after it was built

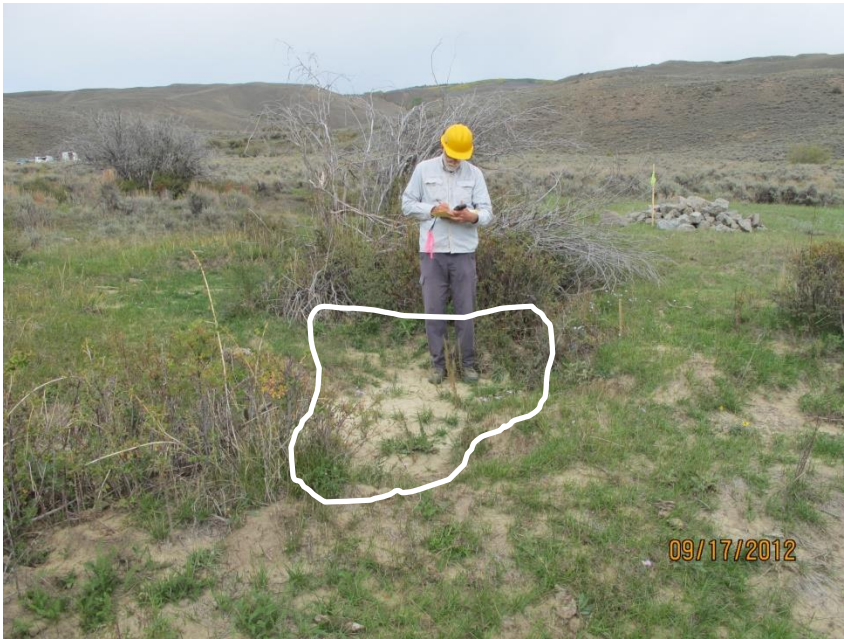
GRT46PP

The white polygon denotes the area where the one rock dam was built shortly after this picture was taken

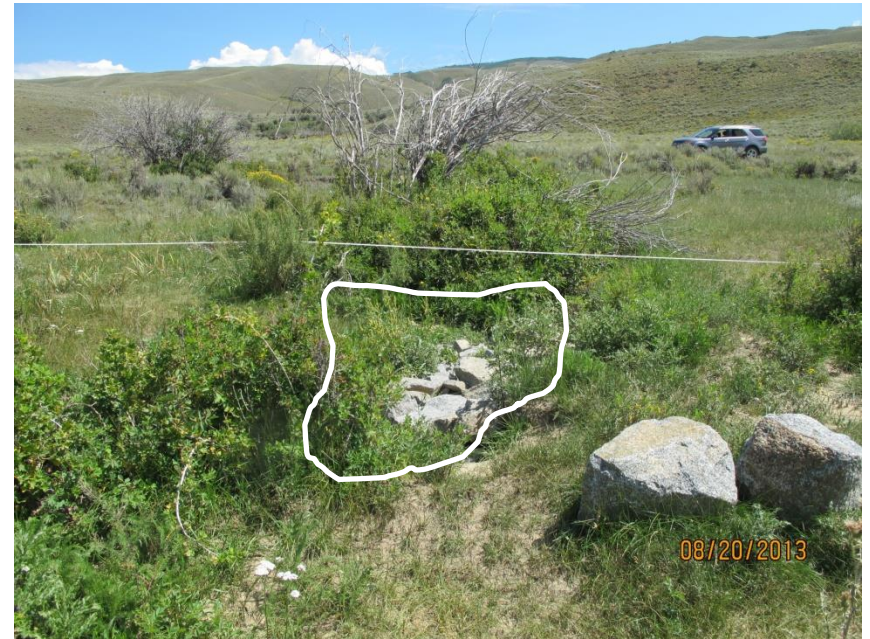
The white polygon denotes the area that was influenced by the one rock dam after one year

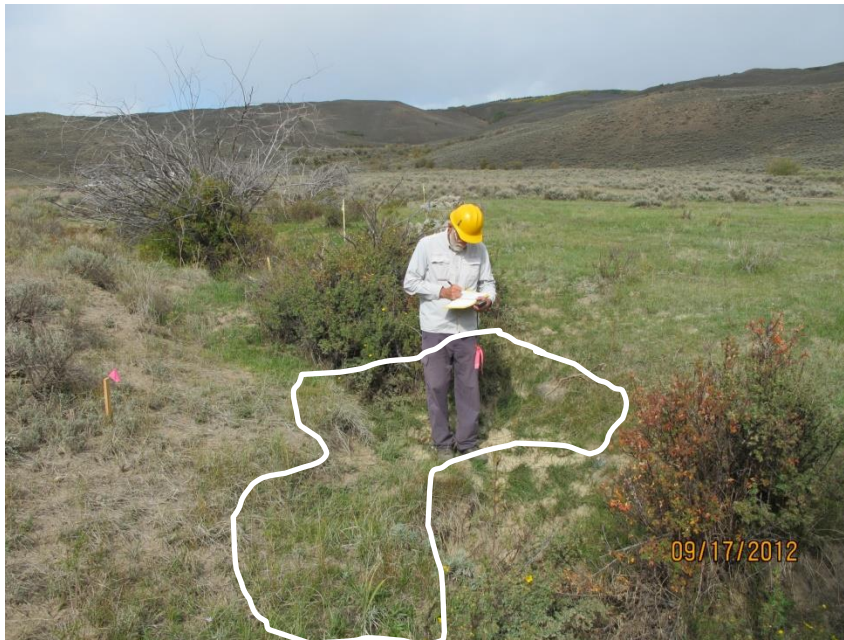
GRT49PP

Bare ground and litter occupied 41% in 2012

The white polygon represents the area that will be impacted by the one rock dam

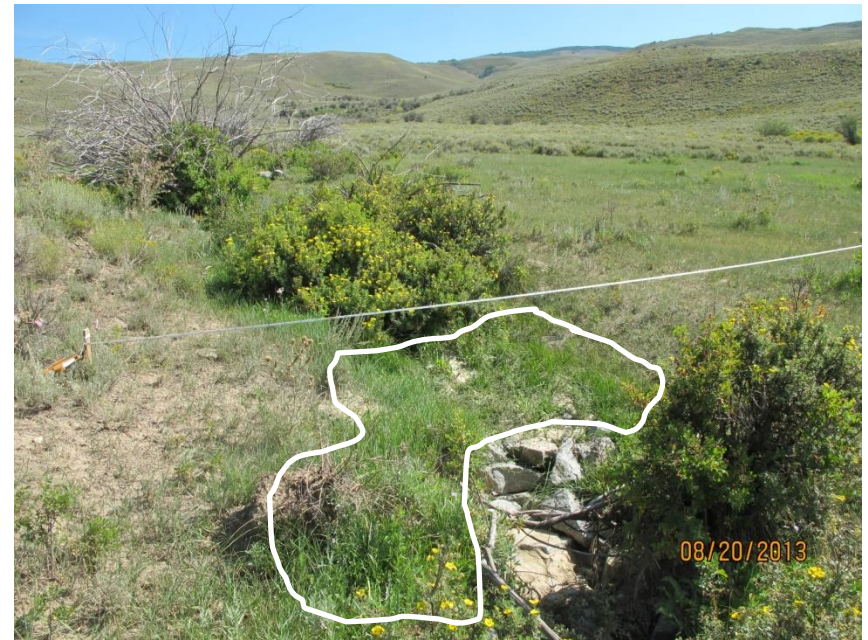
Bare ground and litter occupied 6% in 2013

The white polygon represents the area impacted by the one rock dam after one year

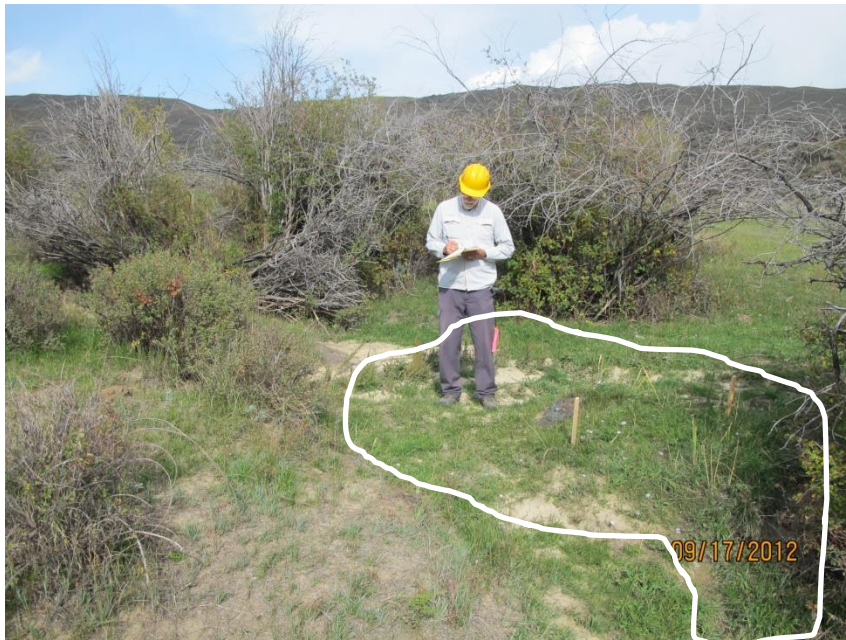
One Rock Dam on Ephemeral Stream GRT53PP

The white polygon outlines the floodplain that the one rock dam will influence.

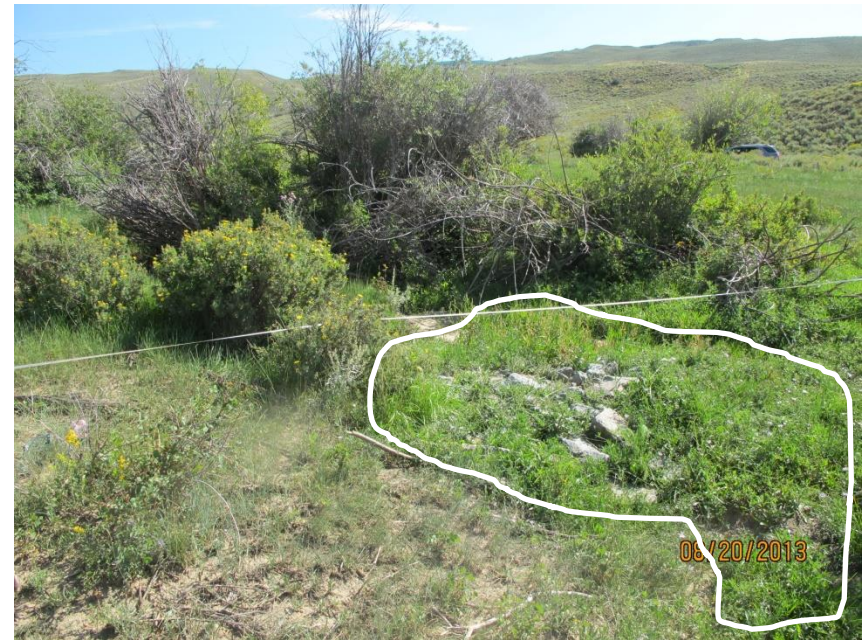
The white polygon outlines the floodplain that the one rock dam influenced after one year.
