Priority Restoration Sites Upper Gunnison Basin

Gunnison Climate Working Group

Wolf Creek Ranch (Private) - East Fork and Middle Fork Upper Gunnison Basin Restoration Structures and Monitoring

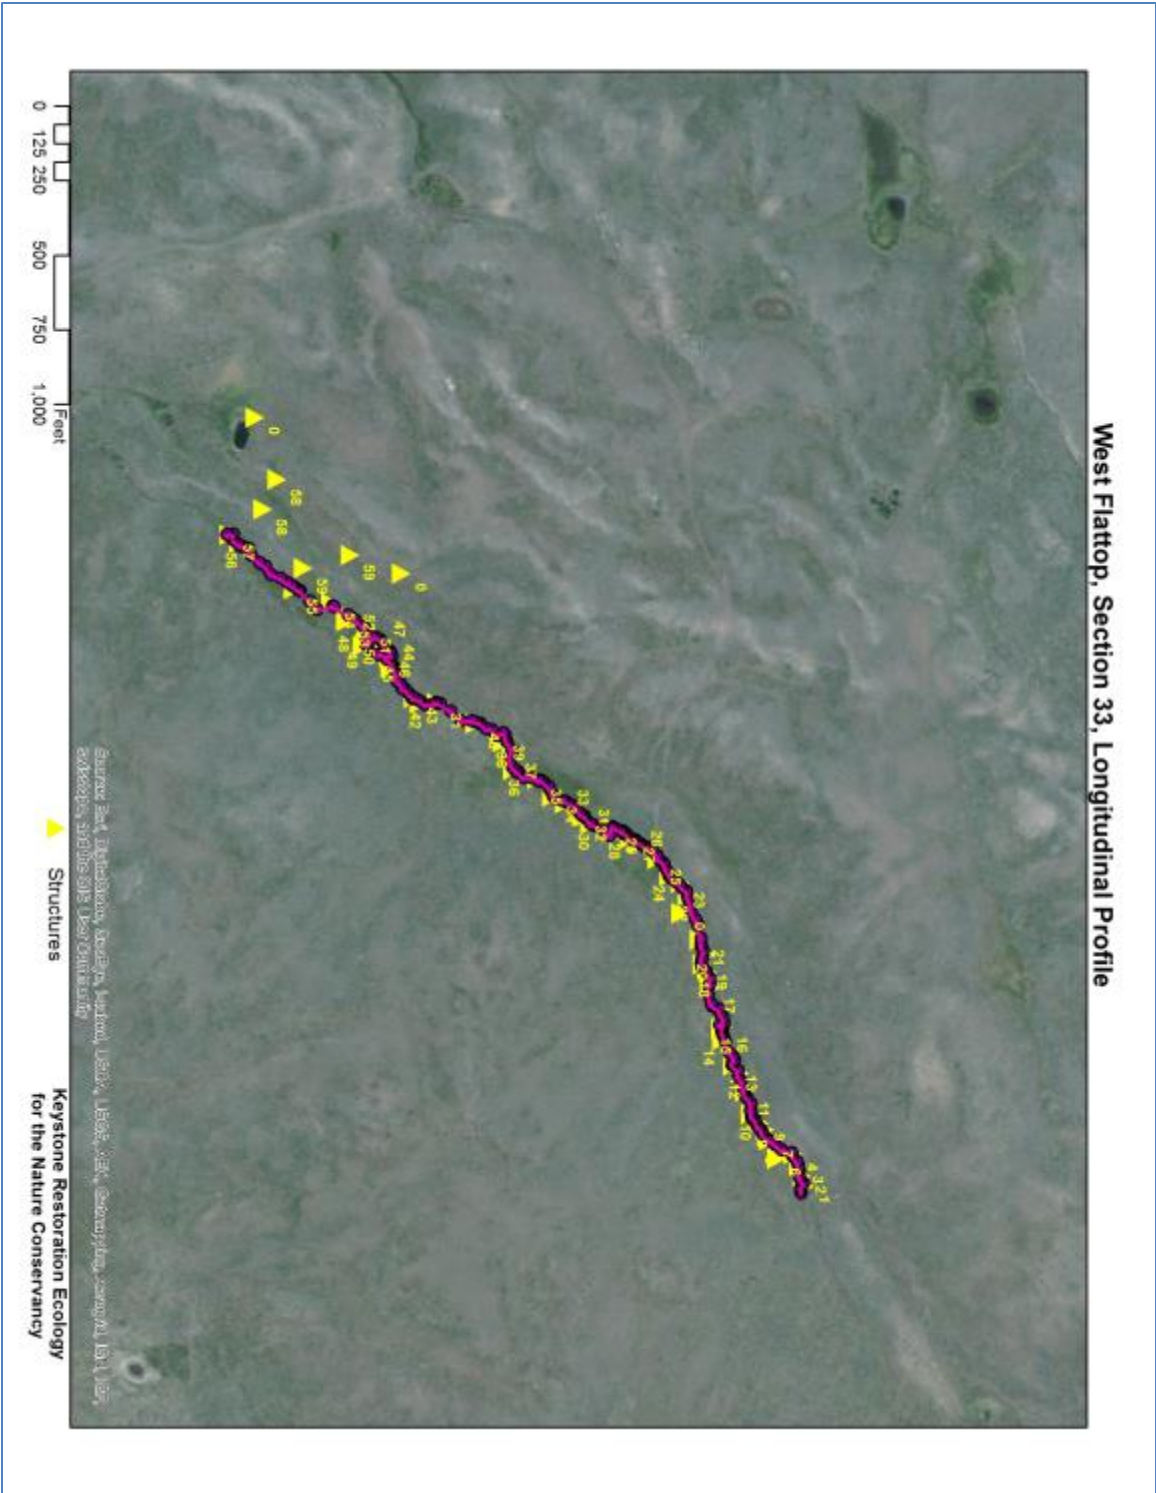
West Flattop, Section 33, Longitudinal Profile

West Flat Top, Section 33: A longitudinal profile was taken of 2700 feet of the channel at the Section 33 restoration site. This small channel runs along Henkel Road, the access road to the site, and is relatively narrow and steep with a 5% slope. Structures such as one rock dams and rock rundowns were used to raise the grade of the channel and re-irrigate the narrow floodplain.

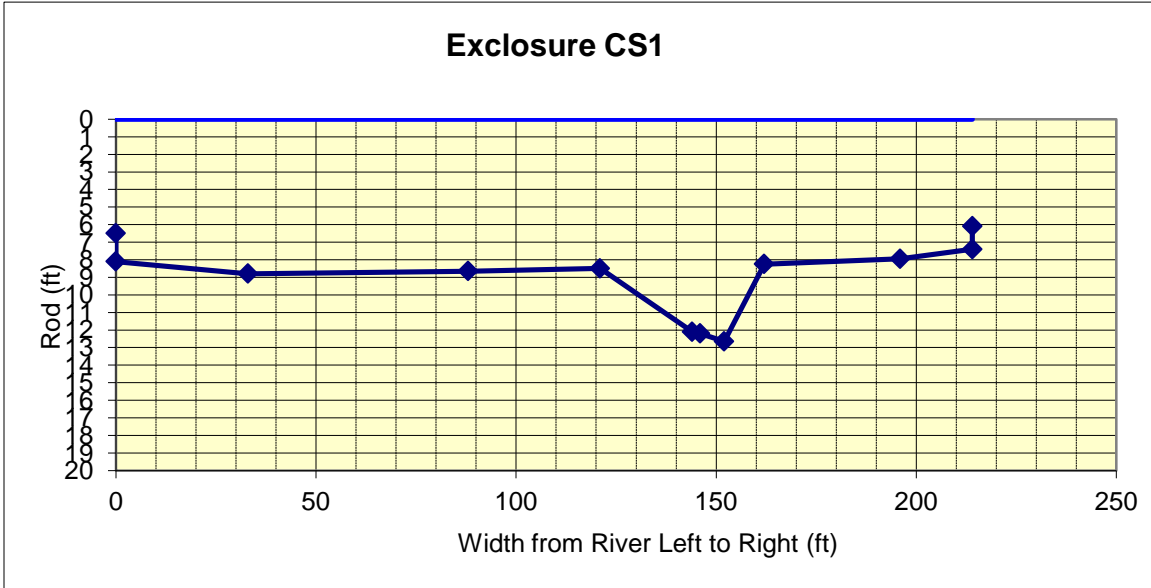
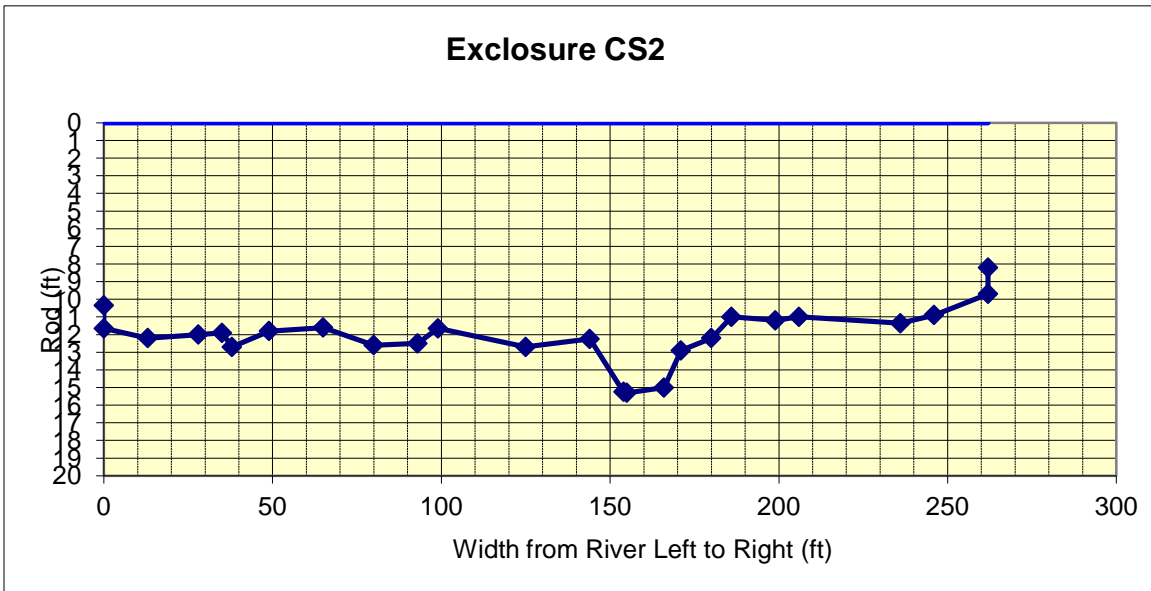
A small exclosure fence that has been in place for decades was the location of another set of rock restoration structures. The exclosure site is deeply gullied, and because of this, two baffles were used to erode a steep bank and create floodplain at the new, gullied elevation of the channel. The cross sections show that the channel was once to the east side of the present gully, and this was a wet meadow or wetland.

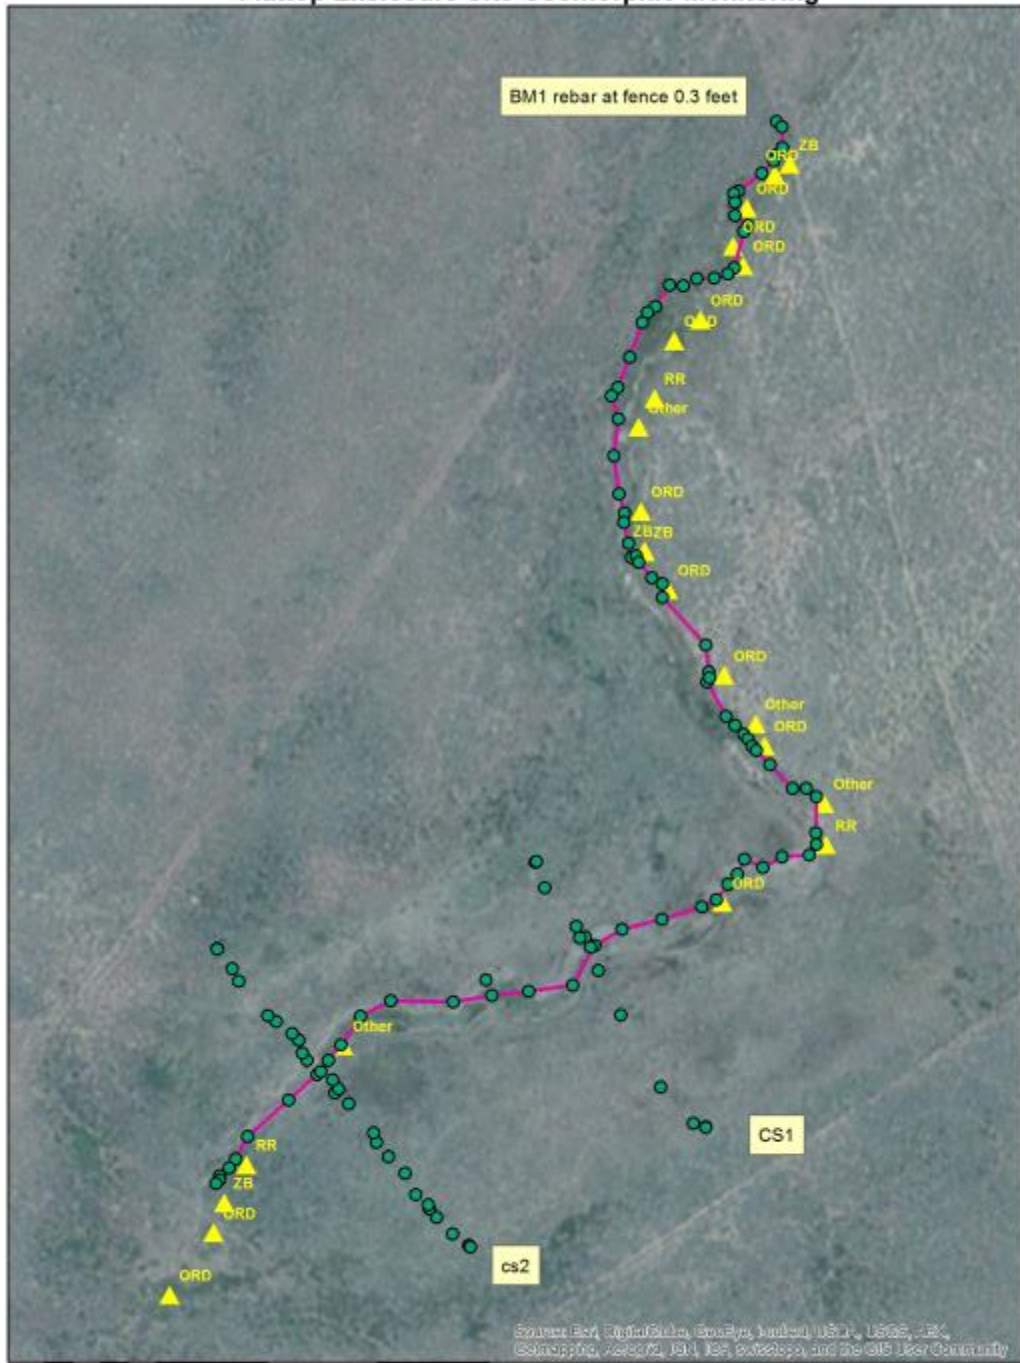
Flattop Enclosure Site Geomorphic Monitoring

The longitudinal profile of the exclosure from fence line to fence line along the channel.

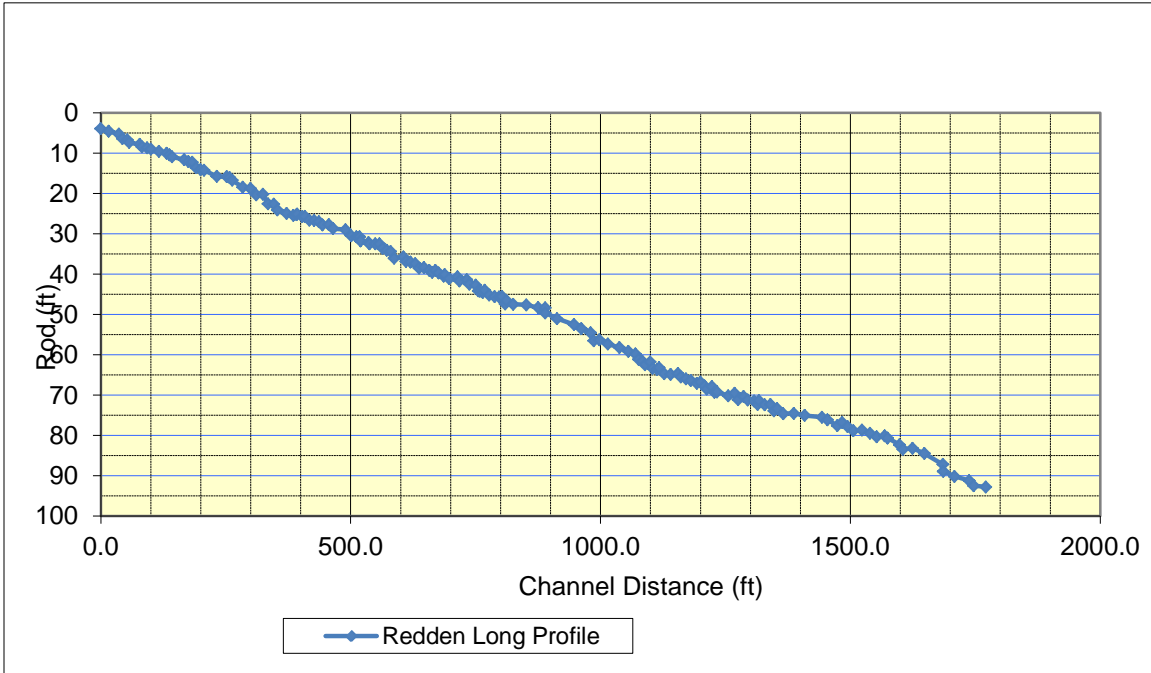
Keystone Restoration Ecology surveyed a longitudinal profile and cross sections at the Redden Ranch, below West Flat Top. The upper portion of the channel had already filled in behind the one rock dams installed in 2012 with sediment from gullied slopes uphill. This erosion, while damaging to the hill slope, is repairing a much more productive wet meadow by providing the necessary sediment to fill in the channel. The channel was surveyed by KRE for 1700 feet and has a 5.3% channel slope.

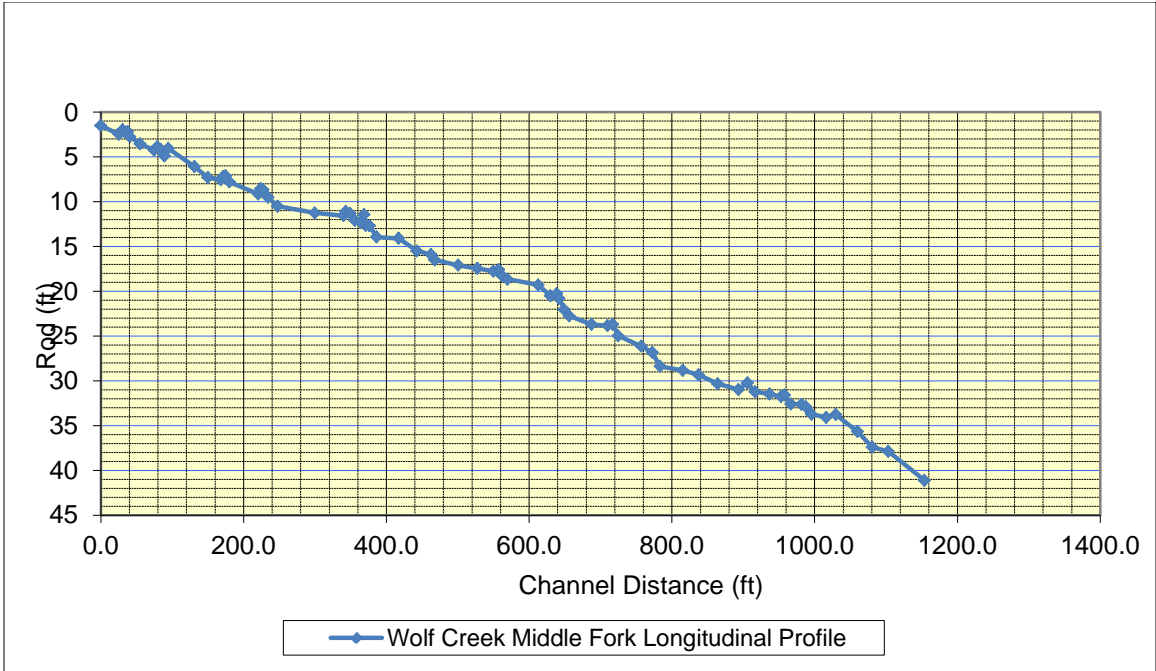
This profile shows the locations of many of the structures as “high points” in the profile. This profile is the tributary channel beginning at the road and running downstream to wide valley with the spring, where the Middle Fork begins.

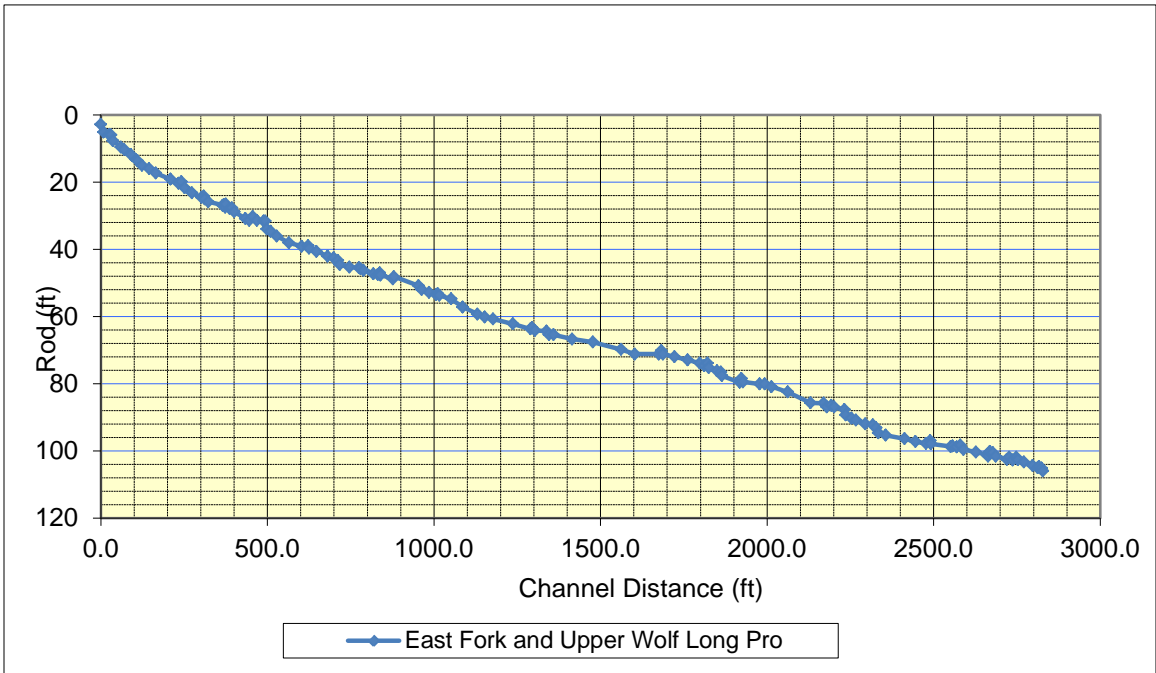
This profile starts at the spring at station 0, the wetland at the confluence runs from about 1000 to 1300. The culverted crossing is at 1350, where the Upper Wolf Reach begins, and runs downstream to the beginning of Lower Wolf Reach.

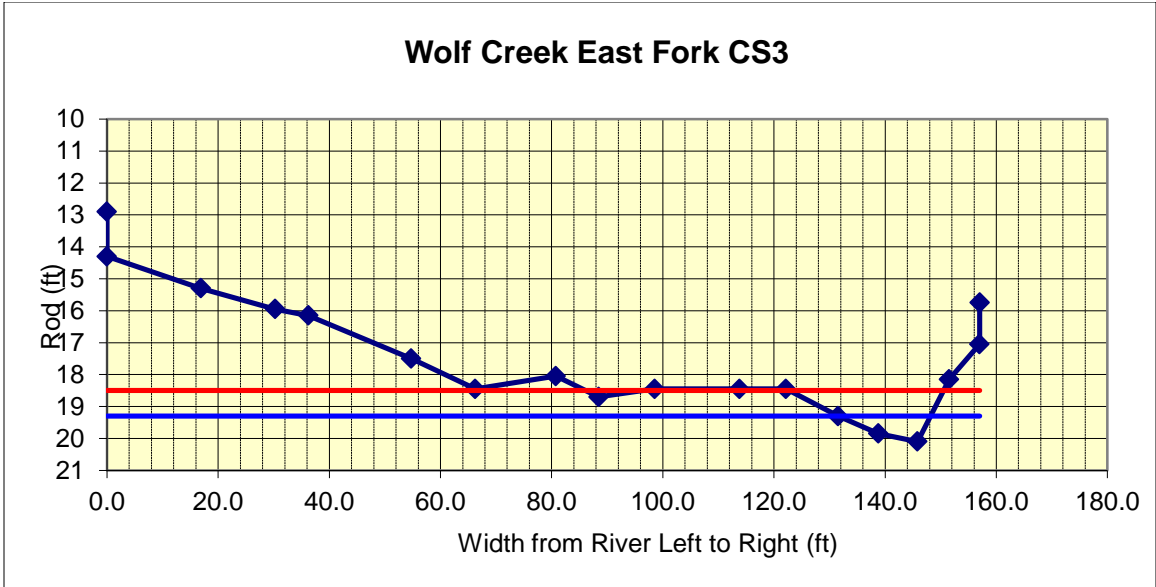
This cross section was taken at the end of the “spring valley”, showing several channels which could contain the flow from the spring. Presently, the spring is flowing at station 150 on the cross section, in the lowest elevation channel.

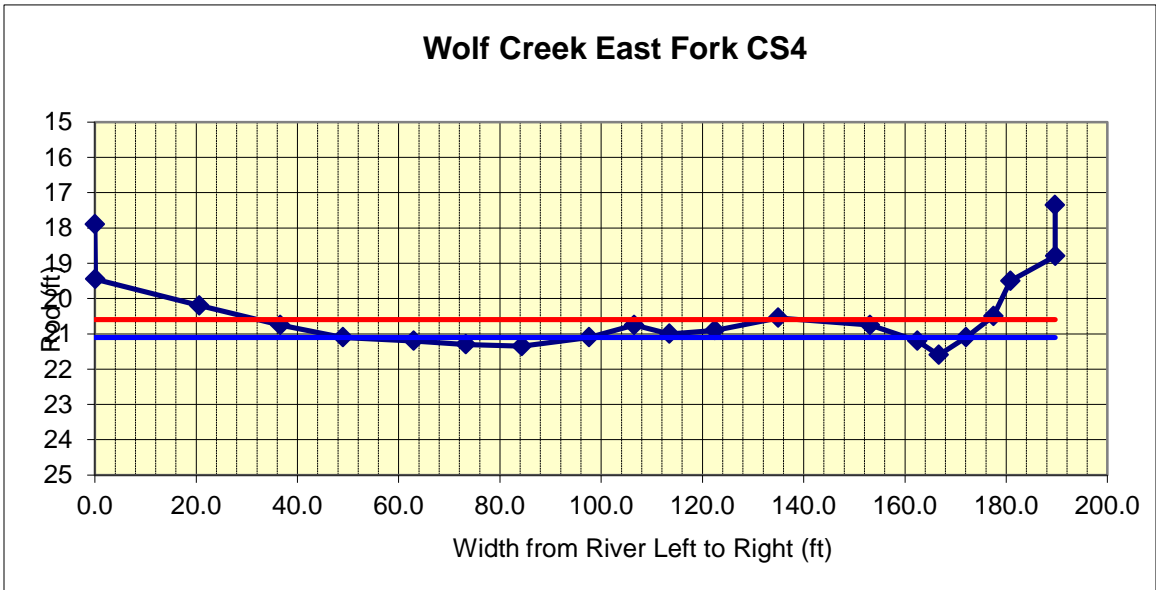
This cross section was taken near the confluence with Upper Wolf Creek, where the water spreads across the wetland. The water has spread throughout this cross section after the work was done in 2012. There is water in channels from station 60 to station 170.

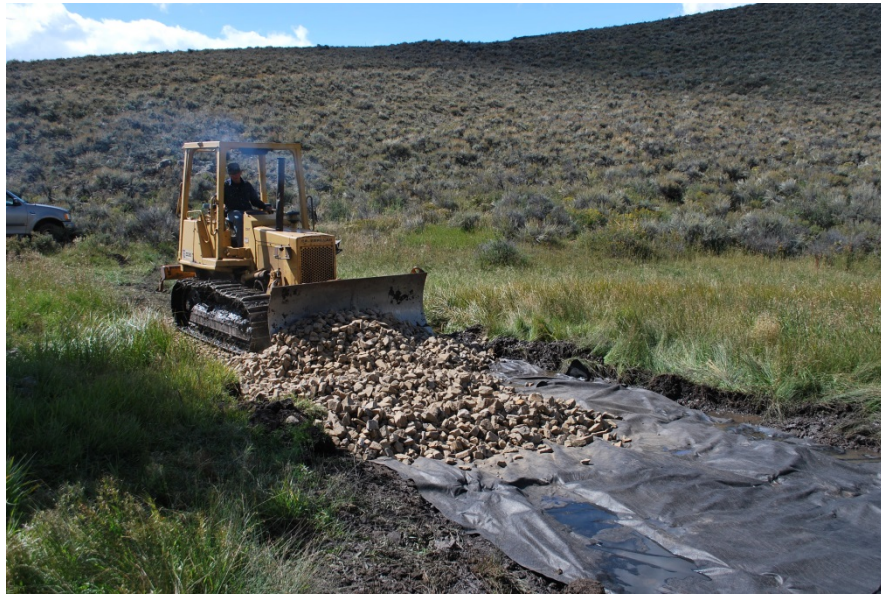
Building low water crossing on Wolf Creek Ranch

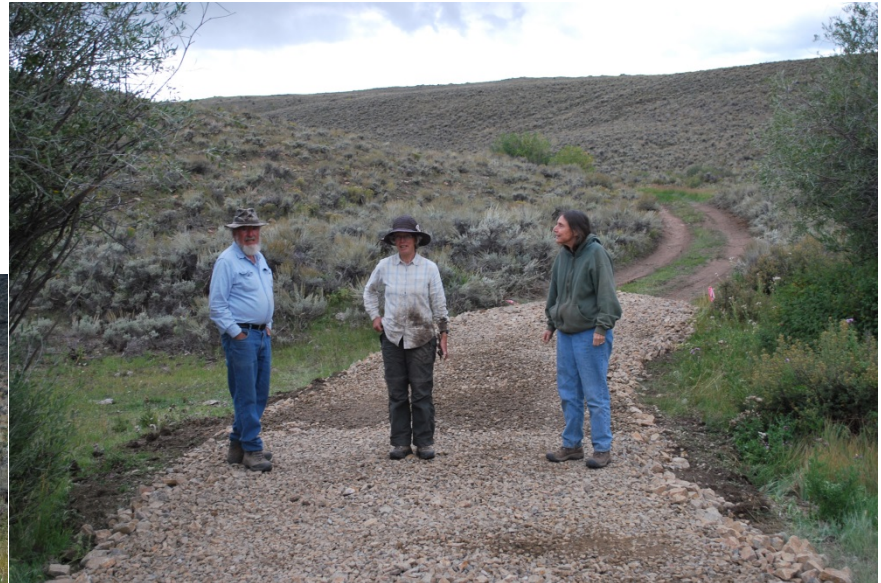
Completed low water crossing at West Fork, Wolf Creek on BLM lands

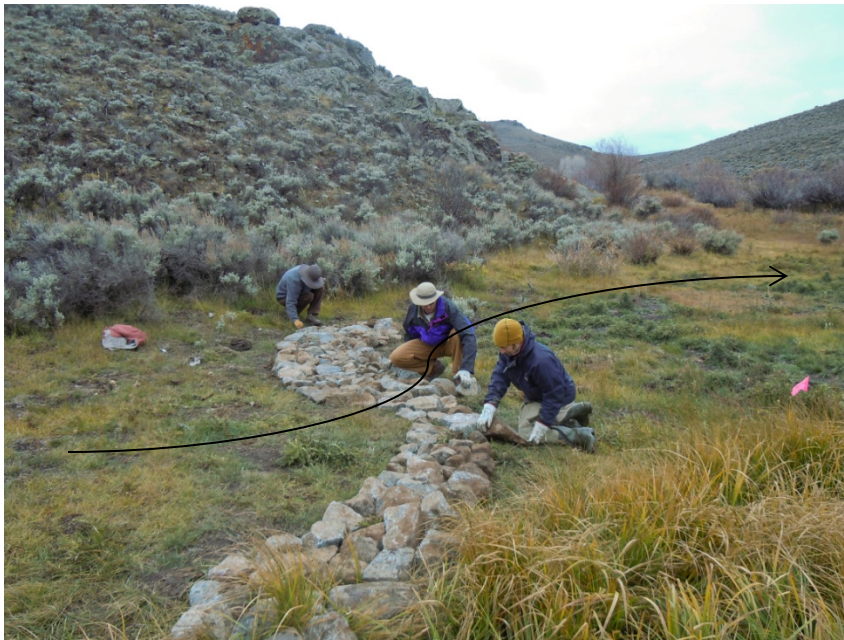
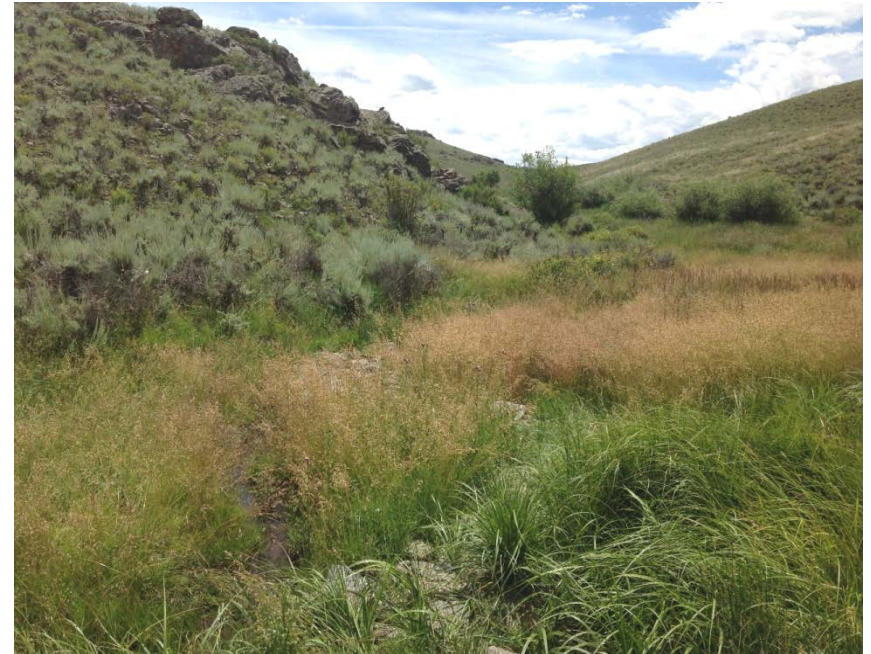
Wolf Creek Ranch Media Luna #43: Left: during construction in Oct. 2012 Right: 10 months later in Aug. 2013

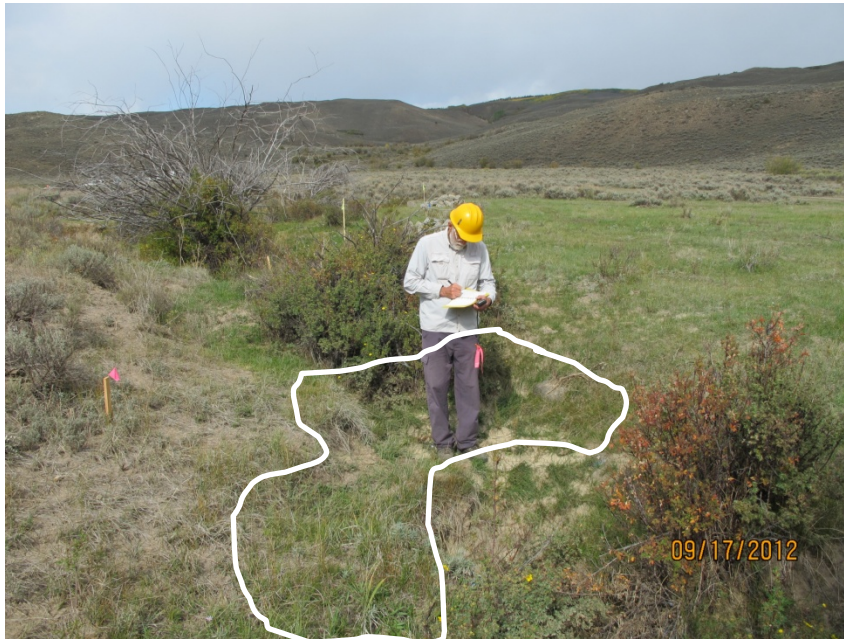
One Rock Dam on Ephemeral Stream

Bare ground and litter occupied 41% in 2012

The white polygon represents the area that will be impacted by the one rock dam

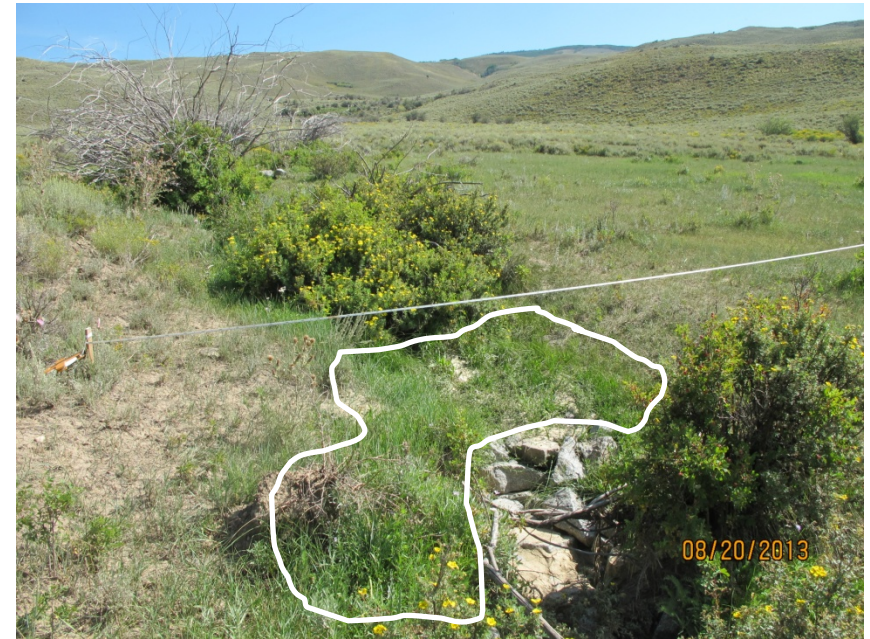
Bare ground and litter occupied 6% in 2013

The white polygon represents the area impacted by the one rock dam after one year
