Monitoring Result and Project Update

Large Wood Habitat Enhancement and
Stream Bank Stabilization Sites
Soquel Demonstration State Forest

Cheryl Hayhurst, P.G.
California Geological Survey

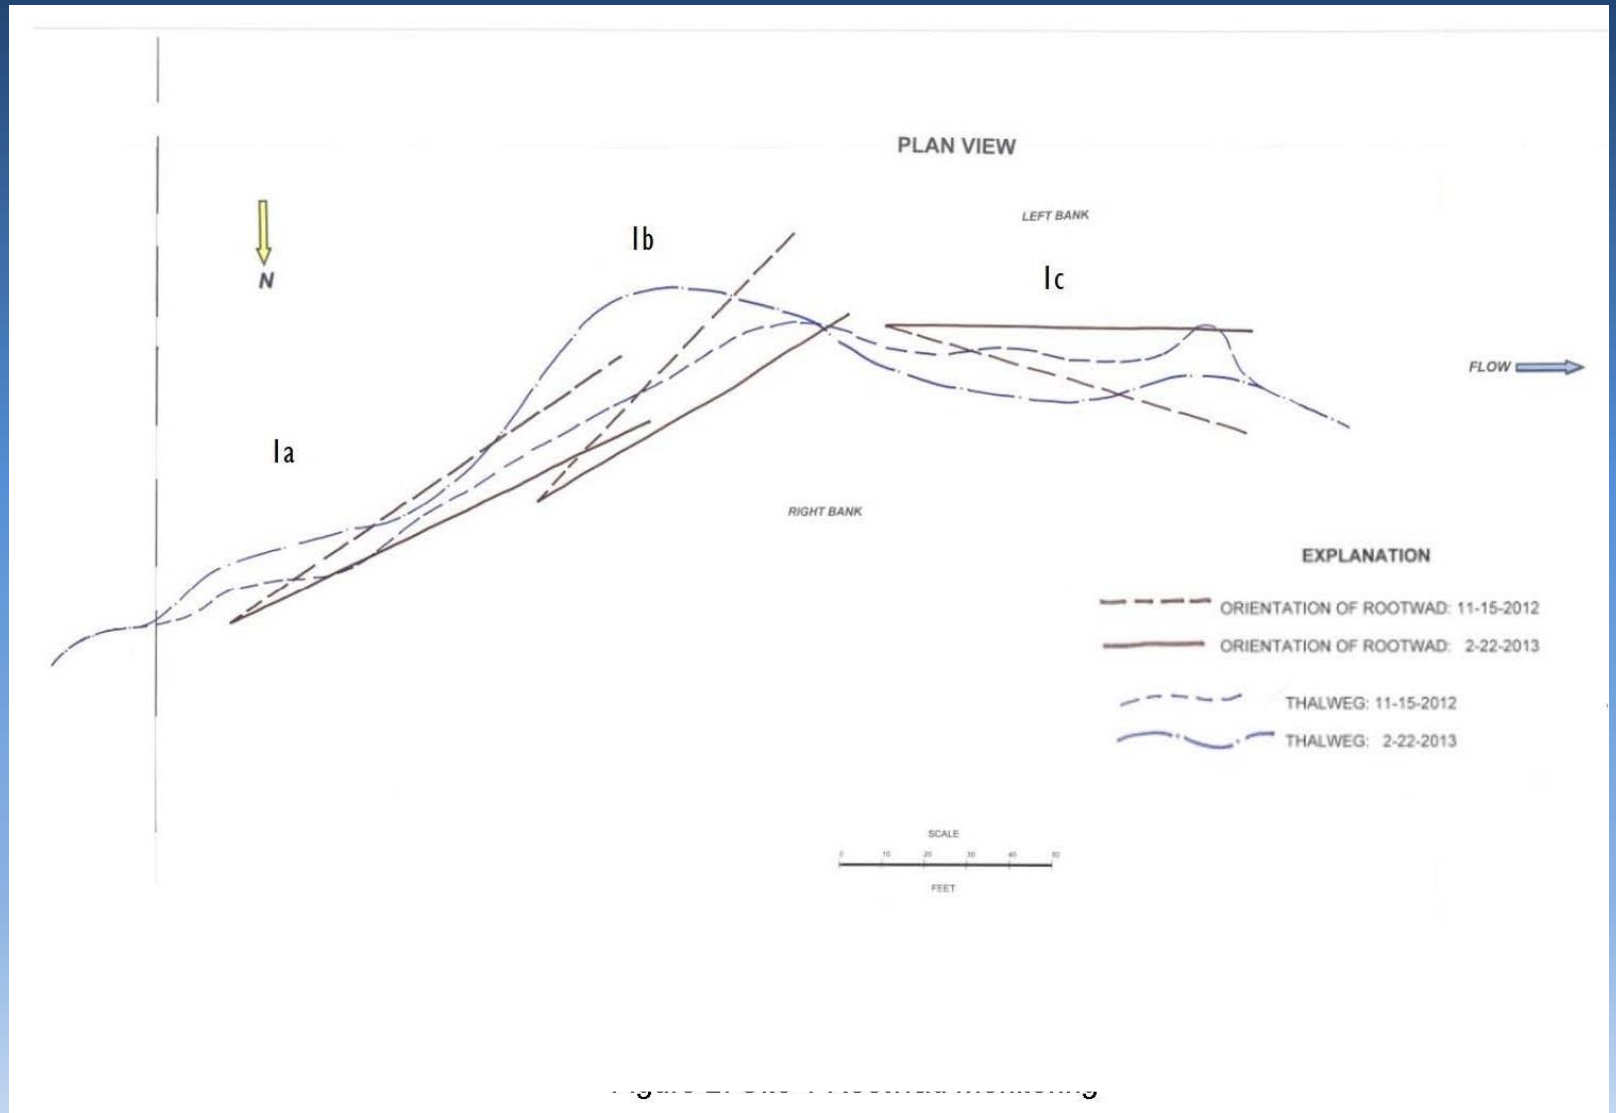
Site 1: Rootwad Monitoring

- Incipient pools (depth < 1 foot) increased from 1 to 5
- Pools (depth > 1 foot) increased from 0 to 2
- Channel appears to have locally aggraded approximately 1 ½ feet through project reach

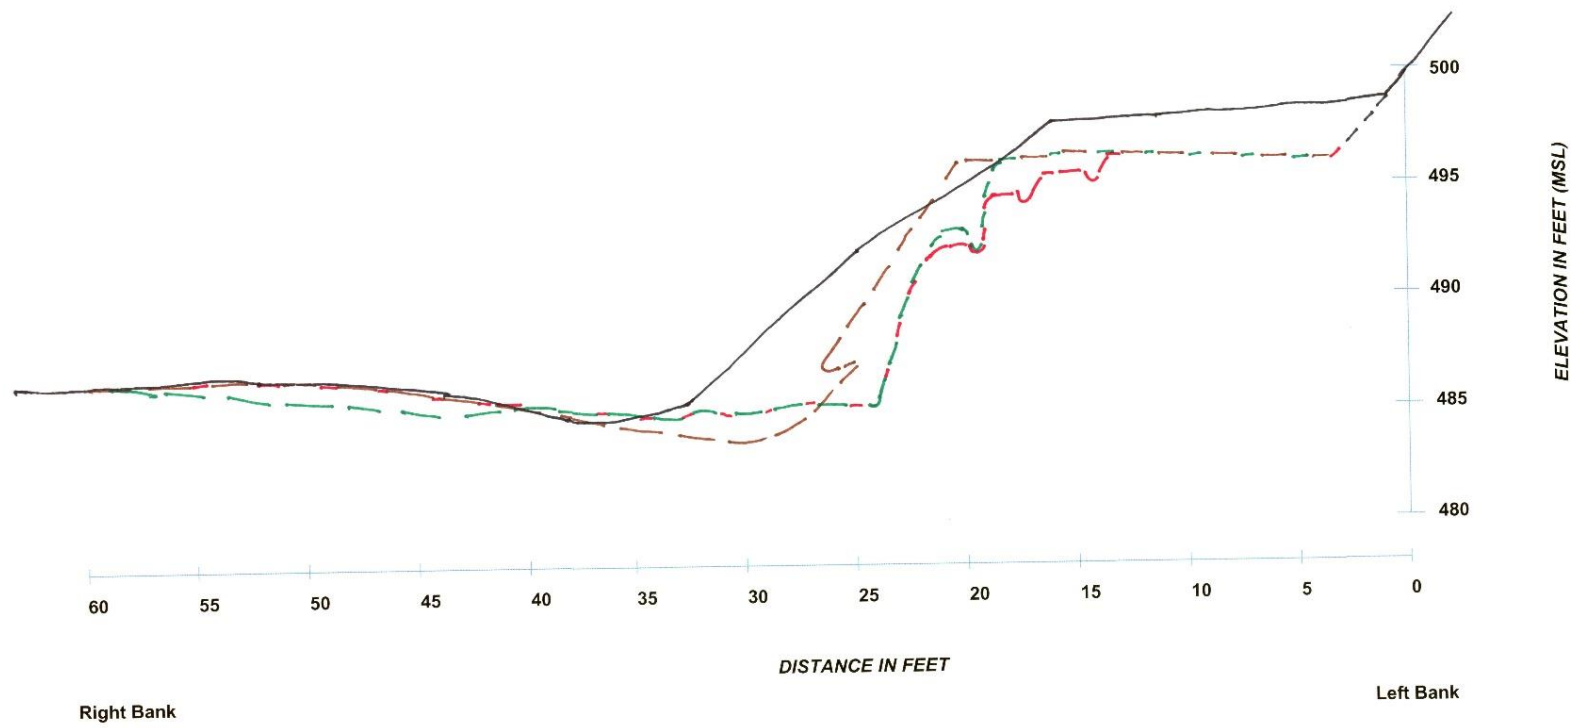
Stream Bank Repair Cross Section: As built vs previous

Comparative Cross Sections
Soquel Demonstration State Forest, Hihns Mill Road Repair,
Sections Prepared by California Geological Survey
2014
